January 3, 2018

Kevin Callan, Executive Director
Washington State Major League Baseball Stadium
Public Facilities District
PO Box 94445
Seattle, WA 98124

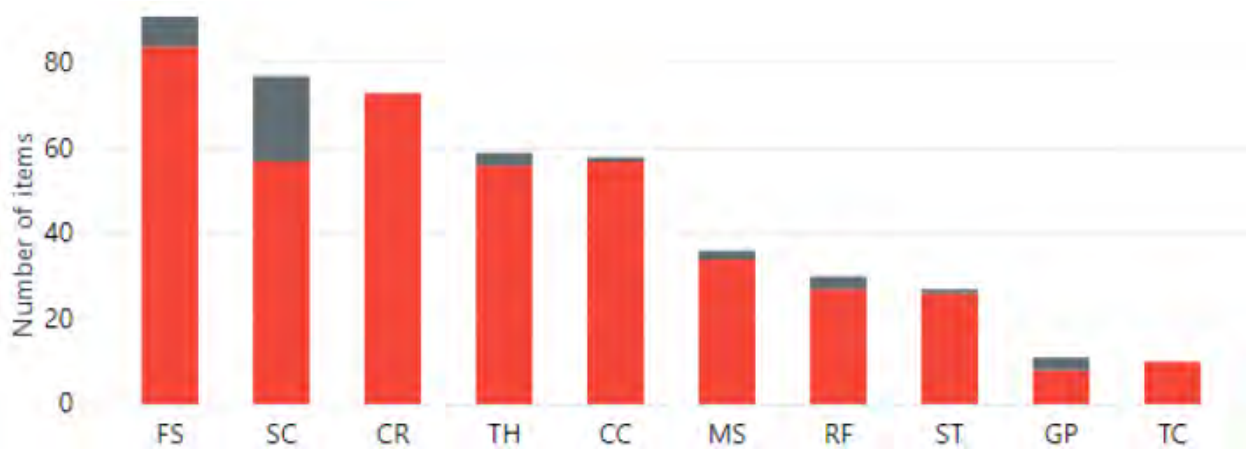
*Note: Red represents the '451 total 'Open' issues, and Grey represents the 40 'Closed' issues.

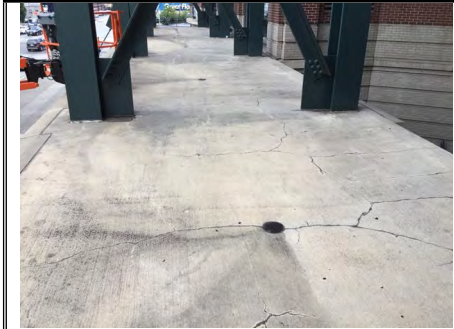
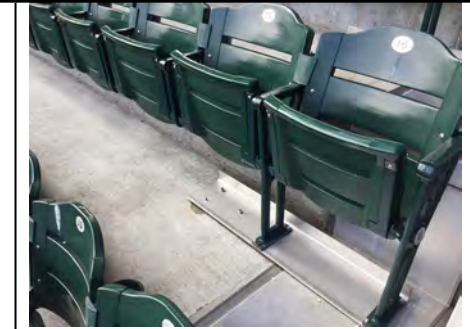
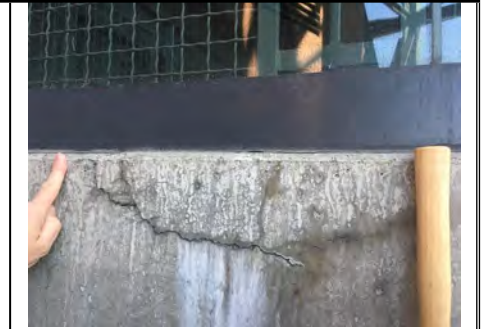
<p>CC- Cracked concrete deck, above PFD Office, and Ticket sales on south side. Issue #497, Priority 2.</p>	<p>MS-Missing bolt at base plate. Issue #582, Priority 3.</p>	<p>SC-Spalled concrete at slab edge of staircase. Issue #501, Priority 1.</p>

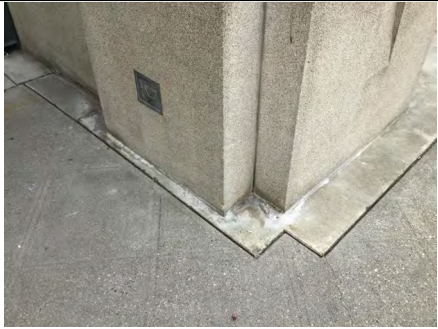
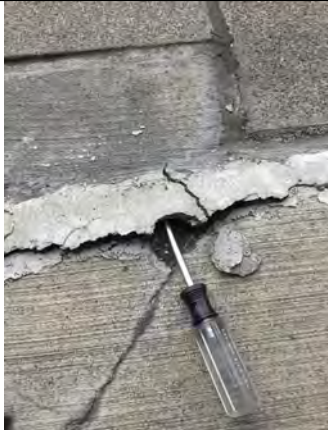
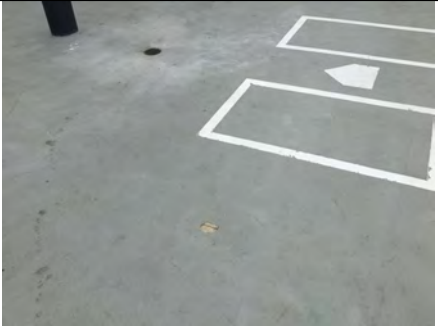
<p>CC - Efflorescence buildup at base of column. Further examination required Issue #508, Priority 4.</p>	<p>CC - Failure of previously repaired joint at concrete deck above south Ticket Sales office. Coordinate with similar issue noted in Structural section. Issue #496, Priority 2.</p>	<p>TC - Level 300 Home Plate courtyard traffic coating has reached the end of its useful life, with multiple areas of degradation throughout. Replacement is required over this off-season (2017-2018). Issue #524, Priority 2.</p>

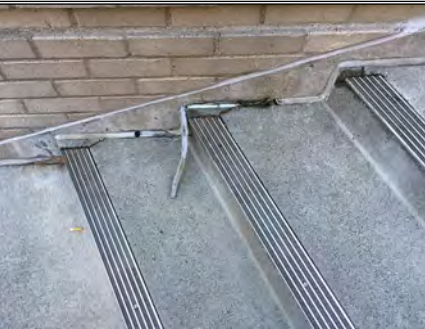
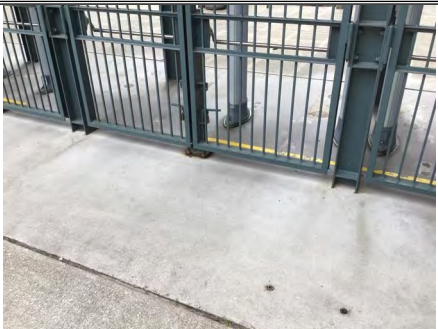
<p>SC - Spalled brick at support pin location beneath the precast cornice. This issue is at multiple locations. Further investigation for repair solution recommended. Issue #613, Priority 2</p>	<p>FS - Sealant failure along concrete stairs to brick wall joint. Repair recommended in off-season. Issue #611, Priority 3</p>	<p>CR - corrosion at north entrance (Left Field) steel gate. This should be addressed during this off-season. Issue #506, Priority 2</p>

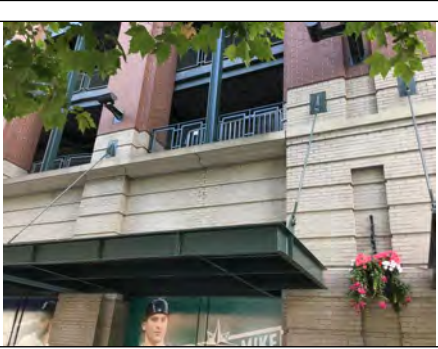
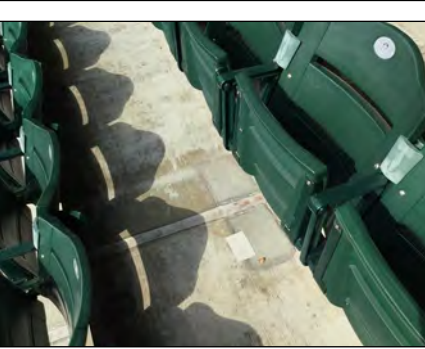
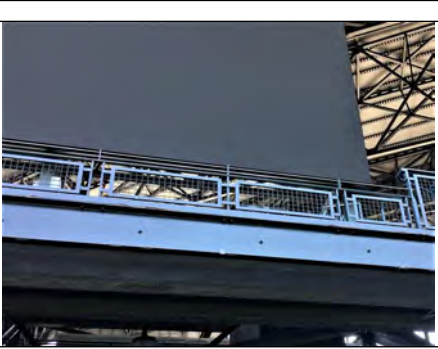
<p>FC - Significant efflorescence build-up beneath cornice to brick wall joint at open bays along west facade. Issue #547, Priority 2</p>	<p>SC - Sample photo of repairs made to spalled concrete (per 2016 MOR issue) at seating bowl.</p>	<p>CR - Corrosion observed at steel rim plate at concrete deck slab edge. Recommend continuing removal of corrosive element and repaint of steel in off-season. Issue #597, Priority 4</p>

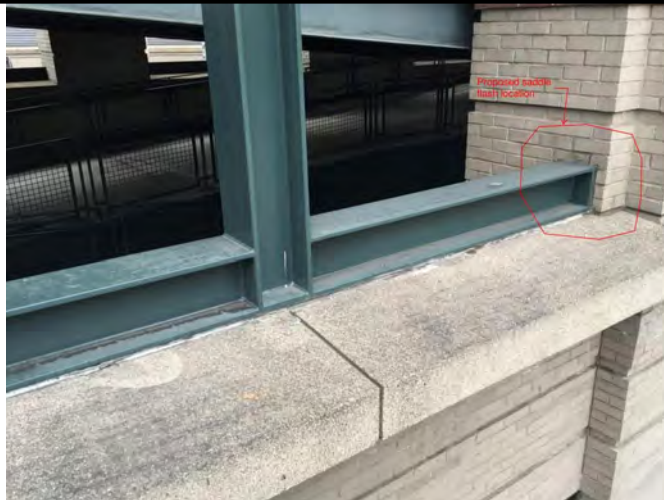
Condition prior to saddle flash install and sealant replacement.

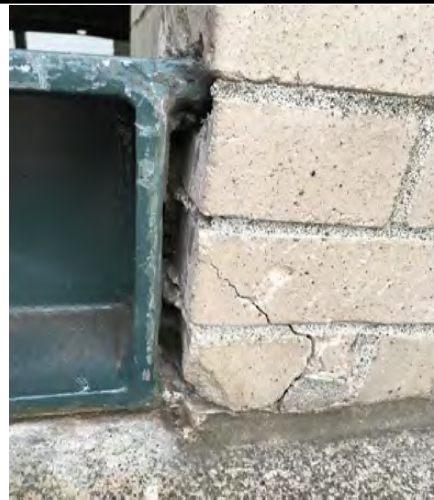
Beam end with failure at brick pilaster.

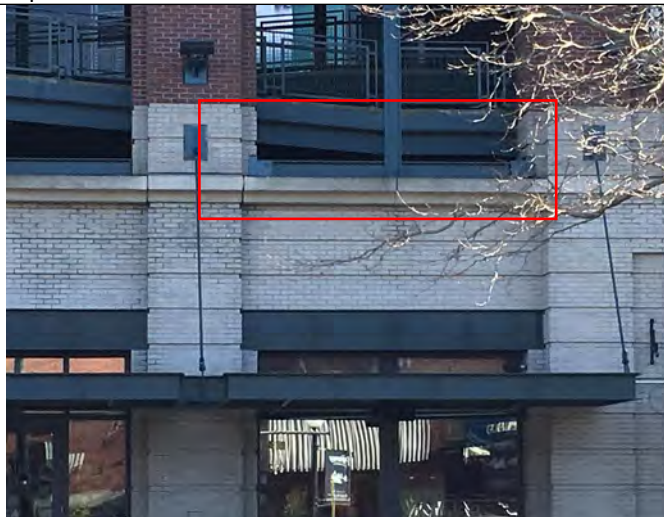
Saddle flashing installed at both ends of beam.

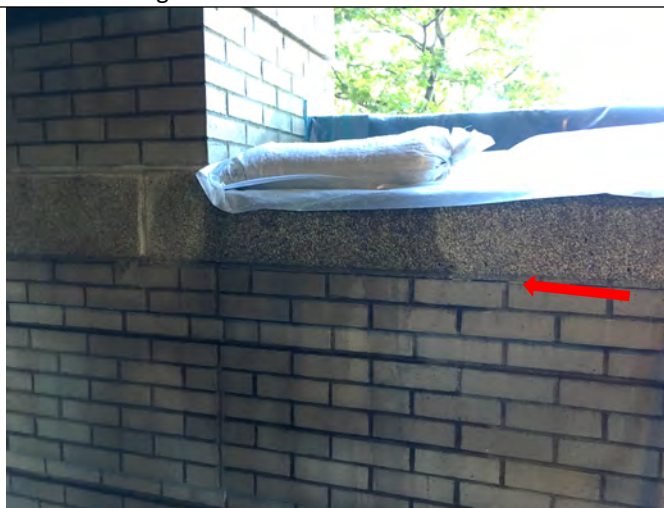
Water infiltration at brick wall to cornice joint during isolation water test.

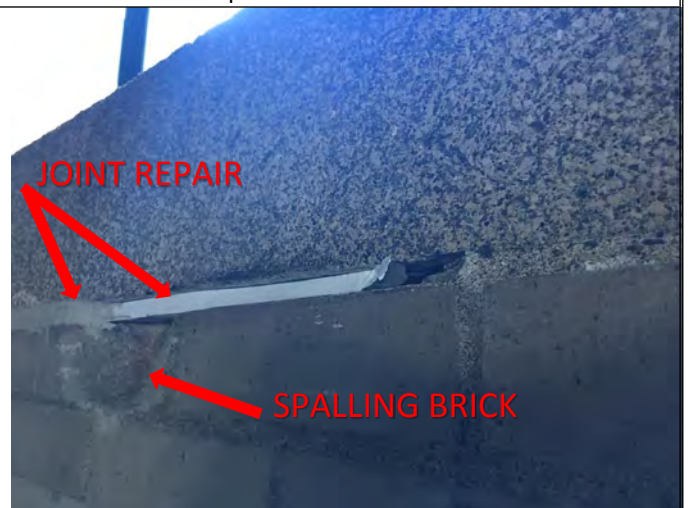
Brick wall to cornice joint repair in progress, located at cornice associated to the west facade saddle flash installation. Also note failure of joint causing spalling brick.

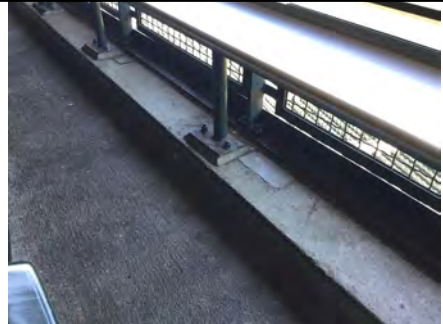
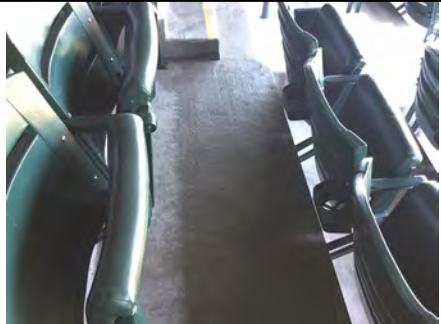
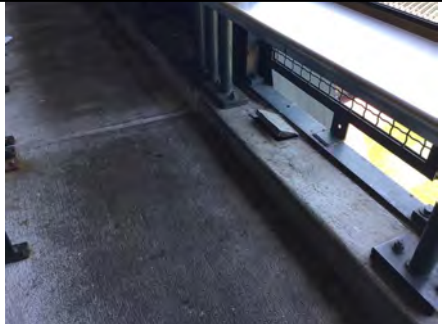
GP - One loose grout pocket at suite 53. Update 2017 MOR - Action completed. Issue #335, Priority 2.	GP - Missing grout pocket near seat 9 row 10 section 236. Update 2017 MOR - Action completed. Issue #358, Priority 1.	GP - Loose grout pocket at suite San Francisco Seals. Update 2017 MOR - Action remains 'Open'. Issue #343, Priority 2.

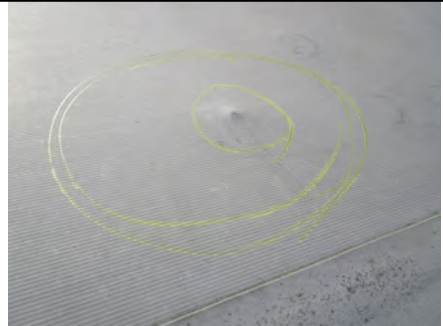
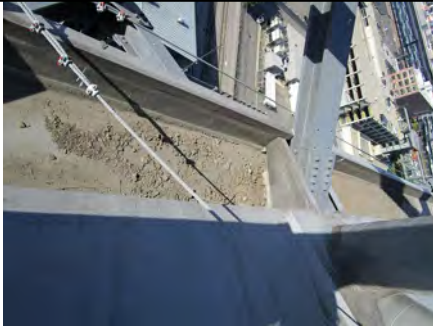
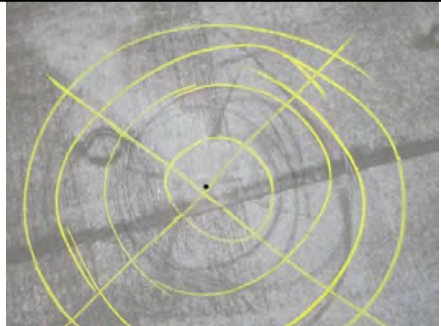
RF - Disengaged fastener	RF - Gutter debris.	RF - Panel #3, south half, bullet hole.

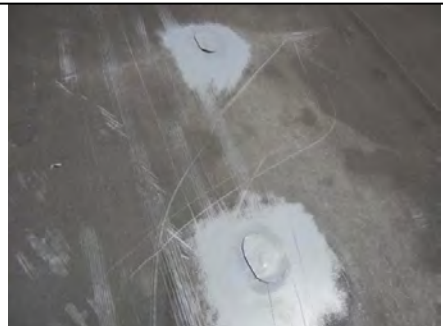
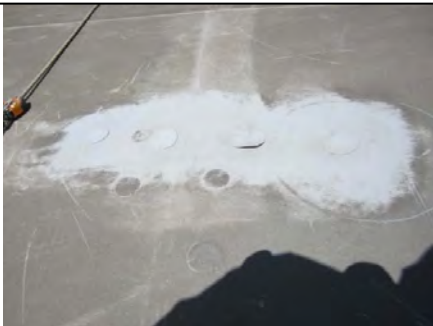
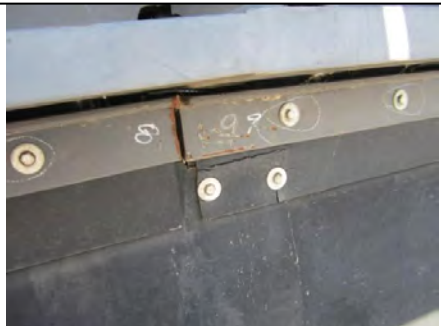
RF - Failure of recently placed patchwork.	RF - Panel 3, south half. Repairs of previous holes that are failing, loose and not properly adhered.	RF - Cracking at Skirt panel connection 8/9. Ongoing issue.

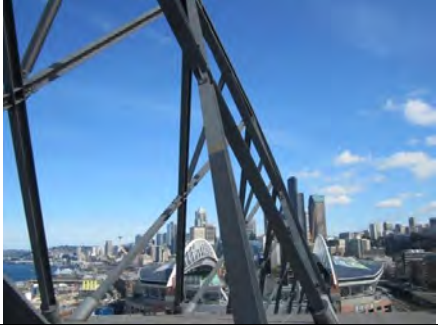
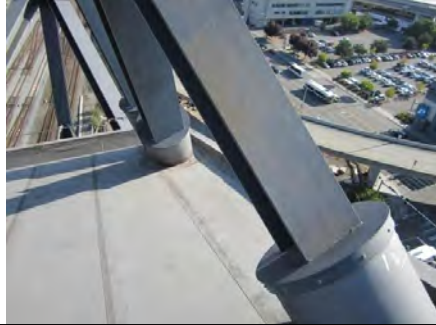
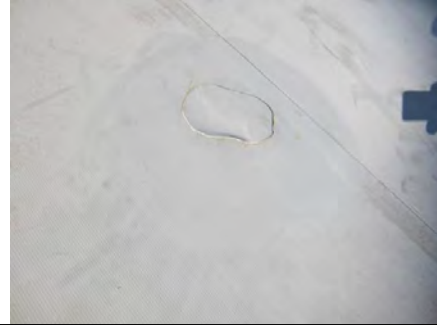
RF - Panel 2, north half. Truss A. Evidence of recent repainting. Note minor corrosions still evident above the recent painting. This is common in several areas of the truss framing.	RF - Panel 2, Truss D, NE corner. Minor corrosion showing through painted finish on truss.	RF - Panel 2 - North half, Truss C, east side. Just east and slightly south of truss Column H. Infill piece of previous hole in membrane. Appears there was a cover patch, that has since fallen off.

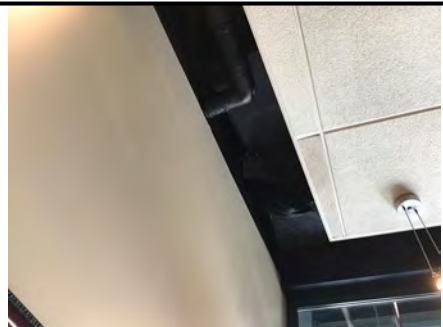
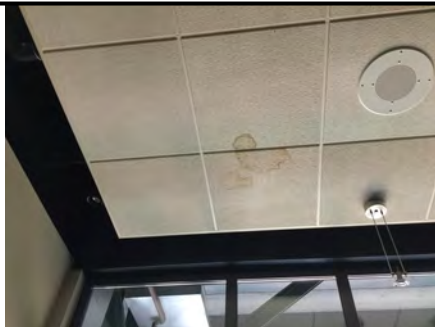
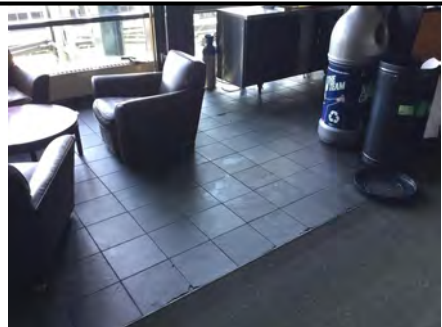
<p>MS- Water infiltration at ceiling of suite 35. Further investigation recommended. Issue #604, Priority 2.</p>	<p>MS - Stained ceiling tile, Suite 29. Issue #605, Priority 4.</p>	<p>MS - Damaged slate tile at food bar, located near Section 220. Issue #607, Priority 4.</p>

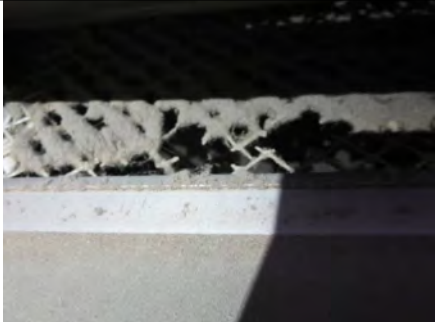
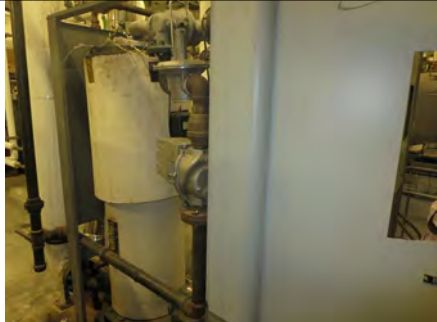
CR – Corrosion on exterior fire sprinkler head. Priority 1.	MP – Deteriorating wire bird screens in the outside air intake louvers for the air handling units. Priority 3.	MP – Inactive heating water boiler due to failed heat exchanger. Priority 2.

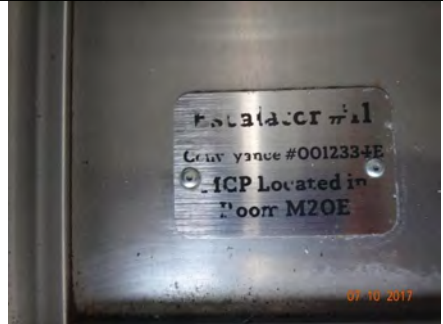
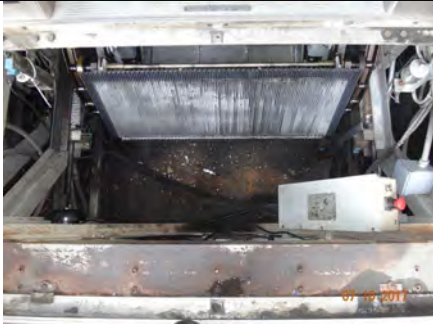
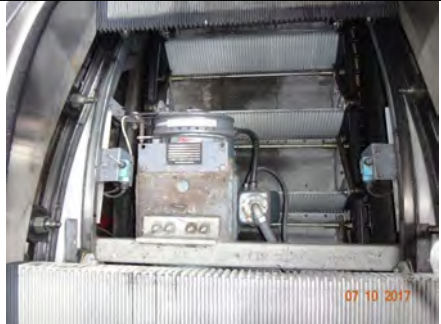
1.1 Sign with escalator numbers is worn.	1.2 Typical escalator pit with minimum dirt.	1.3 Escalator motor at top of escalator with light layer of dust.

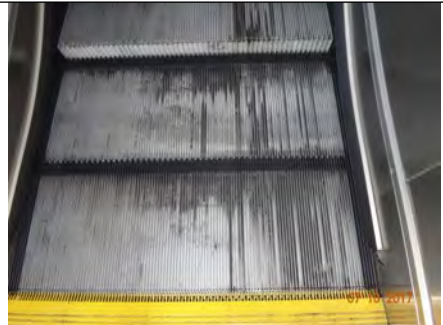
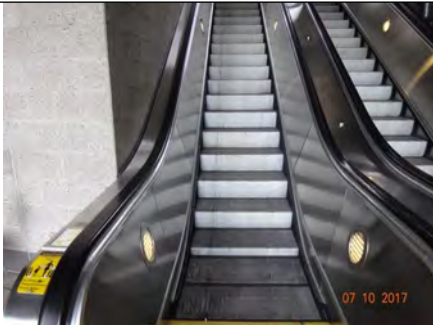
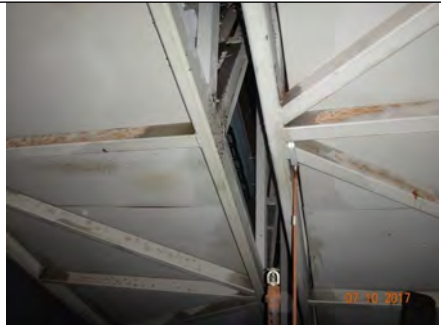
1.4 Escalator steps with excessive oil/grease on steps and risers.	1.5 Escalator with minor oil leak on left side.	1.6 Bottom of escalators 13 and 14 is open to space above freezer.

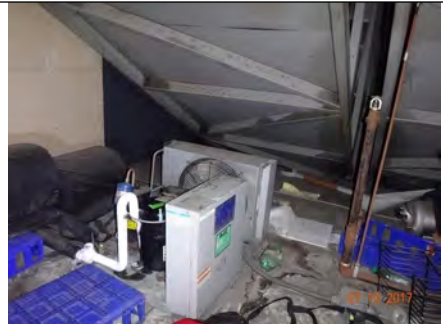
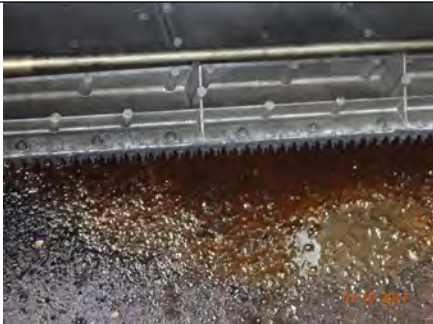
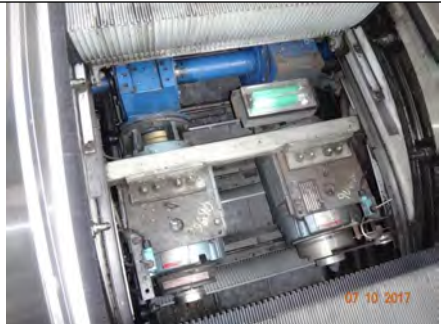
1.7 Underside of escalators for 13 and 14 is open.	1.8 Excess oil accumulation in pit.	1.9 Top of escalator 11 with dual motors.

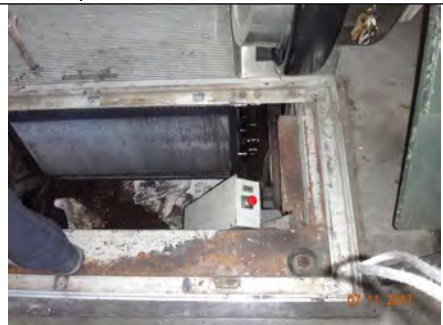
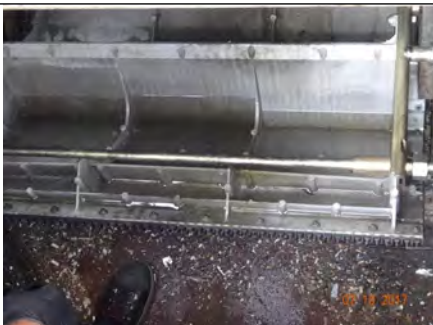
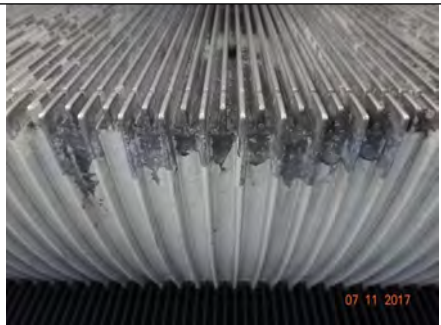
1.10 Pit in fair condition.	1.11 Oil accumulation in pit.	1.12 Finish of leading edge of step is coming off.
