T-Mobile Park

Presentation to the
Washington State Ballpark
Public Facilities District (PFD)
on the
2024 Annual Inspection

T-Mobile Park
1250 1st Ave S.
Seattle, WA 98134

Thornton Tomasetti

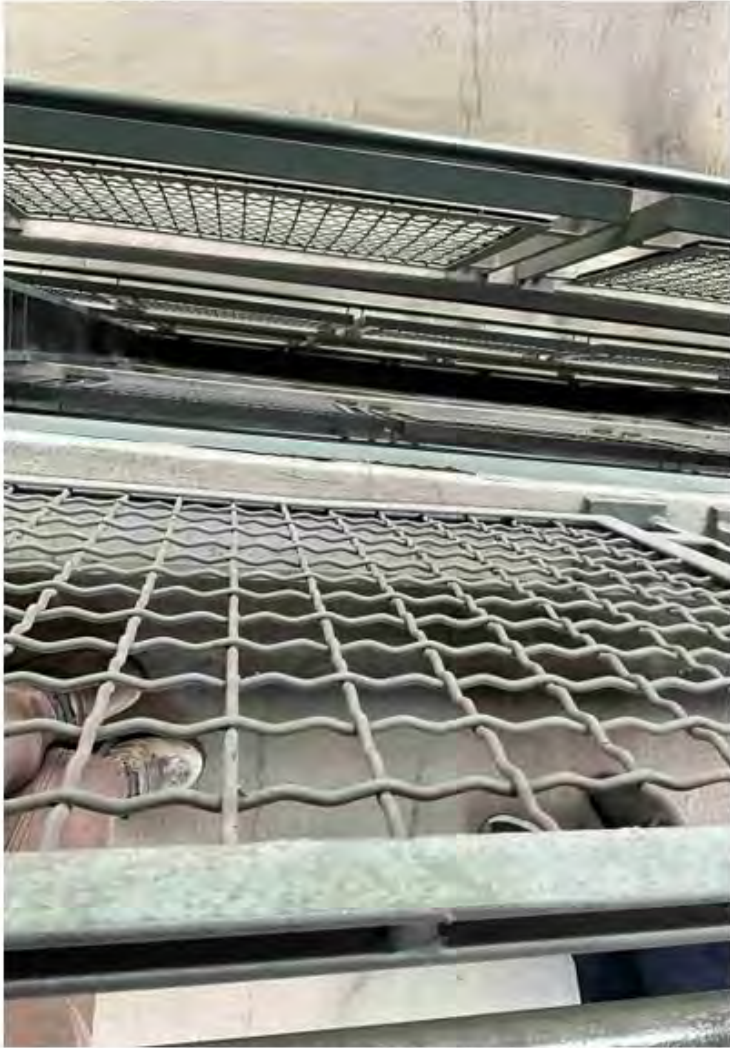
20240730_155843 (Page C-4)

Figure 19. Photos of Representative Slab Edge Conditions Categorized Tier 1

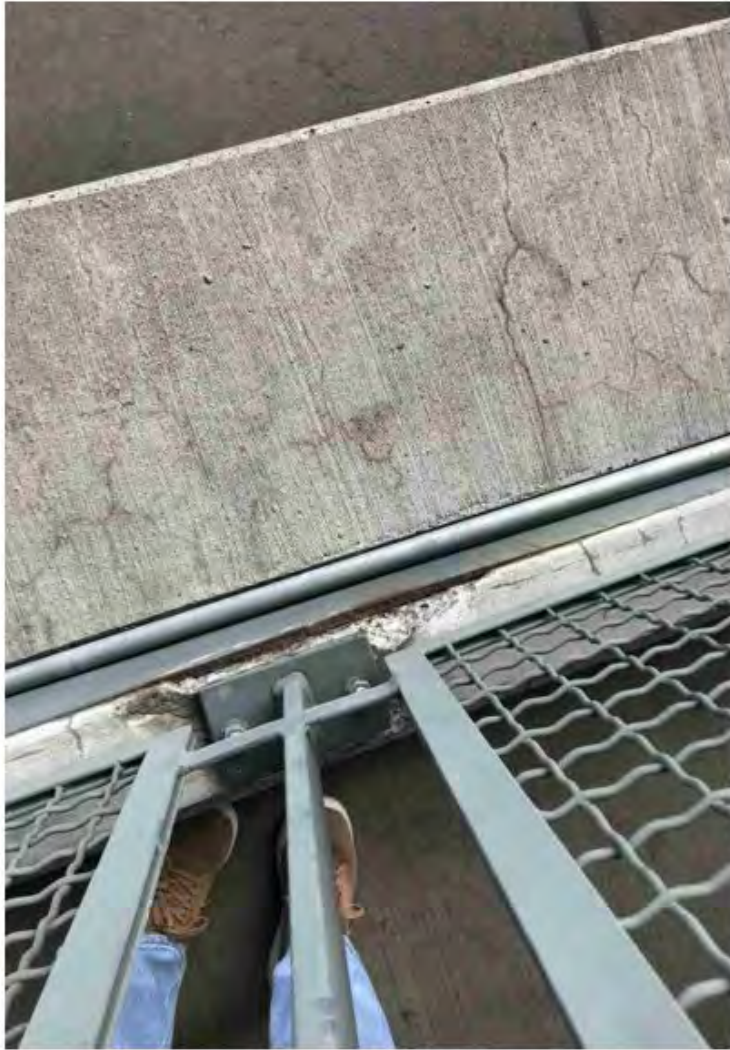
20240730_151624 (Page E-12)

Figure 21. Photos of Representative Slab Edge Conditions Categorized Tier 3

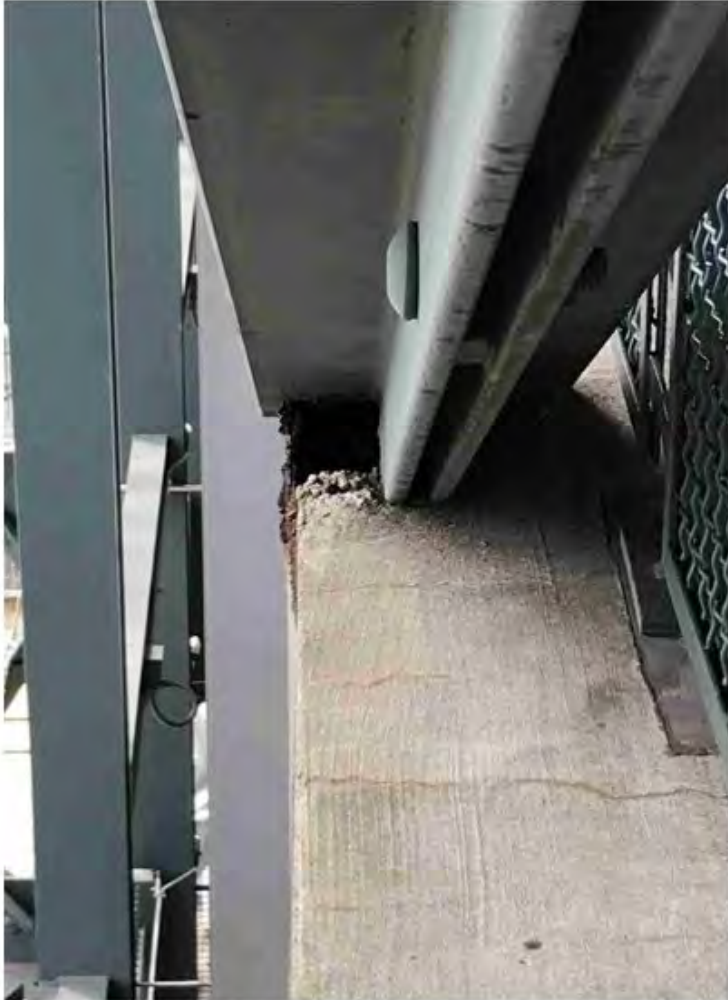
20240730_143434 (Page G-3)

Figure 23. Photos of Representative Slab Edge Conditions Categorized Tier 5

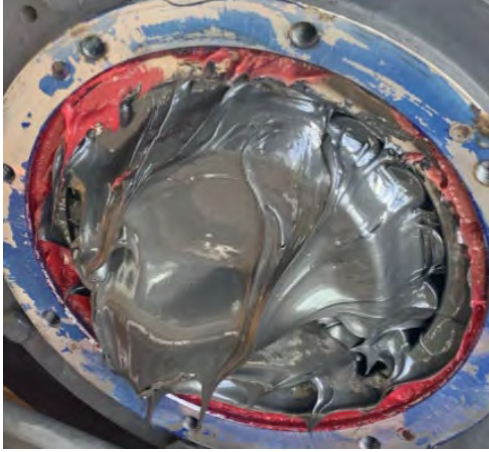
Over-worn, overloaded bearing. Dark grey grease. G5 wear

- Color scaling from G5 (bad) to G1 (good).
- After investigating several wheel bearings on Panel 2 South, various grease colors have been found indicating different amounts of wear.

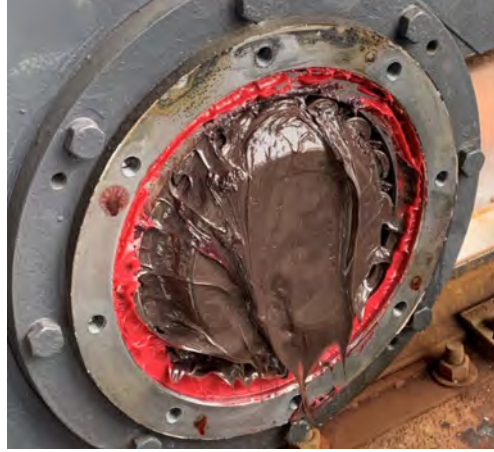
Worn bearing. Purple/brown grease. G4 wear

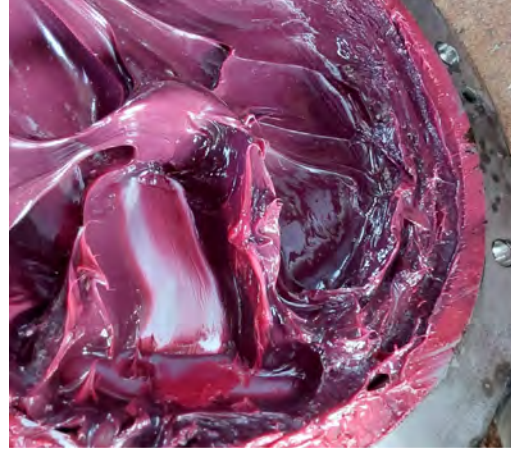
Normally-worn bearing. Purple. G3 wear

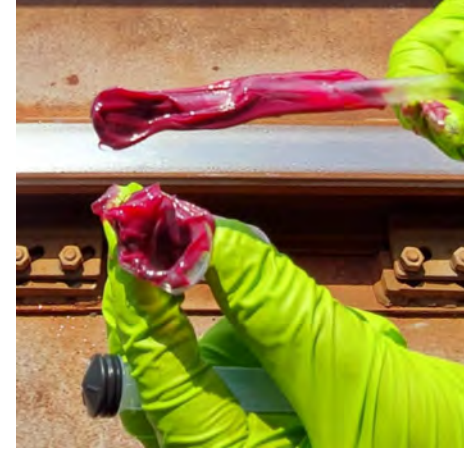
Brand new grease after 1 run. Mixed with residual grey grease. Purple G1-2 wear.

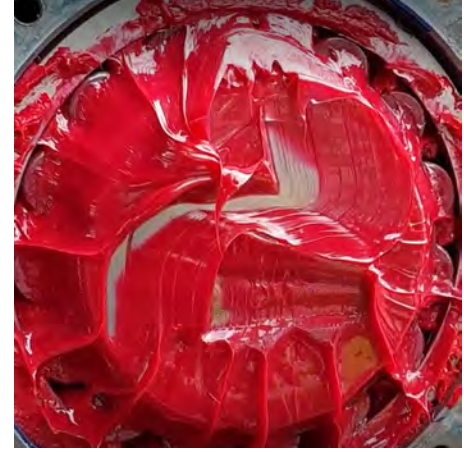
Brand new grease. Bright red. G1 wear
