# Seattle Mariners T-Mobile Park Long-Term Capital Needs Assessment REPORT / MAY 2022

# 1.0 - PREFACE

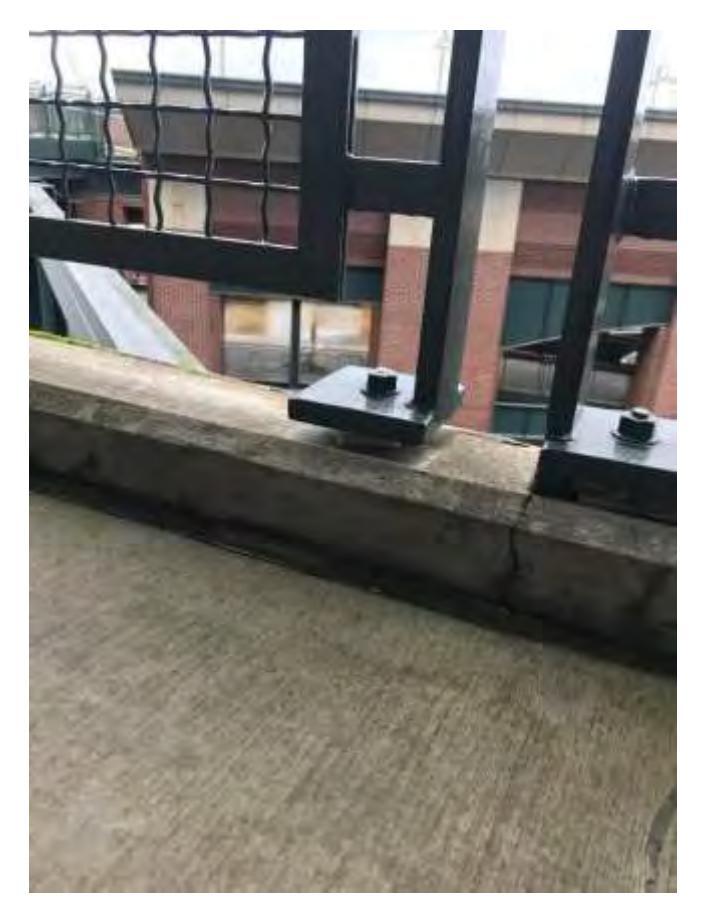
Missing grout at guardrails

Replace grout at guardrail bases where more than 20% is missing.

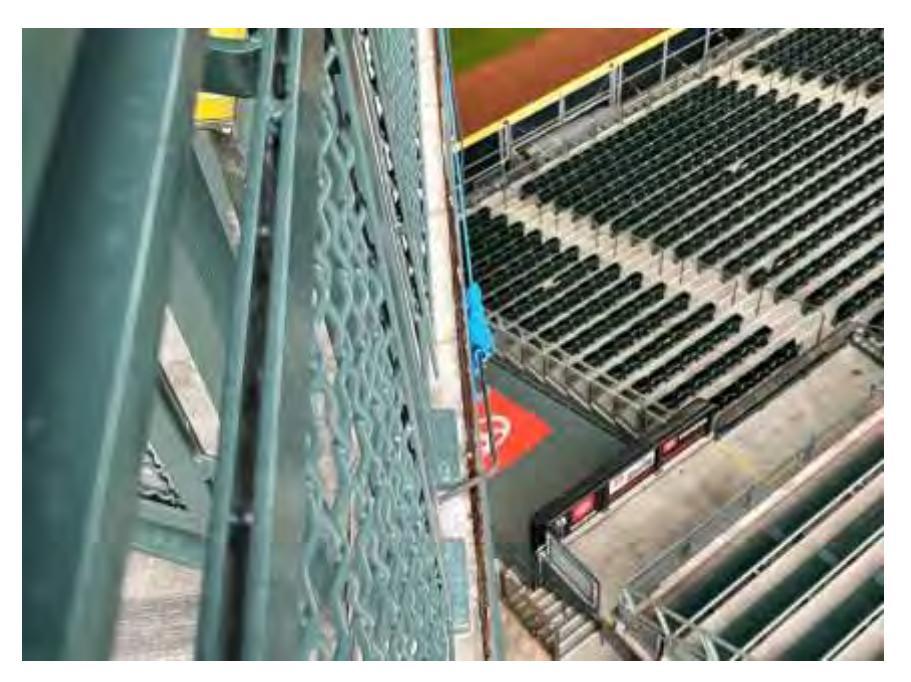
Rust observed at upper concourse deck edges

Gaps should be cleared of any loose material and excessive moisture then sealed with caulking material to prevent future intrusions. Steel elements should be removed of rust, primed with a rust-inhibited epoxy primer, and painted to match the existing structure.

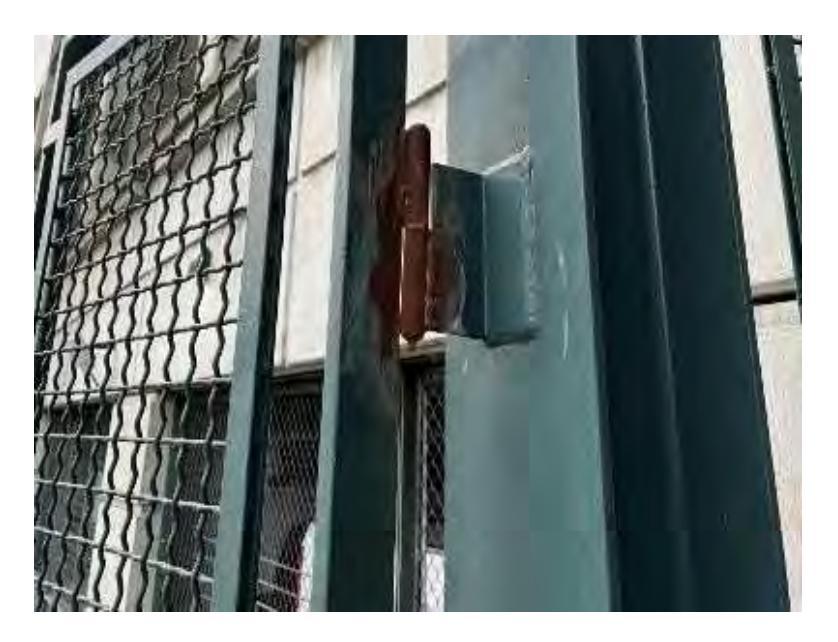
Rust on gate hinges

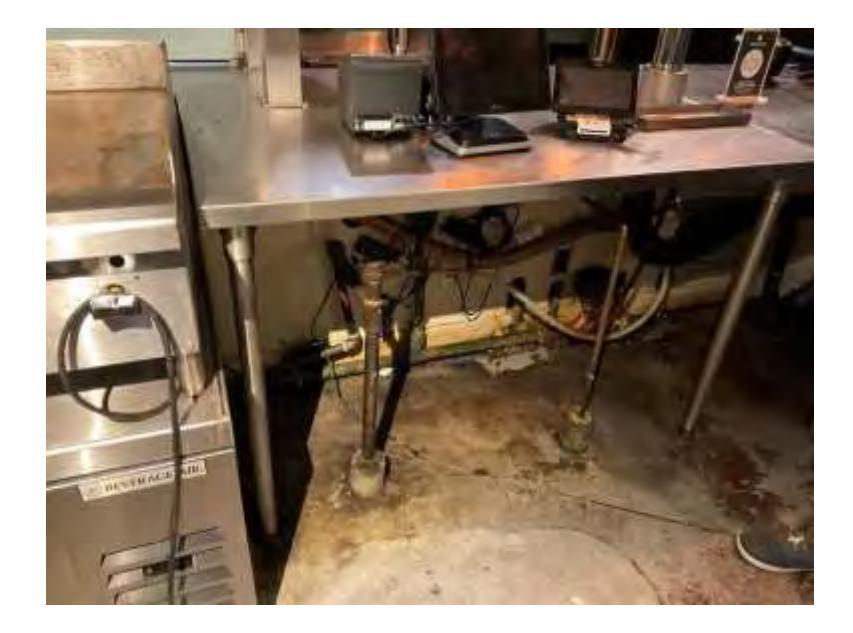
Stainless steel table in room M06A

Implement a phased refurbishment of stainless-steel tables, sinks, and hand sinks in conjunction with planned concession and kitchen renovations. In the interim, replace equipment as it fails.

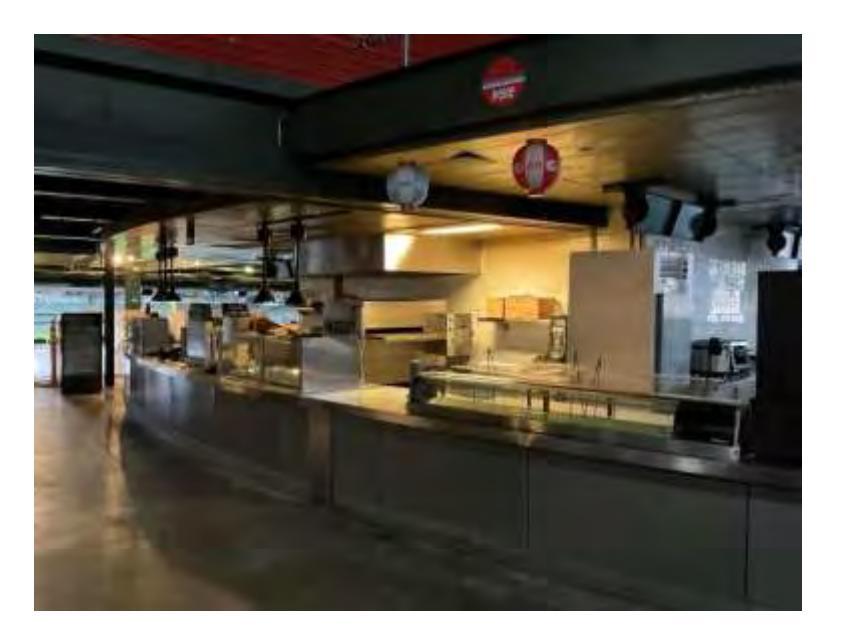
Concessions room M10A

Implement a phased replacement of lighting at concessions in conjunction with planned concession and kitchen renovations.

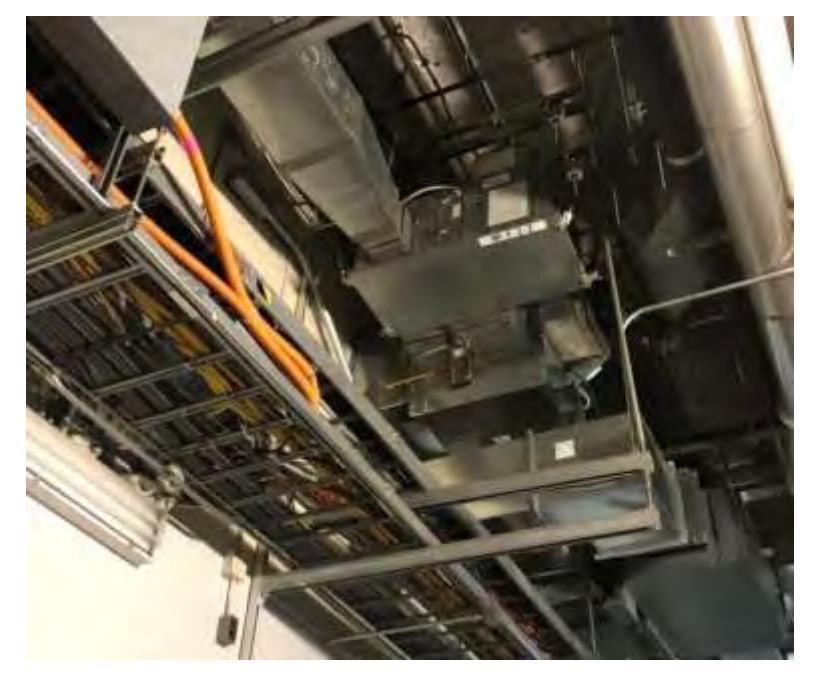
Typical Trane Water Source Heat Pump

Track the replacement frequency each year. As failures become more frequent, initiate a phased replacement plan over a 5–10-year period.

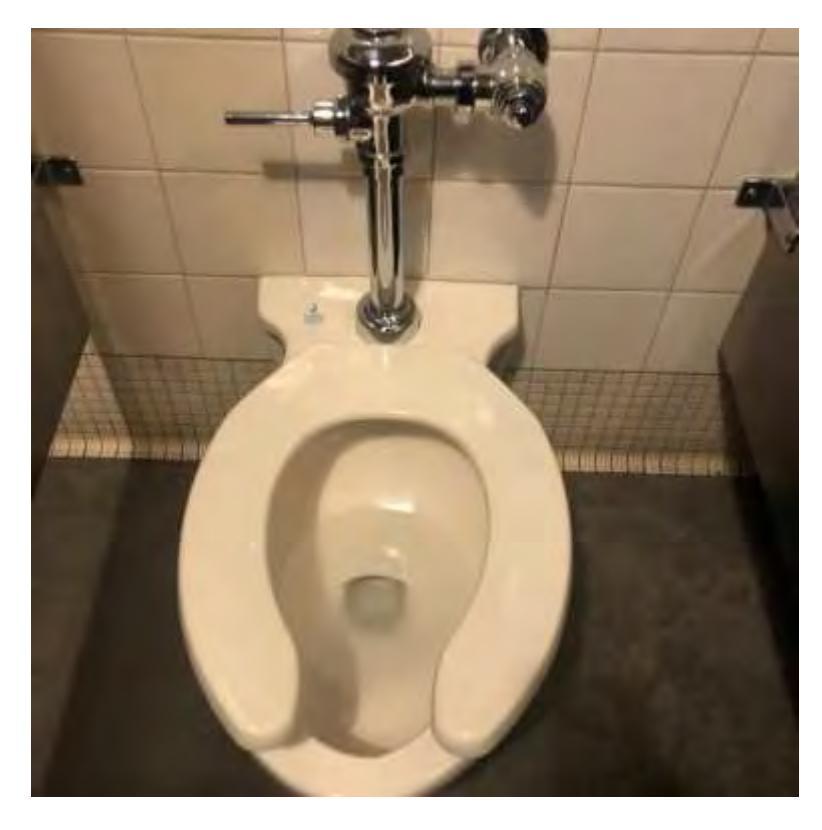
Men's Restroom Toilet

Continue maintenance and service as needed. These fixtures and flush valves should last another 15-20 years. Consider replacement of men's room toilets with low flow similar to women's rooms.

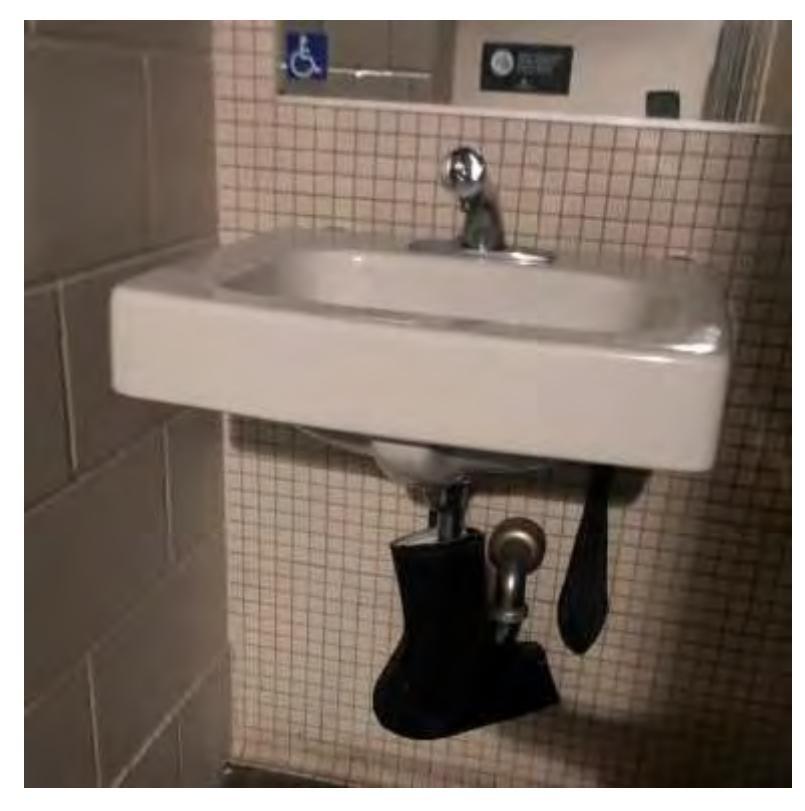
Restroom hand sinks are original fixtures with metered push button faucets. Padding/insulation has been provided at ADA locations. Few problems have been reported.

Public restroom lavatories

These fixtures should last another 10-15 years before they begin to wear, and parts become scarce. Review all ADA locations and confirm good condition of insulation on drain lines where needed.

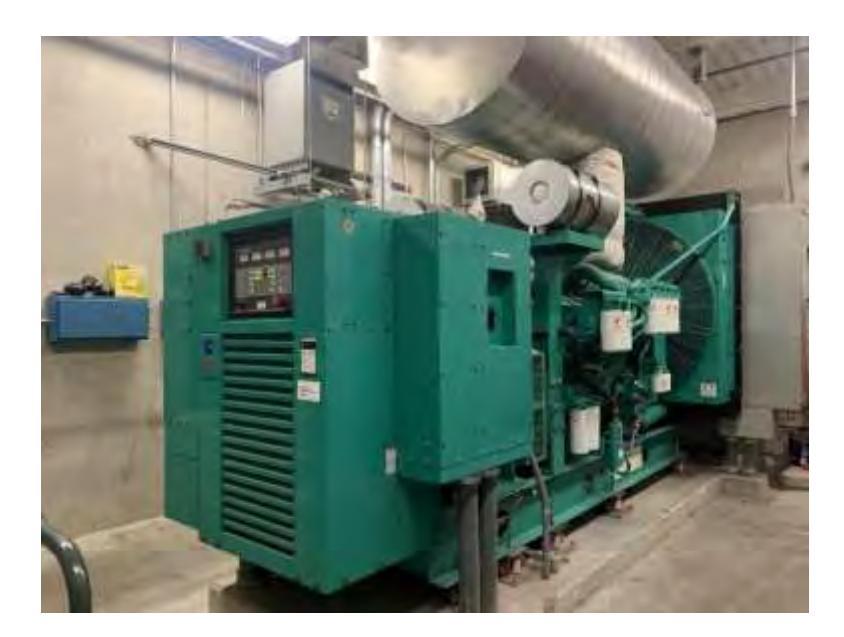
3rd Base Generator

Continue regular maintenance of the generator on the load bank. Operate the generator under building load to ensure the Automatic Transfer Switches adequately transfer the load to the generator. The generator should operate reliably for 3-10 years without major service, at that point a more intensive rebuild of components maybe required.

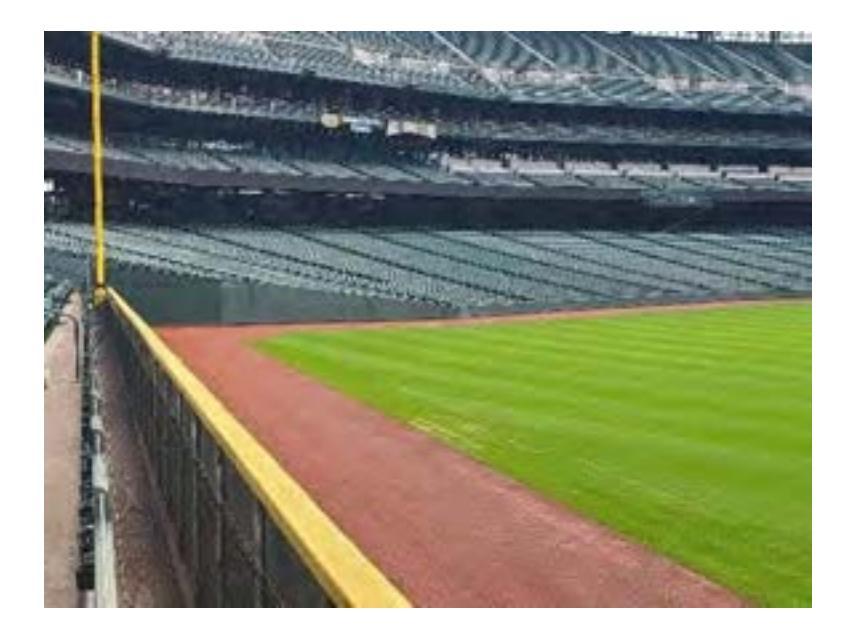
Field wall padding

Replace field wall pads within the first 5 years of the plan.

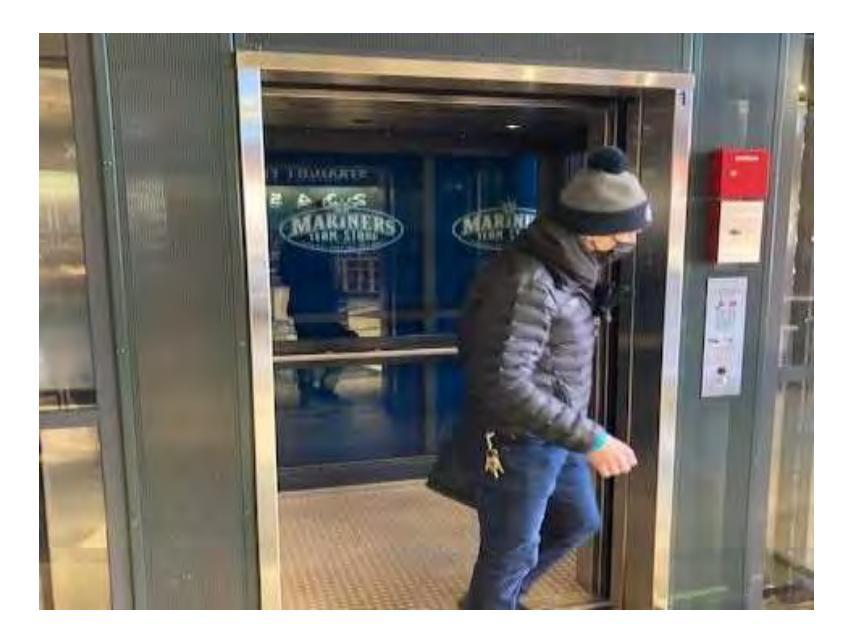
Car 1 entrance

Modernize controls, power unit, fixtures, door operator and door equipment at Car 1. Coordinate with mechanical, electrical, and fire protection.

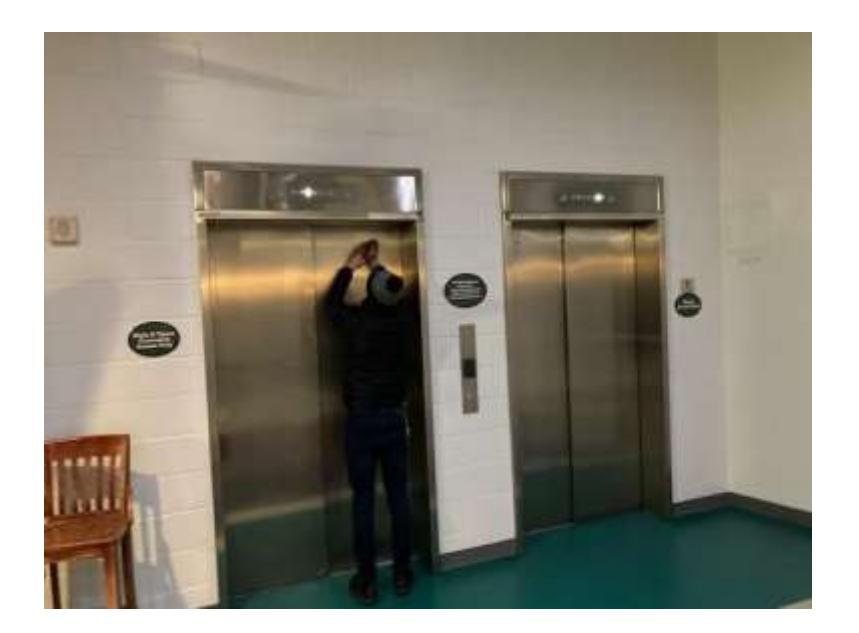
Car 5 and 6 entrances

Modernize controls, AC VVVF motor and machine refurbishment, fixtures, door operator and door equipment at Cars 5 and 6. Coordinate with mechanical, electrical, and fire protection.

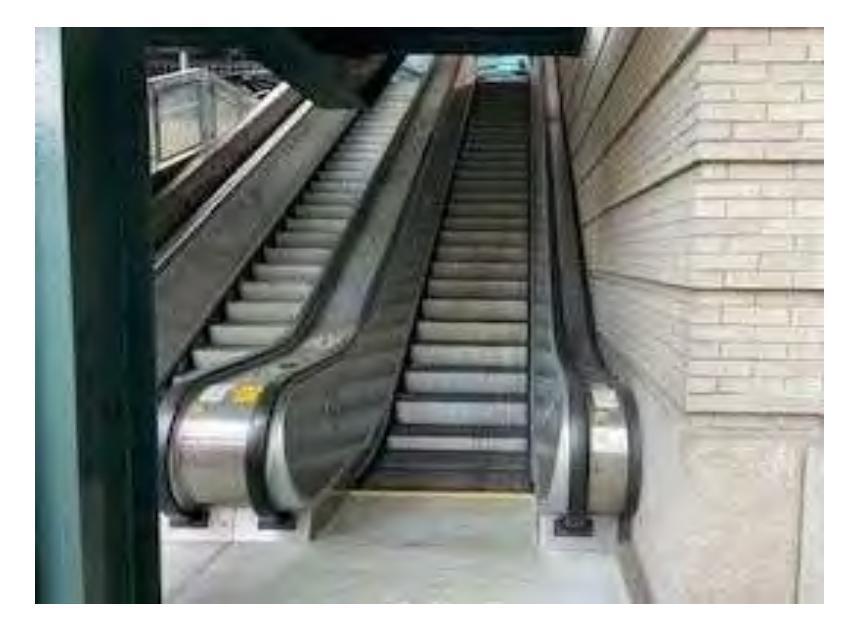
Escalator 11

Replace complete escalator.

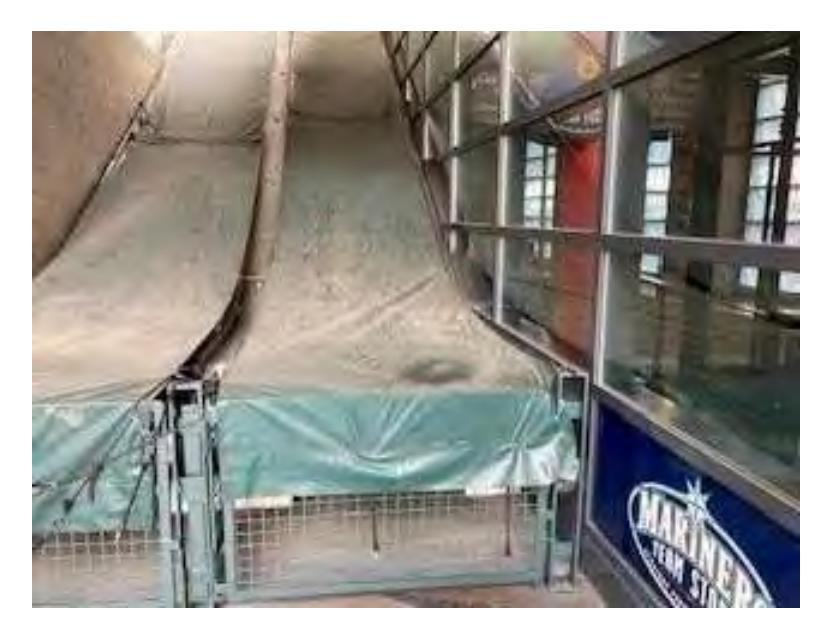
Escalator 14

**Recommendation:** Replace complete escalator.

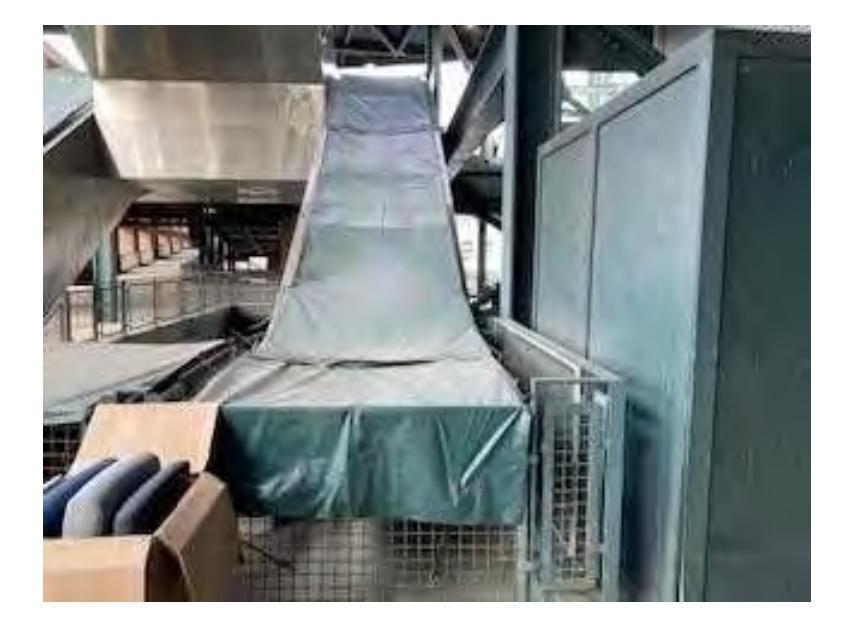
Escalator 16

Replace complete escalator.

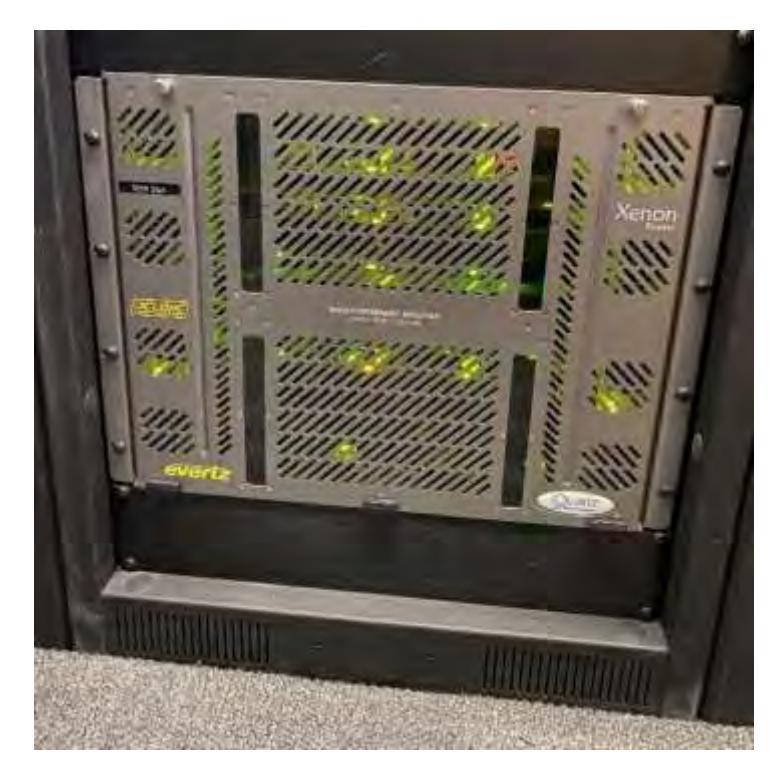
Broadcast router in core

The router should be replaced with current 4K technology. Both systems should be replaced in the next 1-3 years to avoid a potential failure in the middle of a game and avoid a situation in which parts may not be available to resolve any issues that arise.

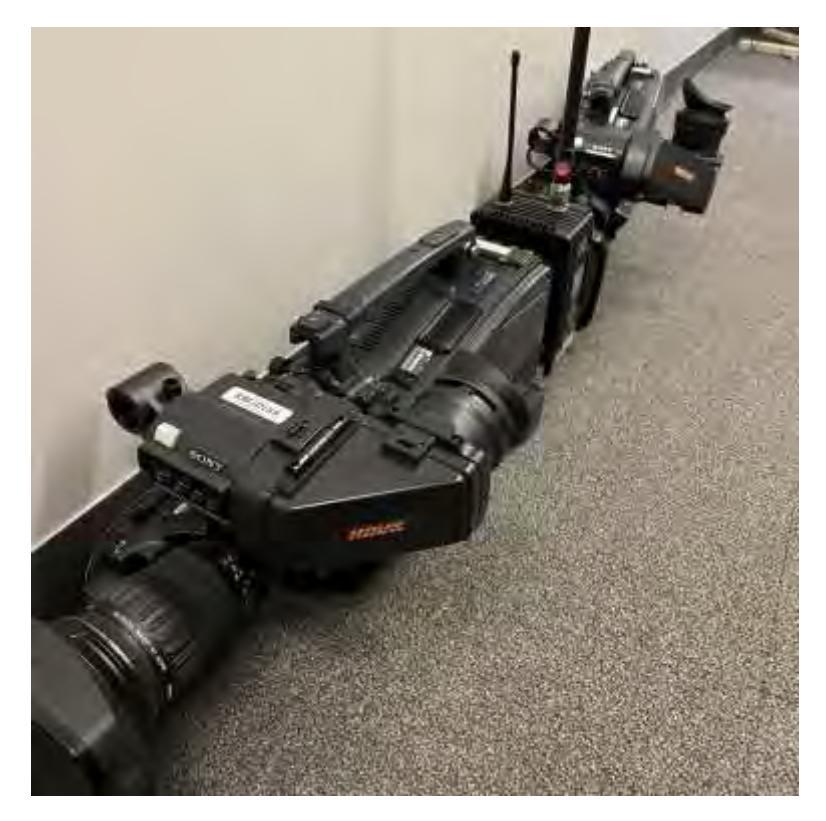
ENG cameras with RF transmitters

Cameras should be upgraded in the next 1-3 years to 4K with a broadcast upgrade to align with current standards. Wireless units are from 2006 and should be replaced in the next 1-3 years.

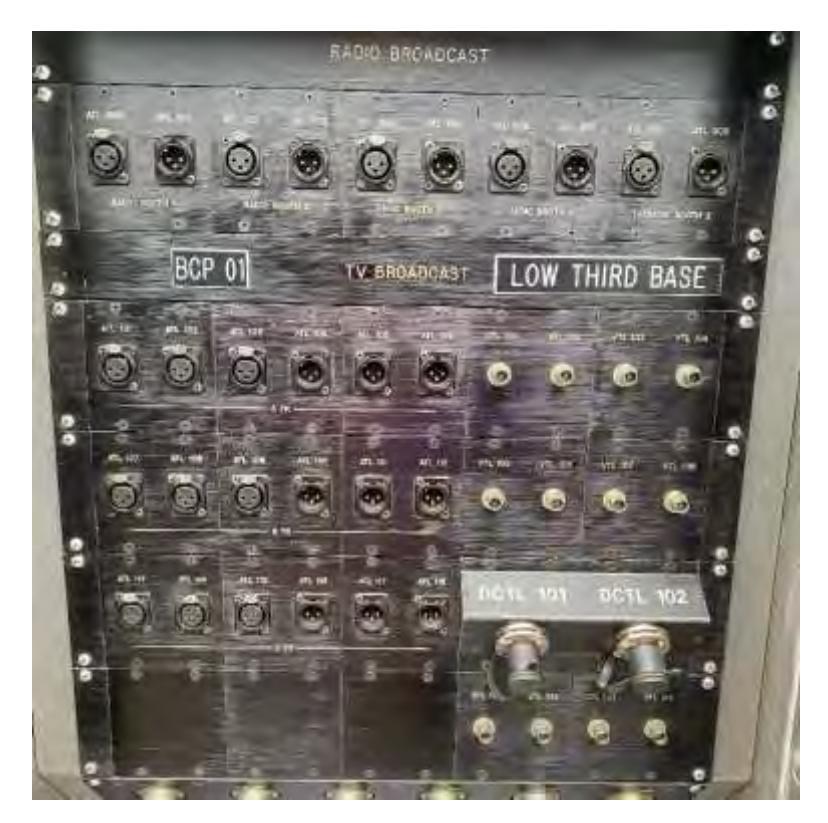
JBT showing triax (at the bottom) and new SMPTE fiber

Remove triax from infrastructure and replace with SMPTE to align with current broadcast standards.

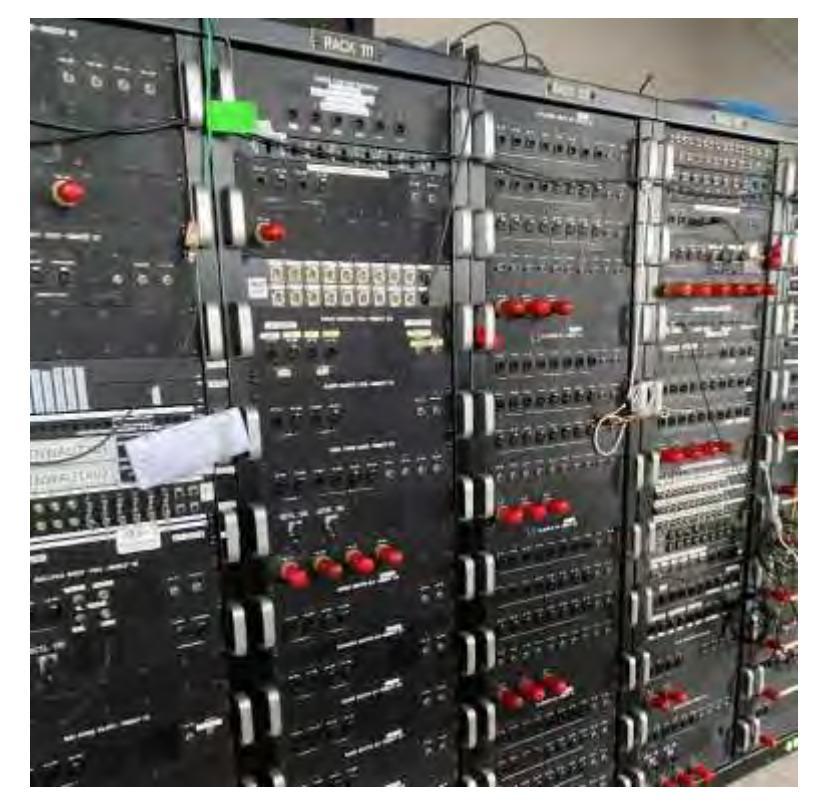
Truck dock racks (red covers are triax connections)

Remove triax from infrastructure and replace with SMPTE to align with current broadcast standards.

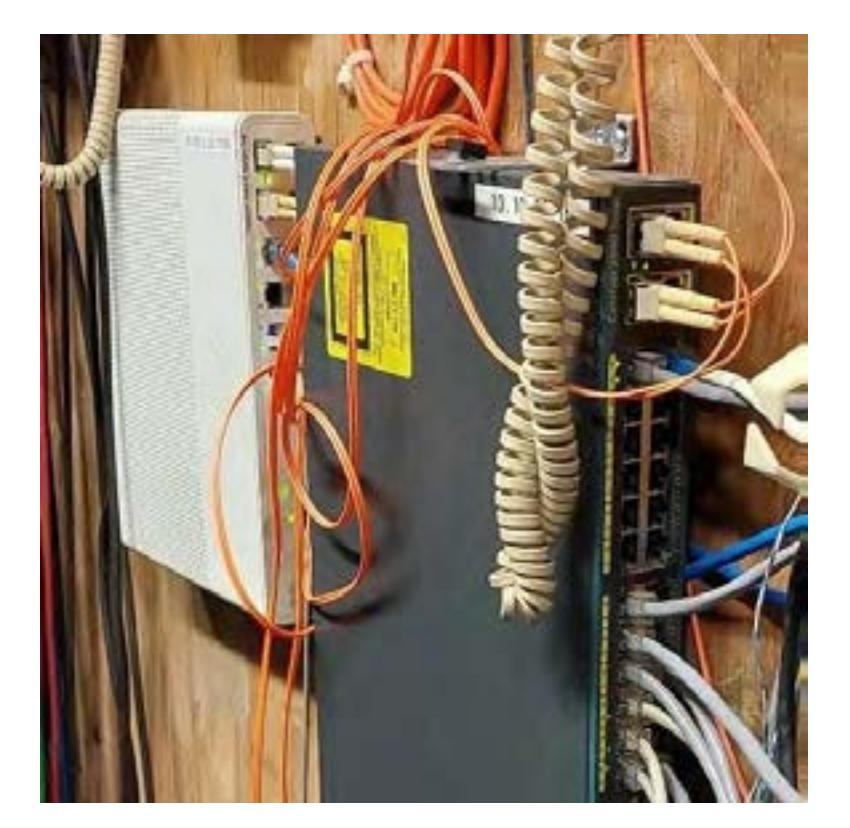
Access Switches wall mounted in a IDF room

The access layer switches need to be replaced. A capital project is planned to start replacement of the switches in 2022.

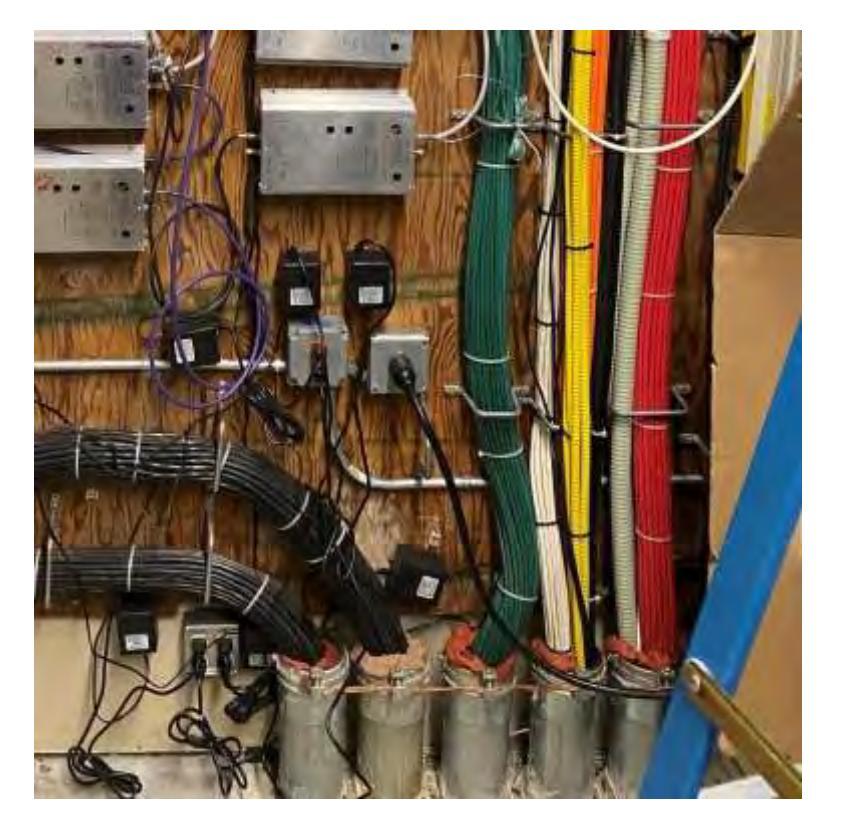
Full backbone riser conduits

Remove older and abandoned cables from the backbone riser conduits.

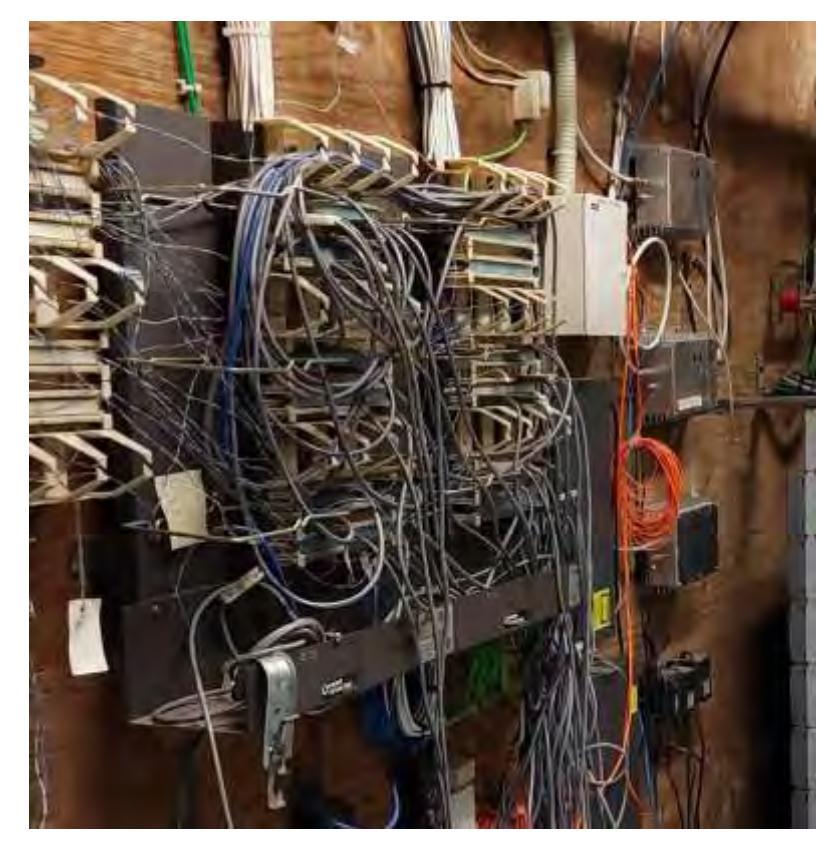
Cat5e horizontal termination wall-field and patching system

A capital project is being planned to upgrade/replace the existing Cat5e with Cat6a cabling.

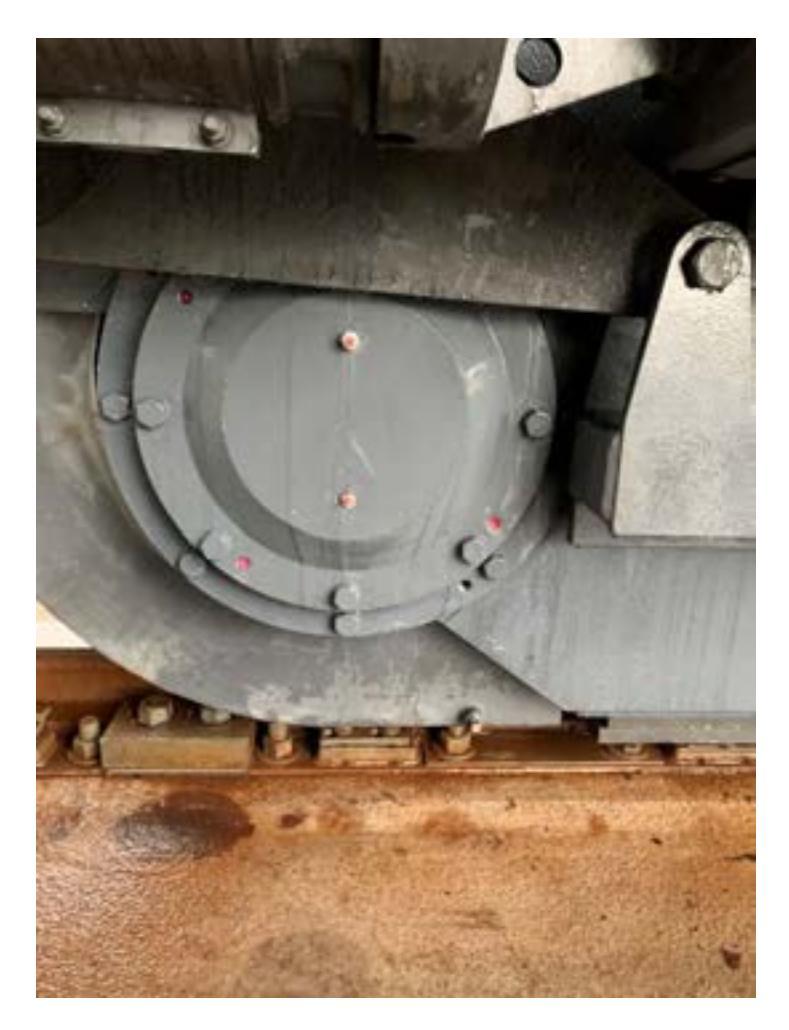
Photo M-1: Observed grease purge (in red) within bearing retainer rings.

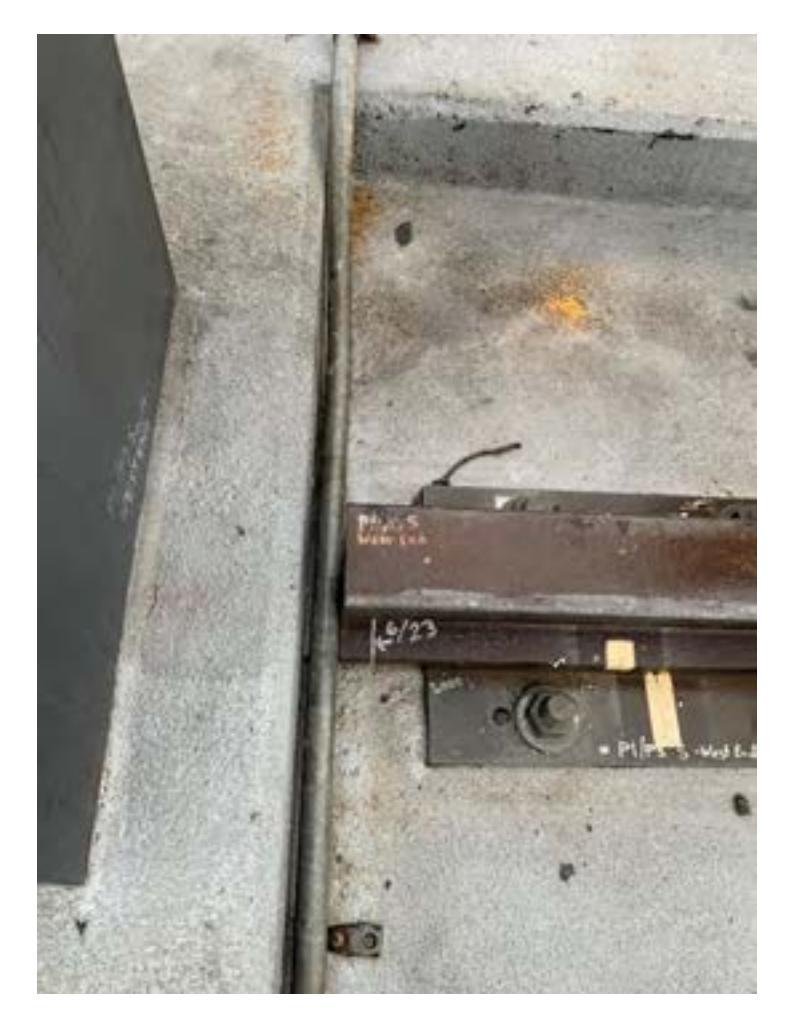
Photo M-3: P1/P3 South rail exhibits movement and is in contact with electrical conduit.

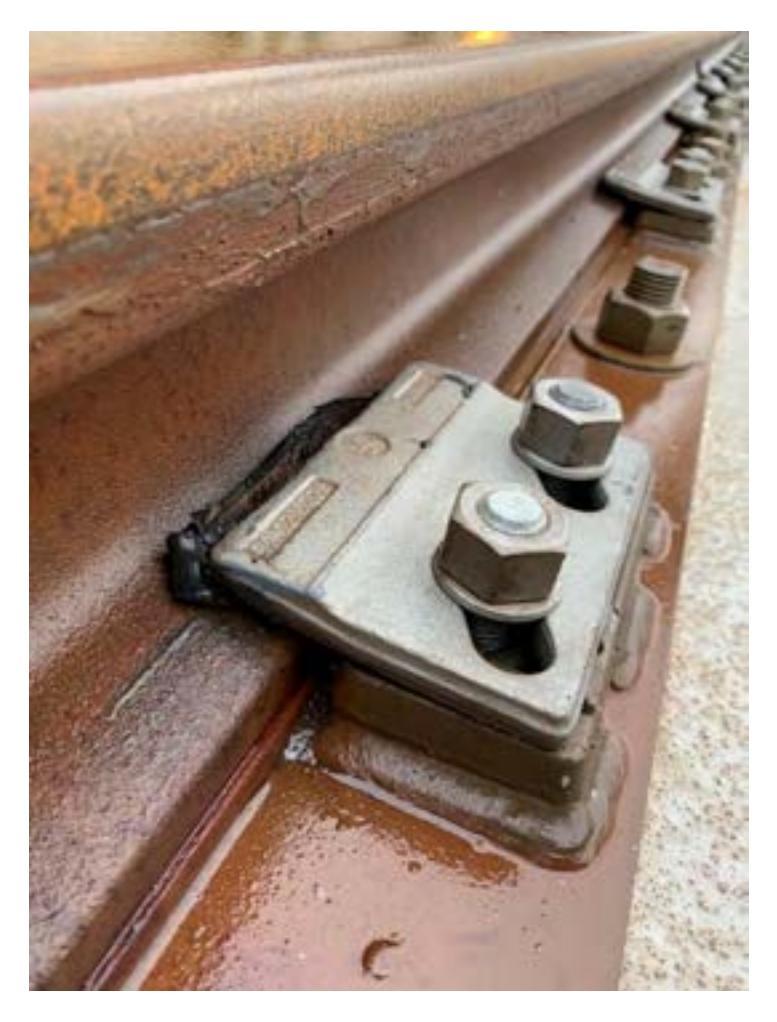
Photo M-5: Nose on Gantrex rail clips exhibit failure

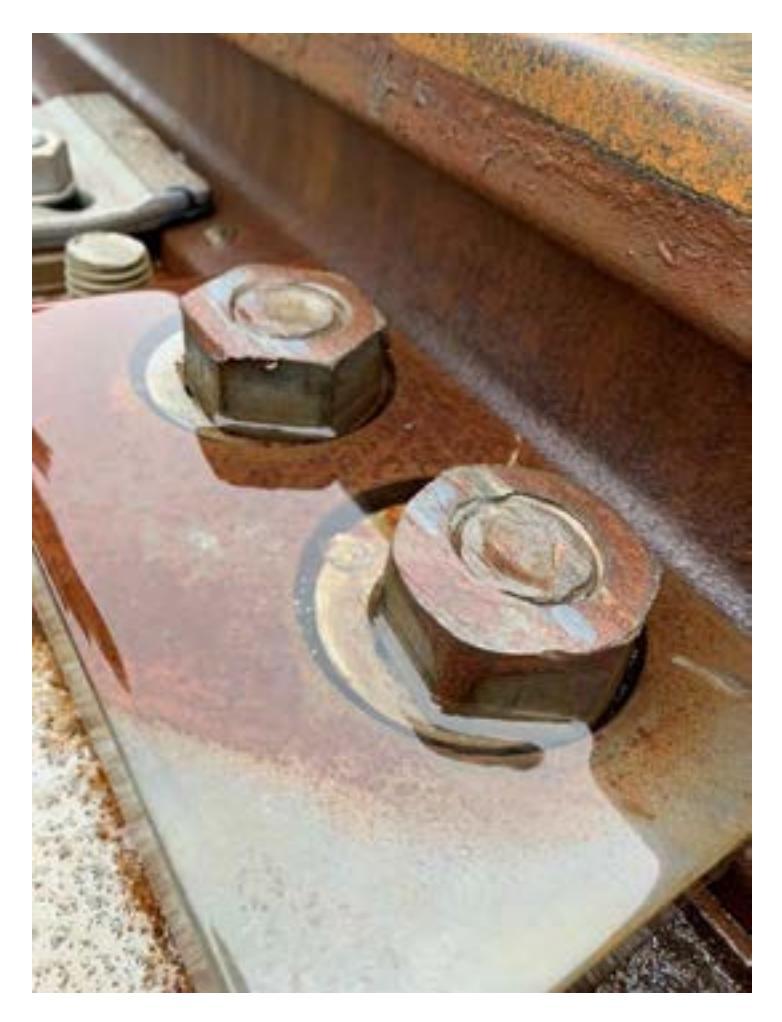
Photo M-6: Typical observed scraping at uplift clamps.

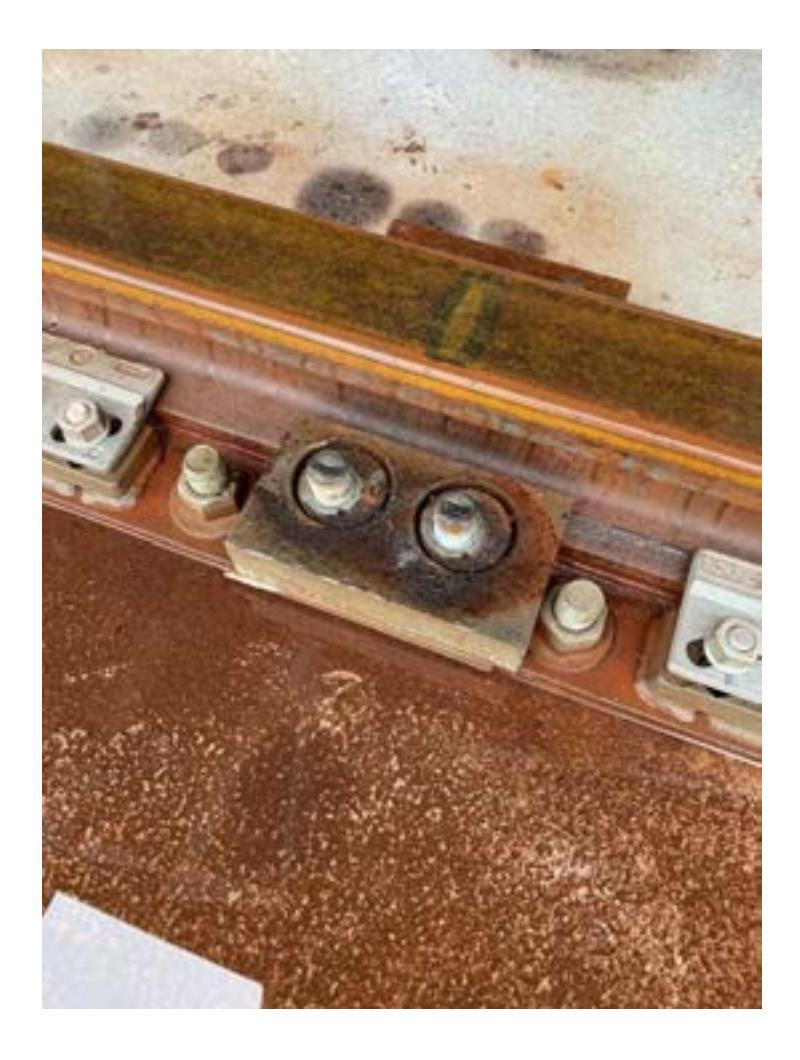
Photo M-7: Uplift clamp fastener nuts to be replaced by maintenance personnel.

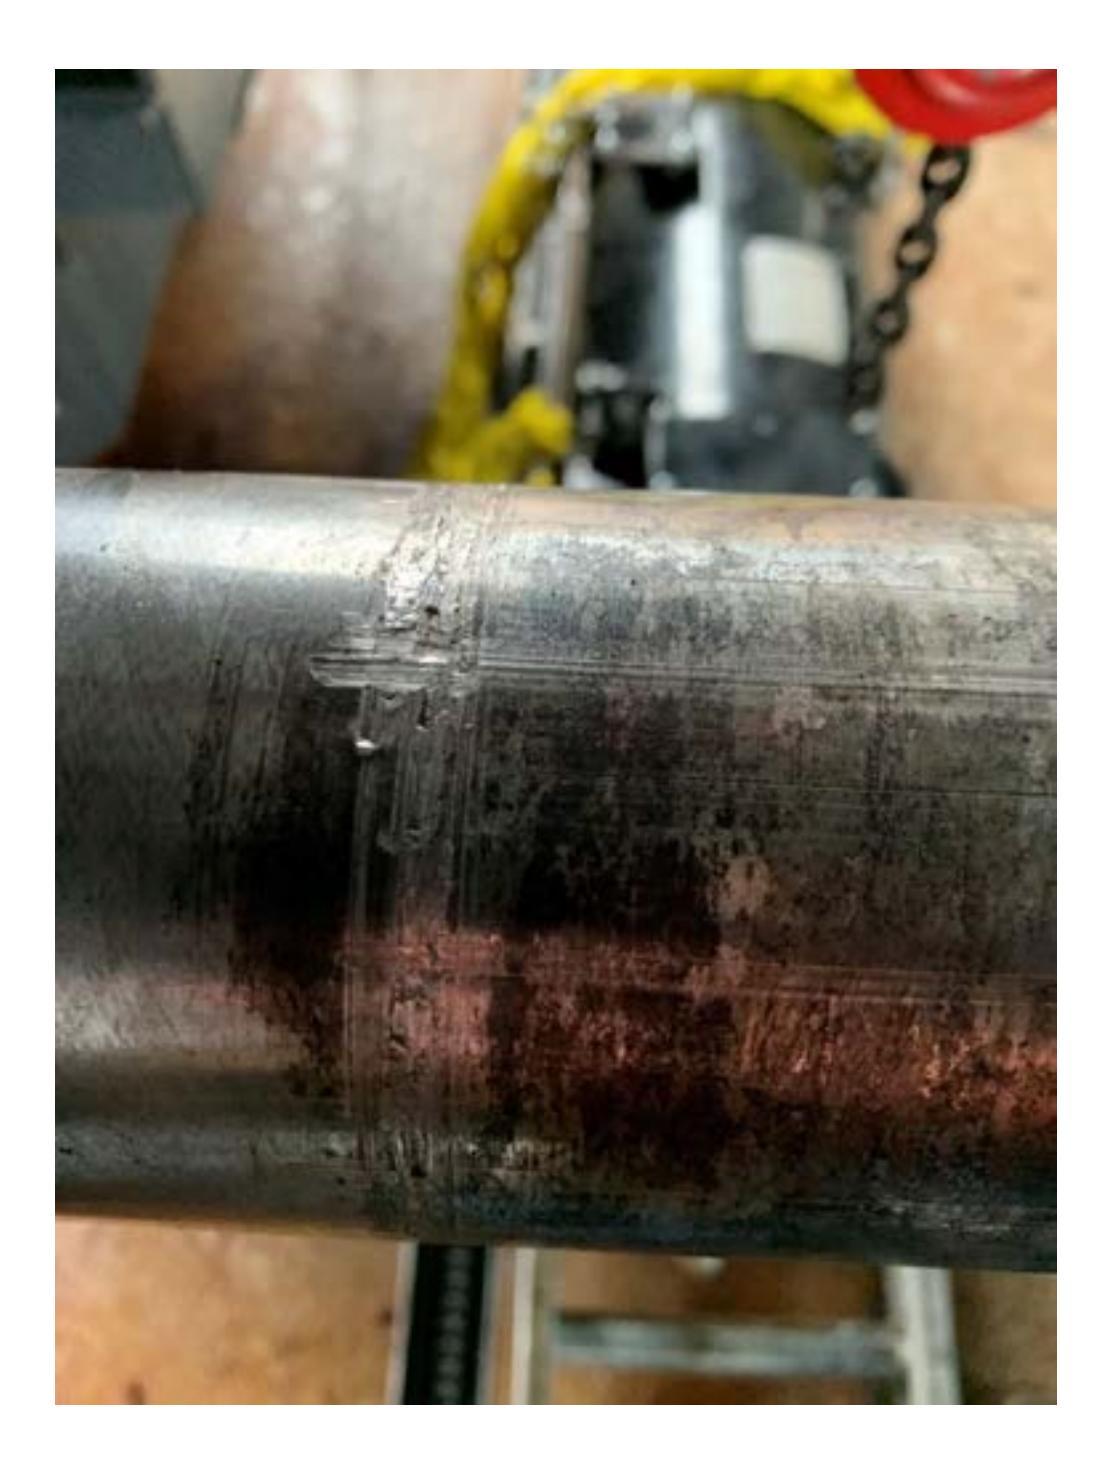
Photo M-8: Circumferential scoring noted a P2S Bogie 3 wheel 2 shaft.

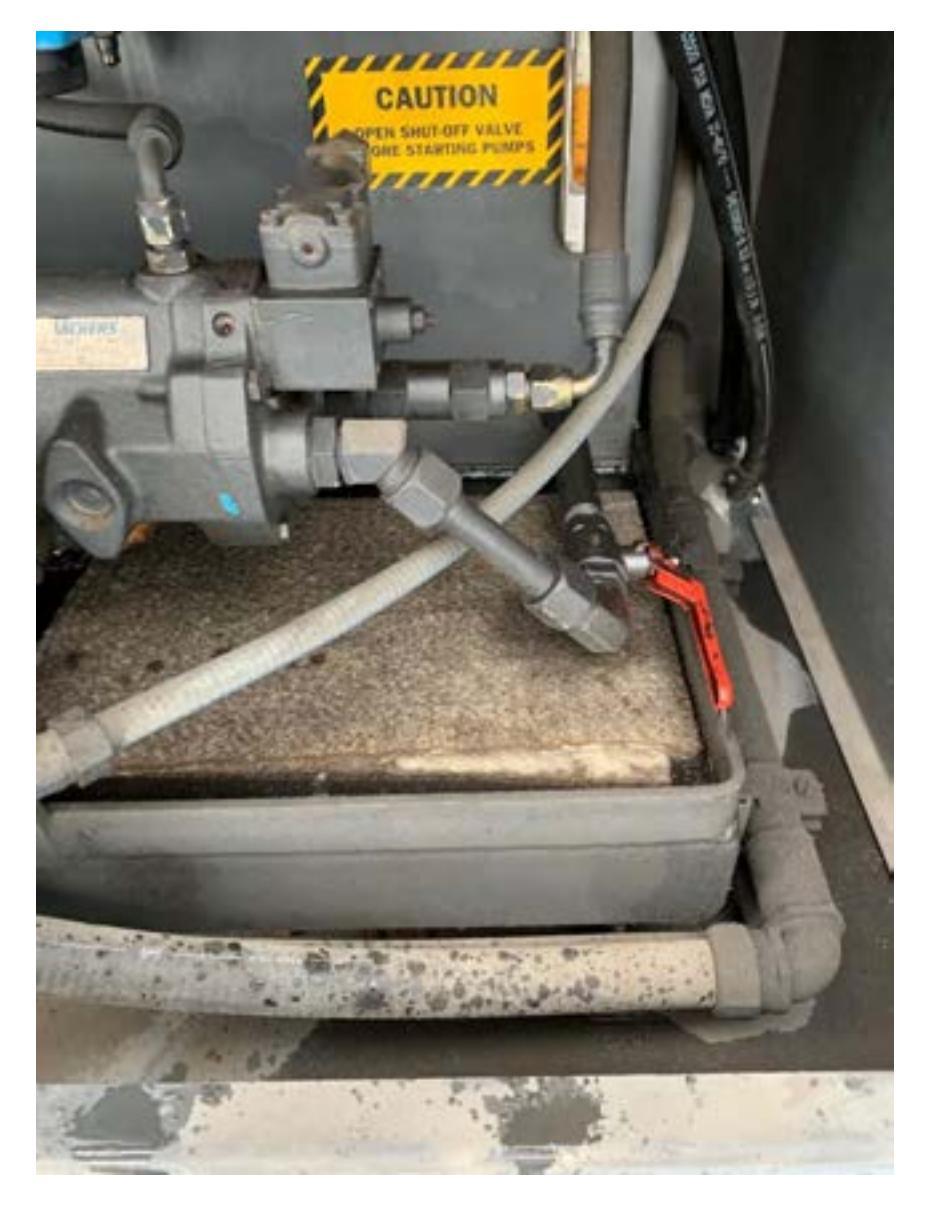
Photo M-9: Typical, hydraulic power unit equipment exhibits minor leakage.

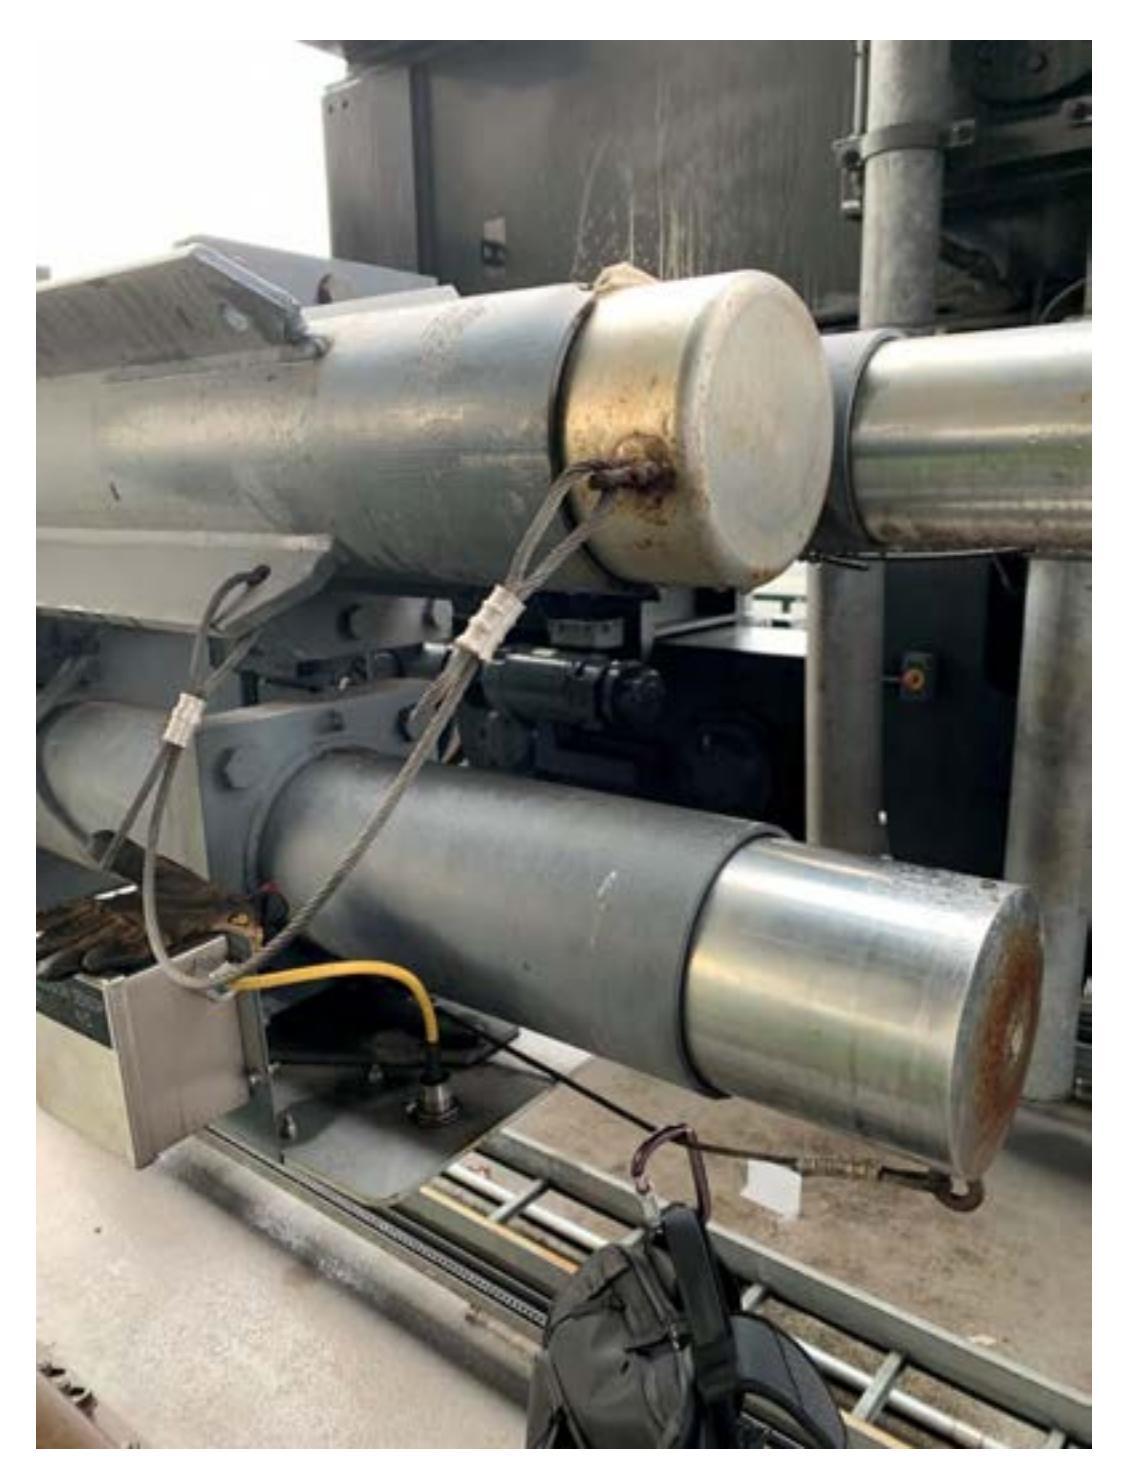
Photo M-10: Panel 1 upper end of travel buffer noted in the compressed position.
