# Seattle Mariners T-Mobile Park Long-Term Capital Needs Assessment REPORT / MAY 2022

# 1.0 - PREFACE

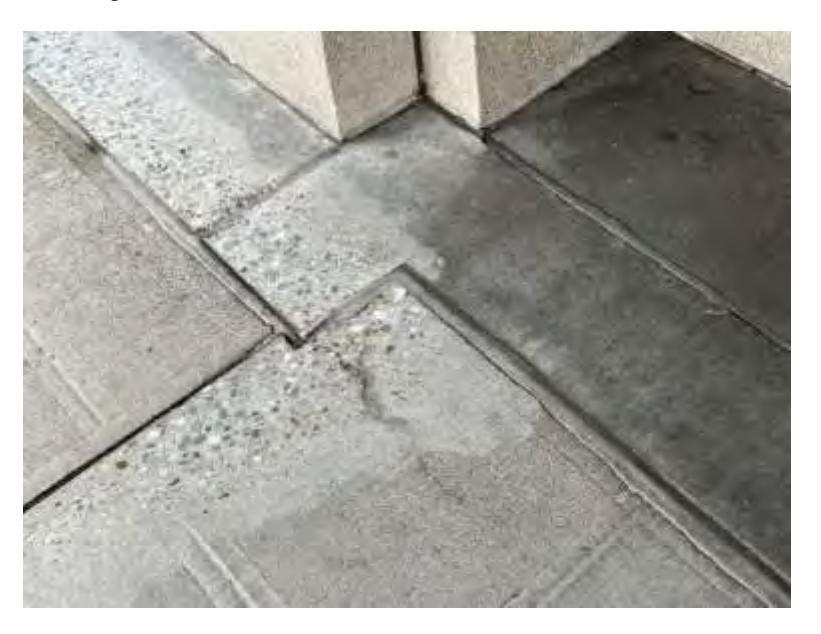
Example of concrete paving ground down to eliminate trip hazards

The long-term goal should be to patch or replace damaged concrete as necessary to avoid tripping hazards over  $\frac{1}{4}$ " in height and/or correct cracking.

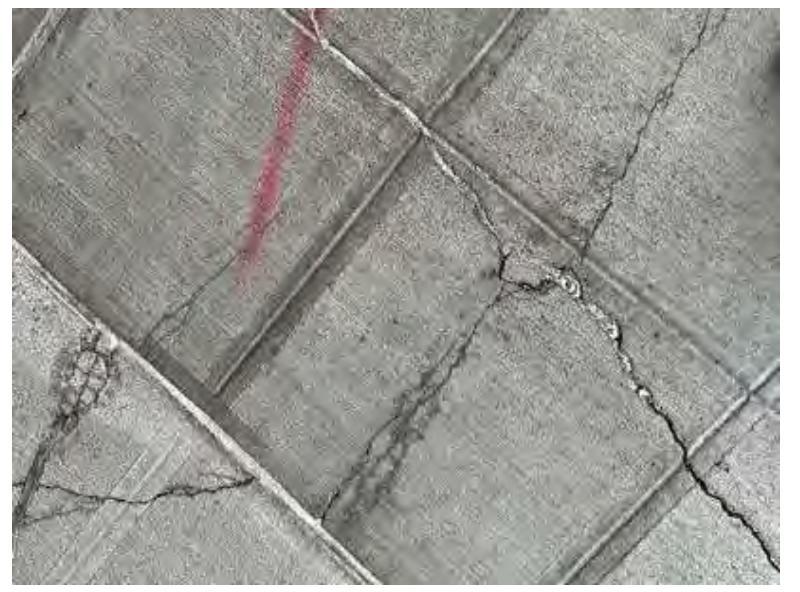
Cracked concrete within property line

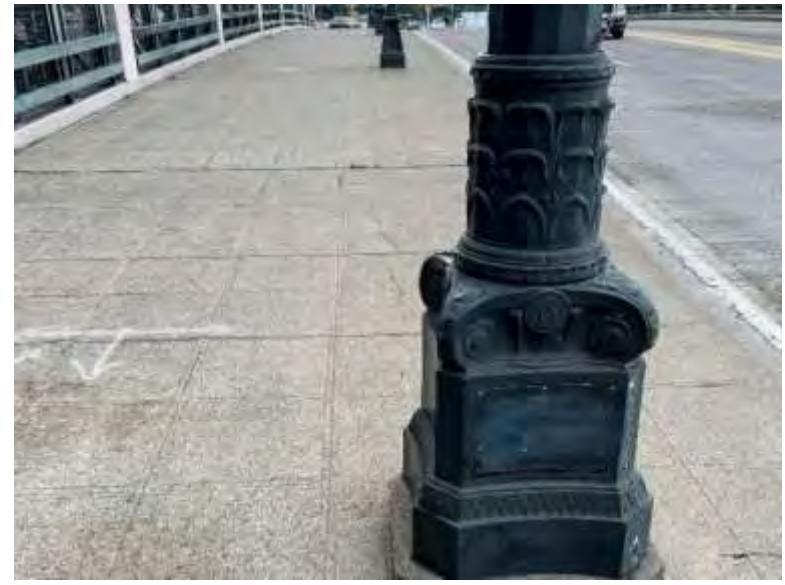
# Observation SW-2: Aging Street Light and Pedestrian Light Poles

Seattle City Light pole

Coordinate with Seattle City Light regarding any potential deficiencies or future improvements.

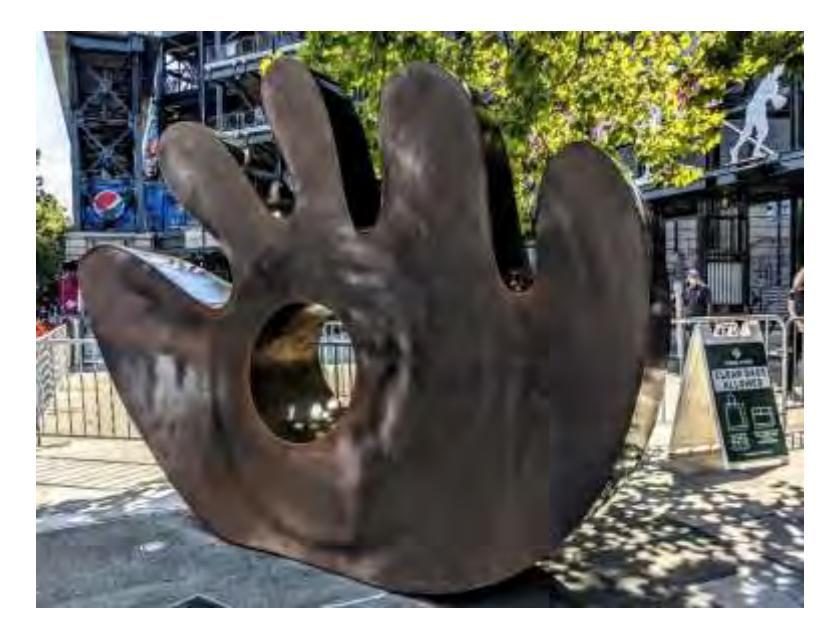
The Mitt at Centerfield entrance

Restore and preserve statues and artwork within the site, as necessary. Suggest engaging an art conservation consultant to develop specific recommendations.

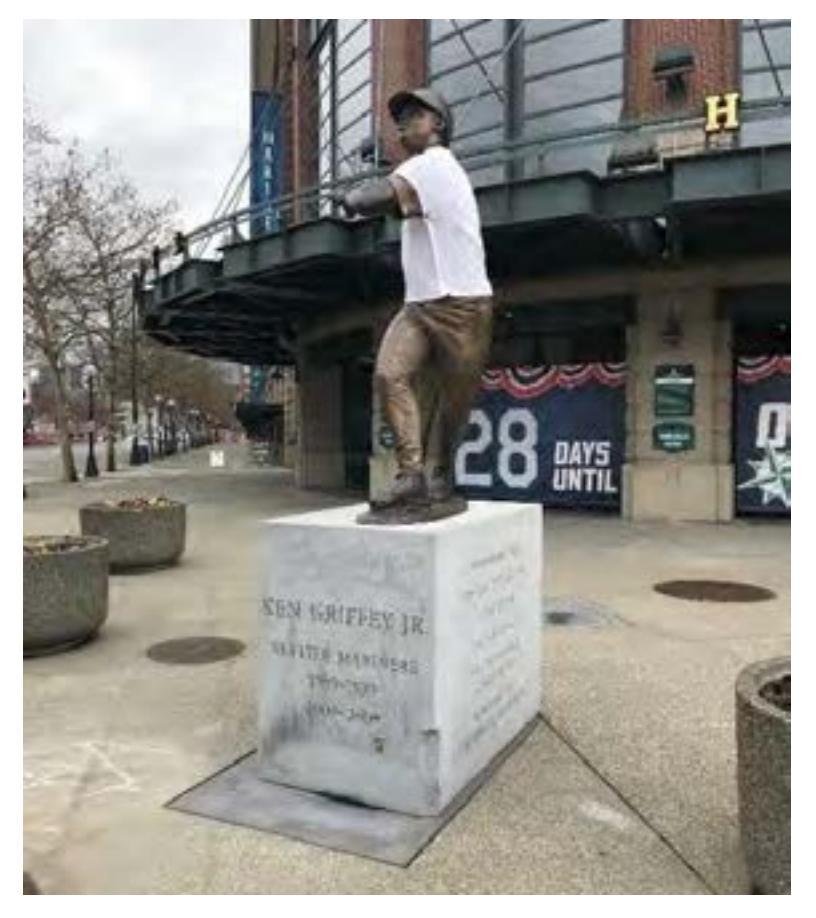
Ken Griffey Jr. statue at Homeplate entrance

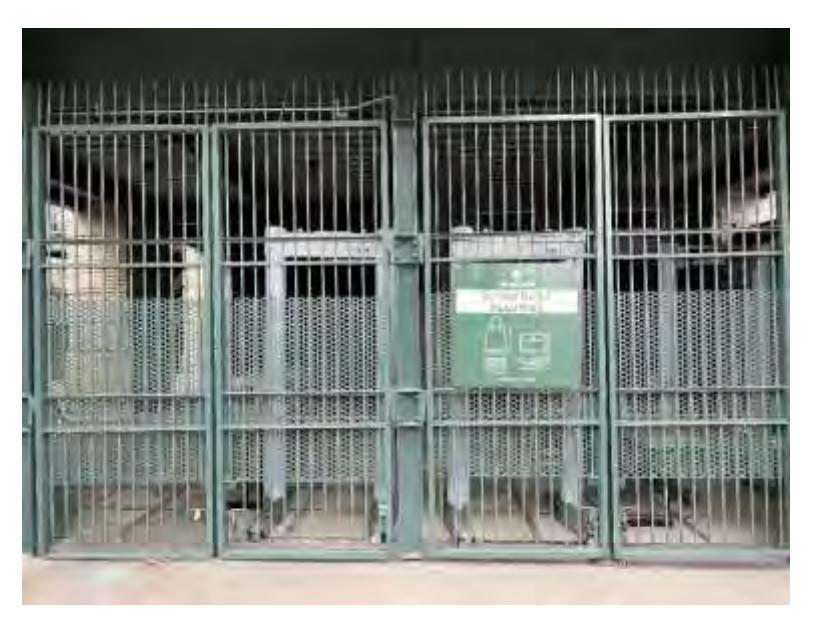
Perimeter gates

Refurbish or replace damaged or deteriorated fence and gate components, including hinges and locking hardware, and paint exposed steel.

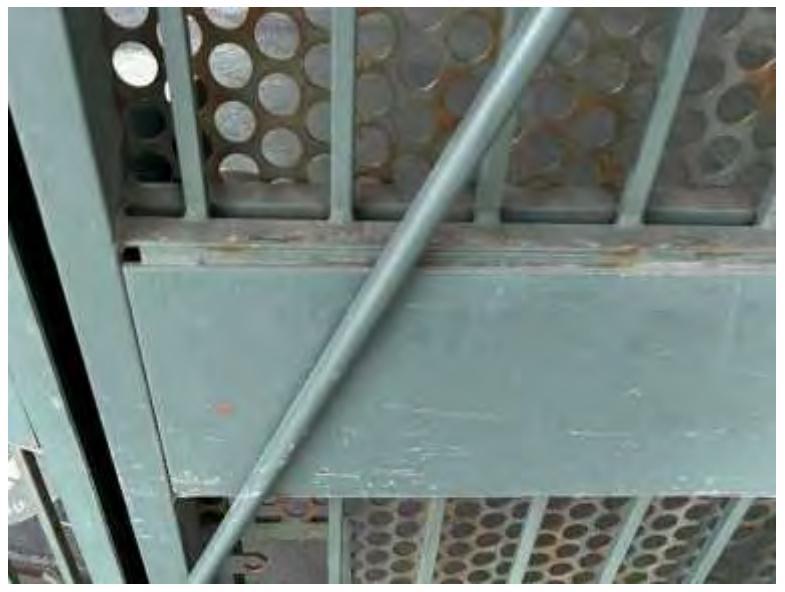
Perimeter gate

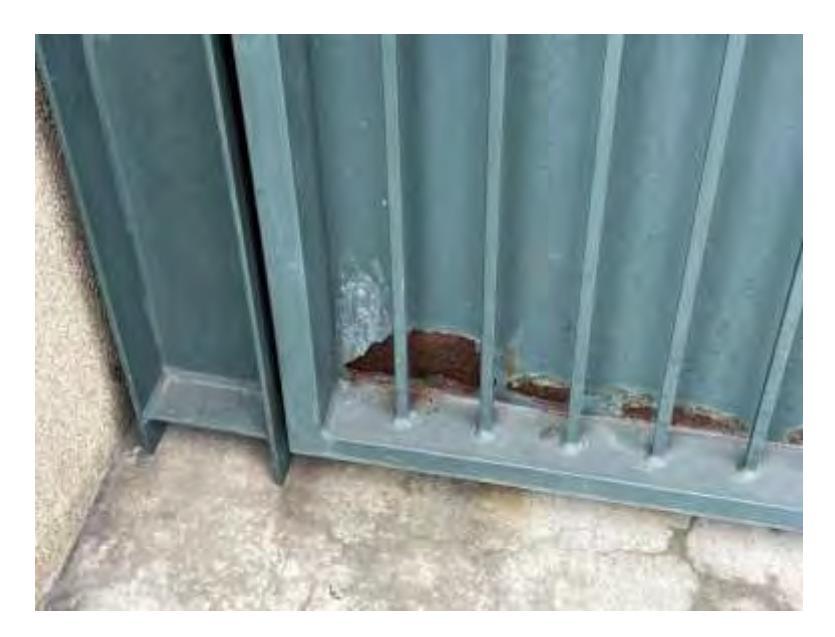
#### **Observation BE-2: Exterior Metal Panels**

#### Rusted metal panel

Refurbish or replace rusted and/or damaged metal panels at the exterior façade.

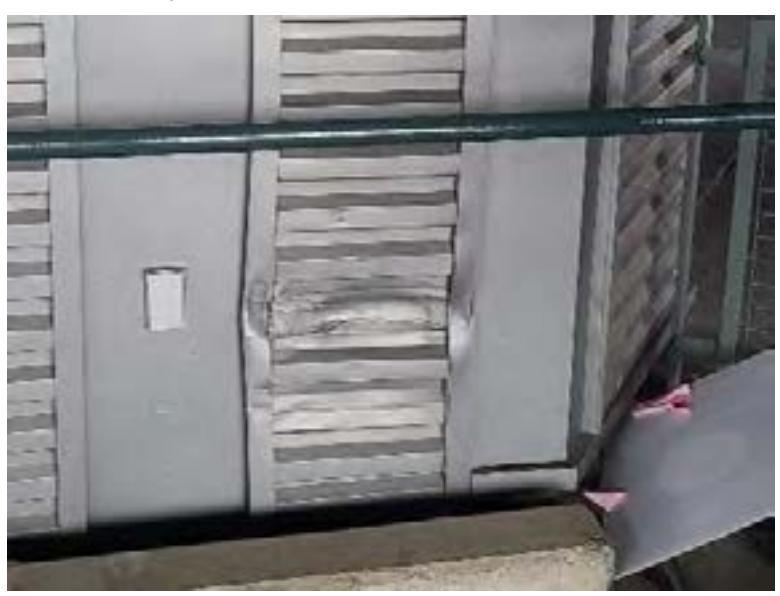
Damaged Metal Panels

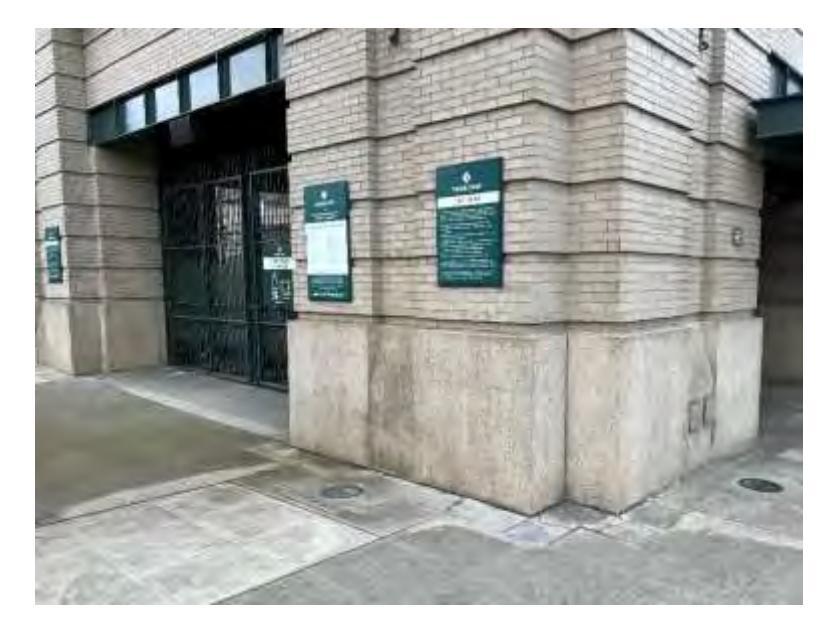
Stained masonry and precast facade

Inspect masonry and precast façade components to confirm there is no water damage, weep holes are clear, and mortar and sealant joints are in good condition. Refurbish or replace defective components. Power wash components as part of a regular maintenance program.

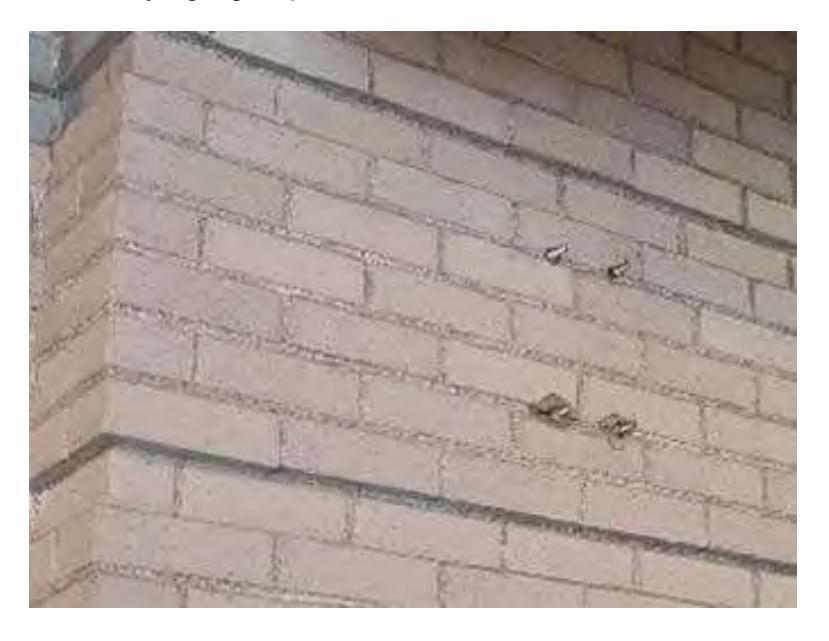
#### **Observation BE-4: Masonry and Precast Facade**

Metal studs at masonry wall from previous sign placement
## FACILITY ASSESSMENT

Inspect masonry and precast façade components for cracks and voids, confirm there is no water damage, verify that weep holes are clear and mortar joints and sealant joints are in good condition. Patch and seal areas affected by signage replacements.

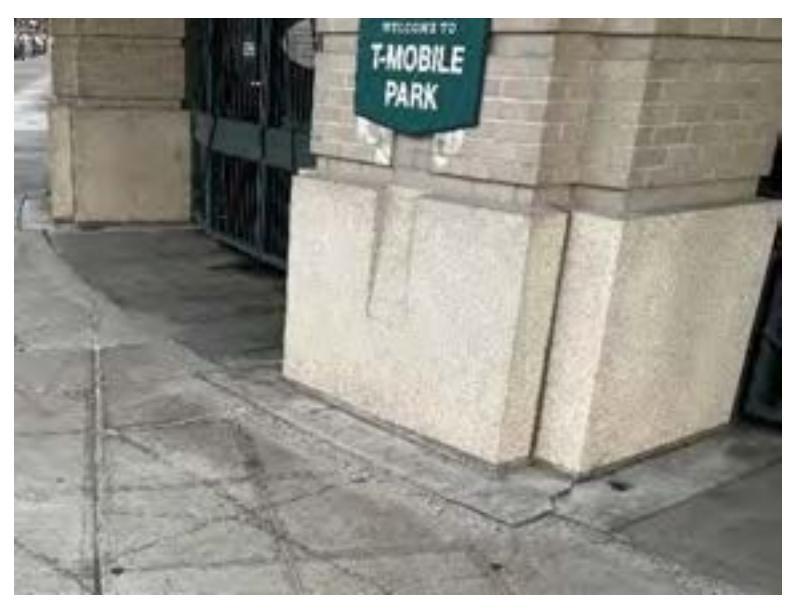
Holes in masonry and adhesive from signage replacement

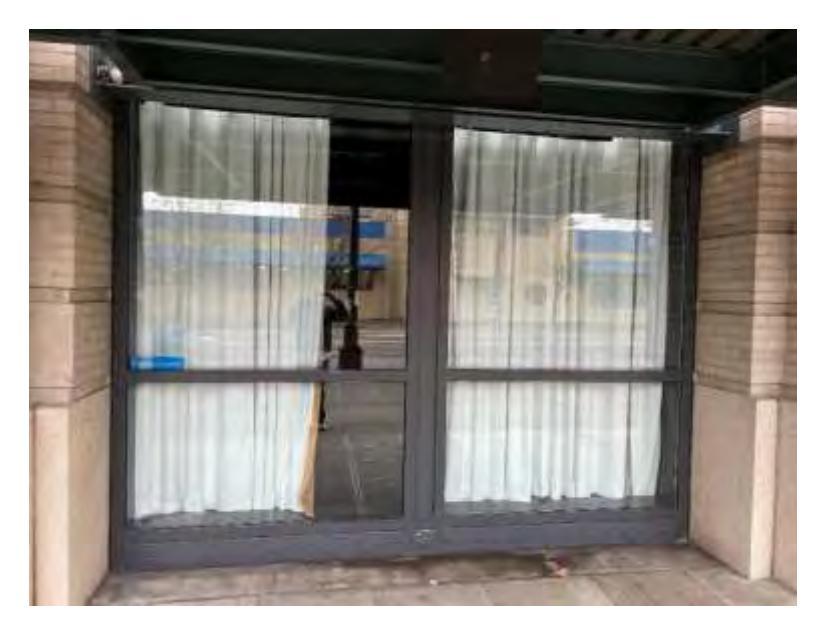
#### **Observation BE-5: Storefront Glazing and Doors**

Storefront glazing system

Inspect storefront glazing systems and replace deteriorated seals and gaskets and door hardware. Replace any severely scratched glass and damaged framing components. Plan to replace door hardware within the next five years.

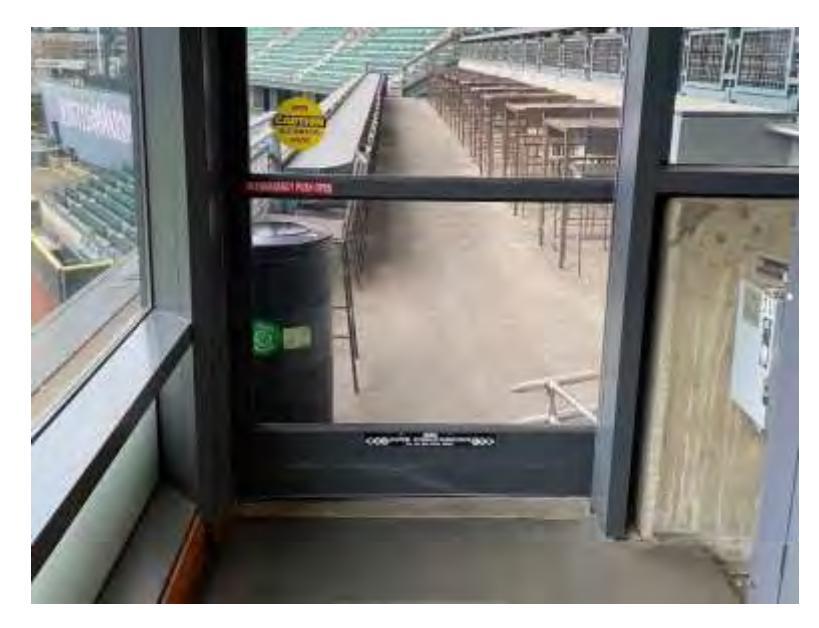
Storefront and automatic door a Hit It Here Cafe

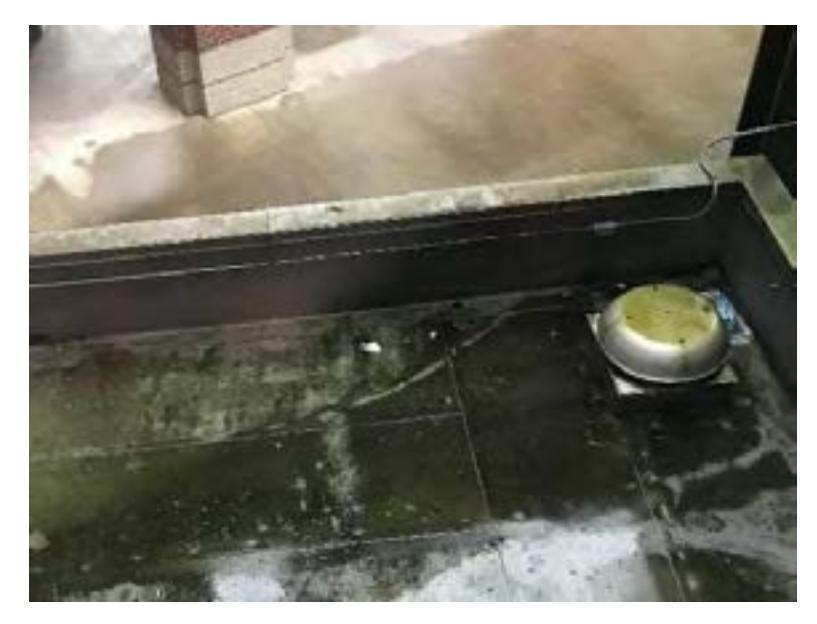
Flat membrane roof

Engage a roofing consultant or contractor to inspect all flat roofs and develop a plan for their eventual replacement over the next 10 to 12 years. Selectively patch or replace roofs that fail or leak in the interim.

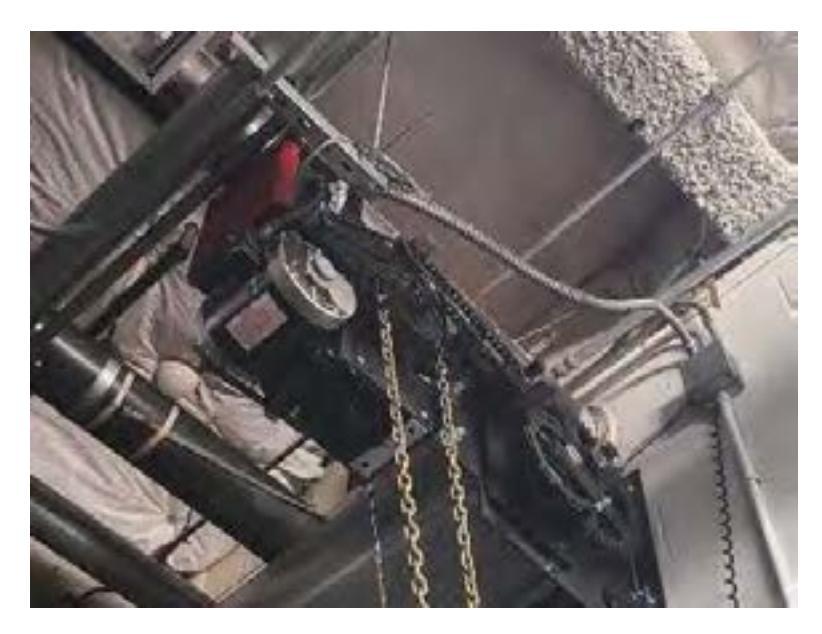
#### **Observation BE-7: Overhead Doors @ Service Level**

Exterior overhead door mechanism

Refurbish or replace overhead door mechanical components over the next 10 years.

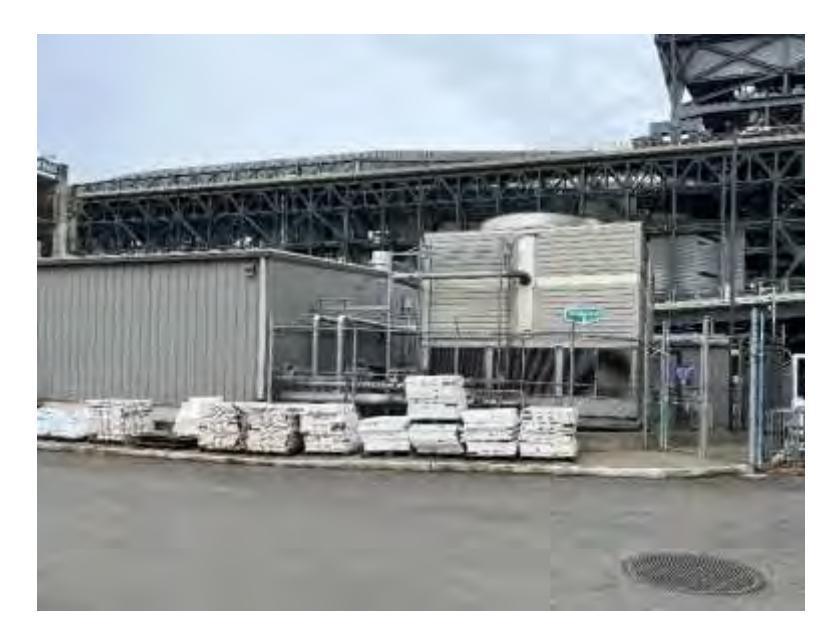
#### Rating: Good

Exterior of central plant building

Recommendation: Refurbish or replace components if they fail.

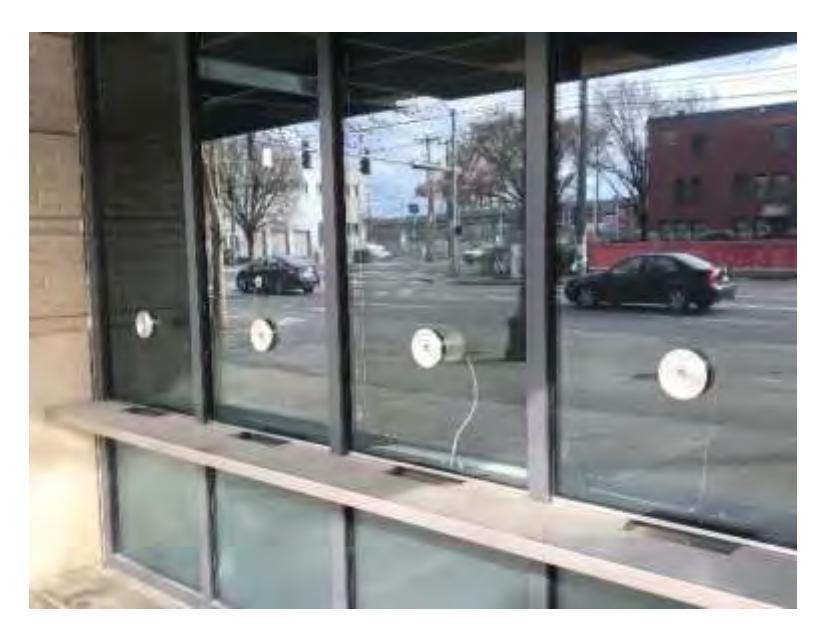
#### **Observation BE-9: Ticket Windows**

Ticket windows near Homeplate entrance

Inspect ticket windows and replace deteriorated seals and gaskets. Selectively replace any severely scratched glass and damaged framing components. Replace two-way speaker system within next 5 to 10 years. Refurbish stainless steel deal tray components as necessary.

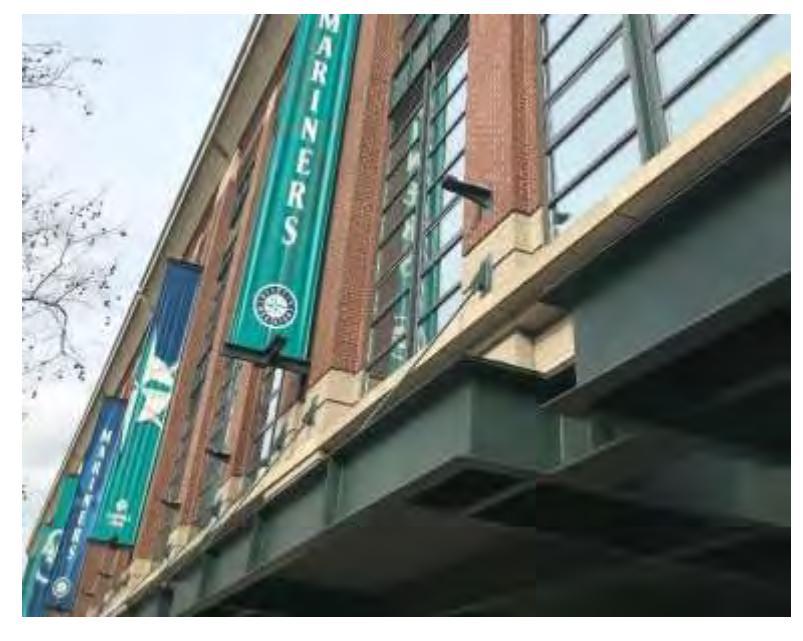
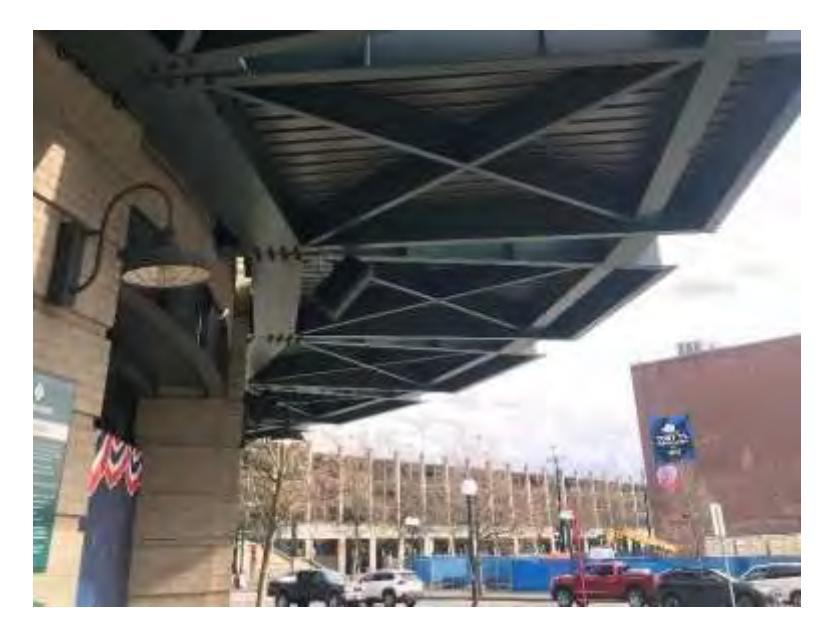
#### **Observation BE-10: Exterior Canopies**

#### Rating: Good

Canopy along First Avenue

Canopy at Homeplate entrance

**Recommendation:** Paint exposed steel as part of the ongoing painting program. Similar to flat roofs, recommend engaging a roofing consultant or contractor to inspect all canopy roofs and develop a plan for their eventual replacement over the next 10 to 12 years. Selectively patch or replace roofs that fail or leak in the interim.

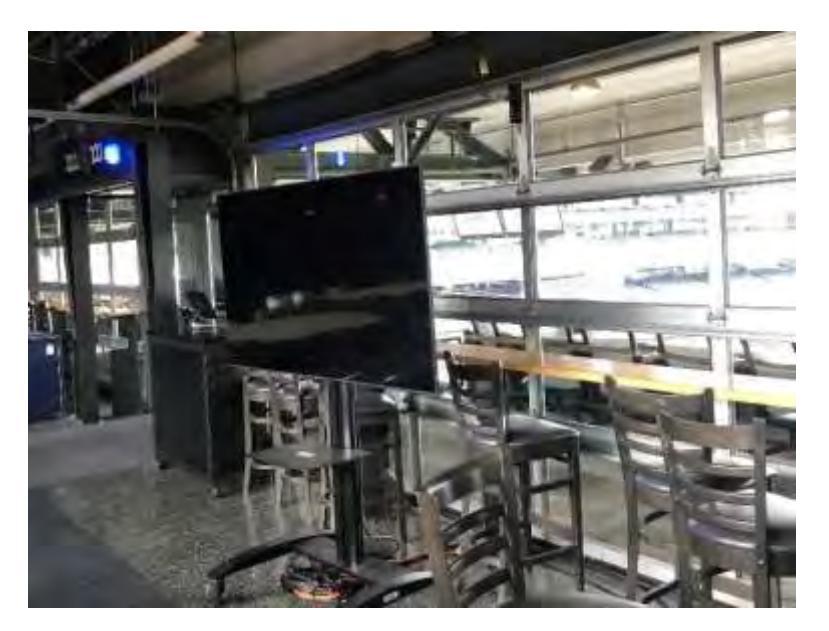
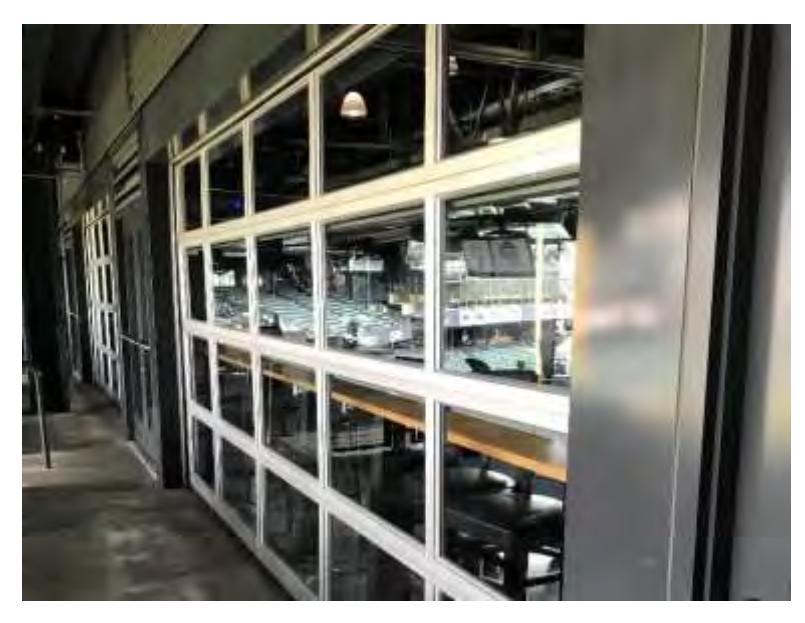
#### **Observation BE-11: Overhead Doors @ Terrace Club**

Interior view of glass overhead doors at Terrace Club

Exterior view of glass overhead doors at Terrace Club

Refurbish or replace overhead door mechanical components over the next 5 to 10 years.

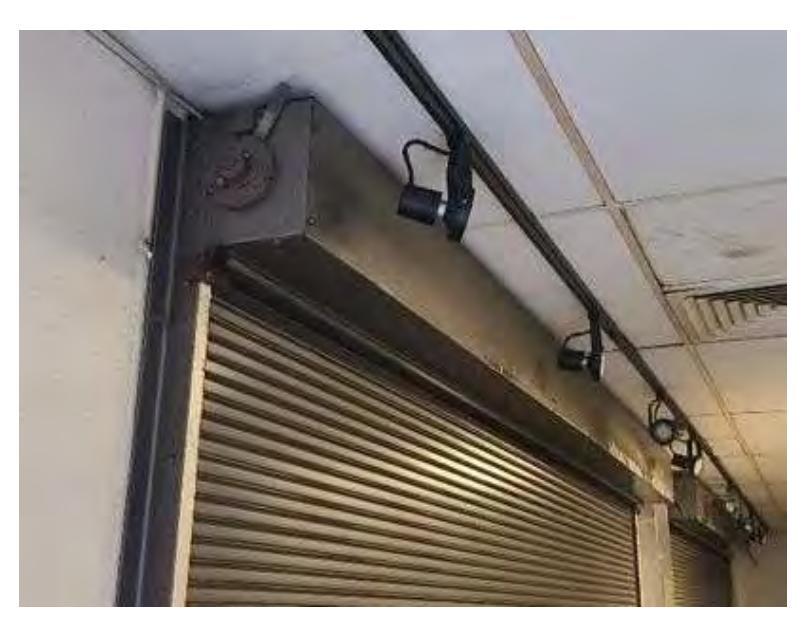
## **Observation BE-12: Overhead Coiling Shutters**

Interior view of overhead coiling shutter

Engage an overhead door contractor to inspect all coiling shutters and develop a plan for refurbishment or replacement over the next 10 years to align with planned renovations of concession and merchandise stands. Selectively replace coiling shutters that fail or are damaged in the interim.

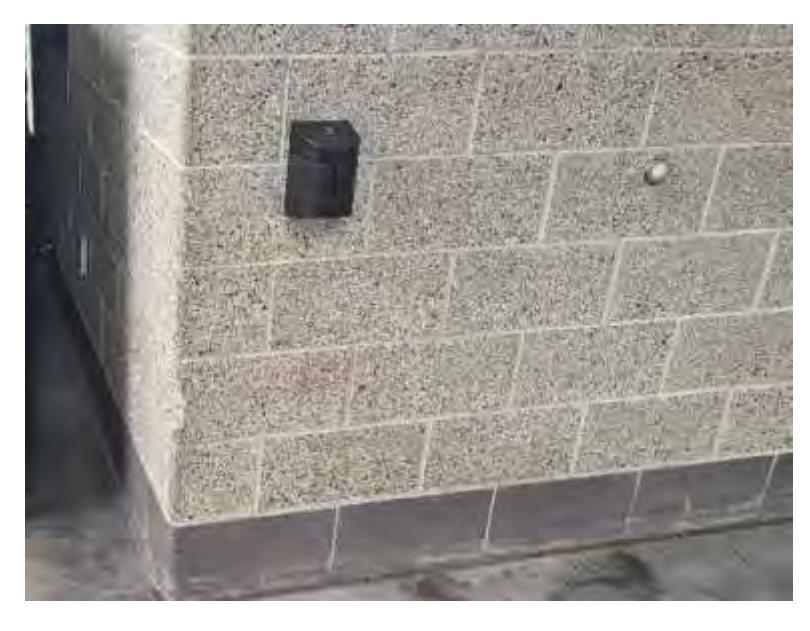
#### **Observation BE-13: Damaged CMU Wall Corners**

CMU wall at upper concourse

Consider adding corner guards to protect CMU walls, especially those in high traffic areas.

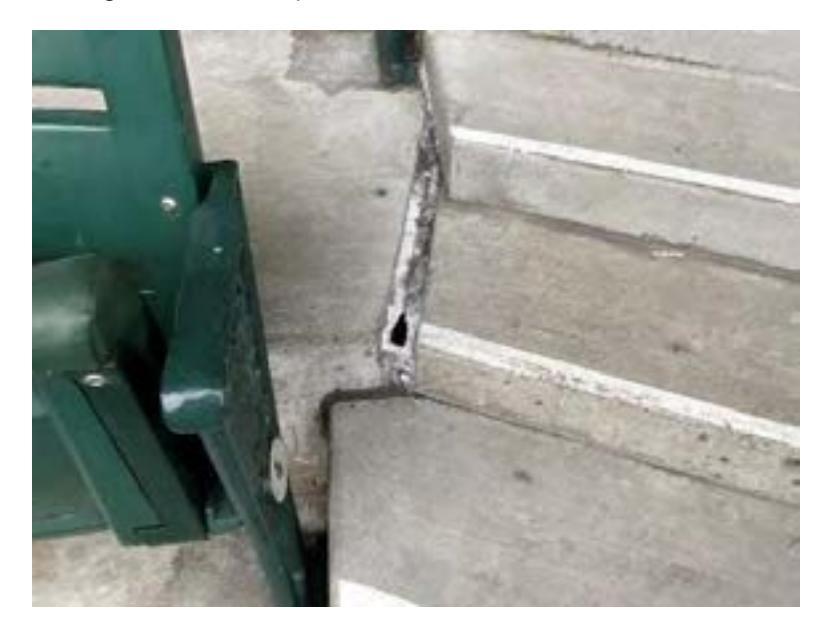
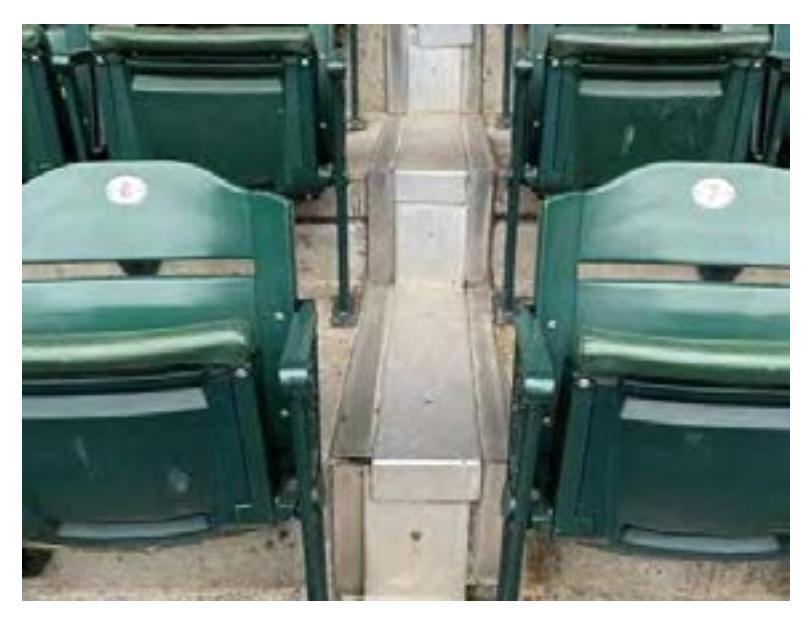
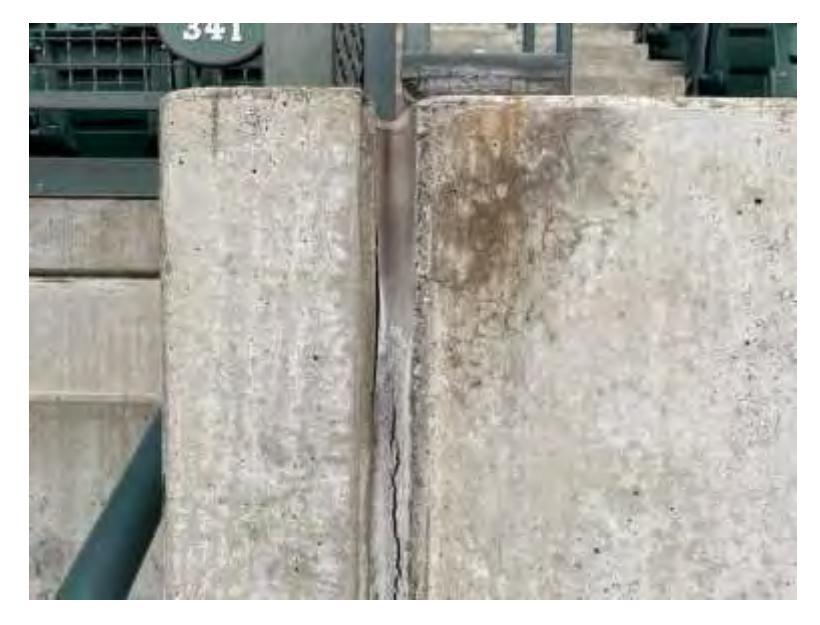
## Observation SB-1: Sealant Joints and Expansion Joints in Concrete Stadia

The sealant joints between precast concrete stadia within the seating bowl are nearing the end of their useful lives and have failed in certain locations. The expansion joints within the seating bowl appear to be in adequate condition and have been selectively replaced over time.

Sealant joint between precast stadia

Expansion joint between precast seating stadia

Sealant joint between precast seating stadia

Replace seating bowl sealant joints within the near term, especially any joints that have failed. Ideally, large-scale replacement of sealant joints and expansion joints should occur in conjunction with replacement of stadium seating to make the replacement work more efficient.

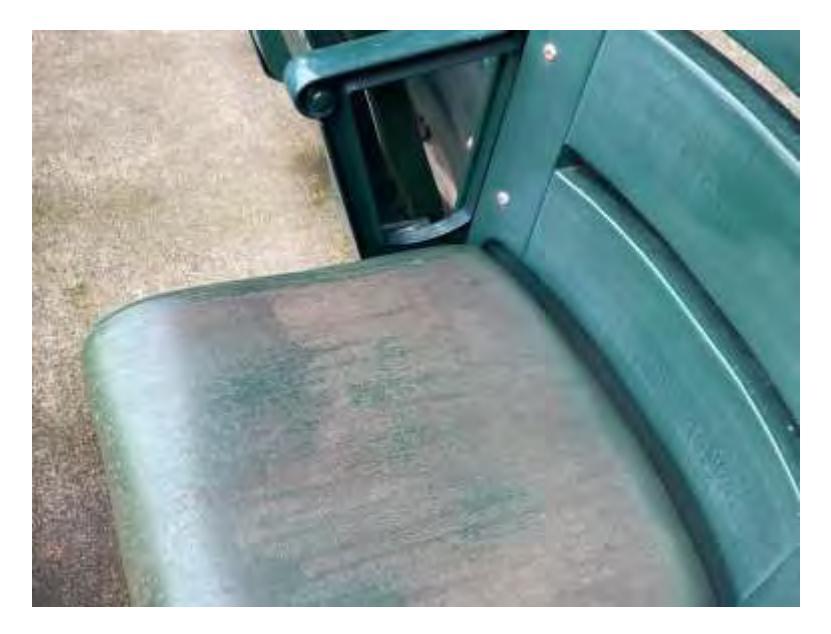
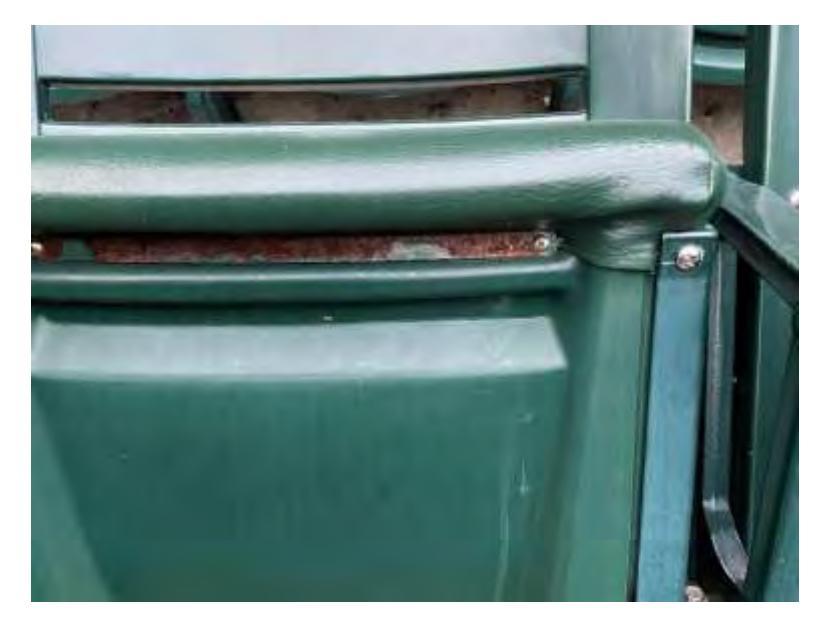
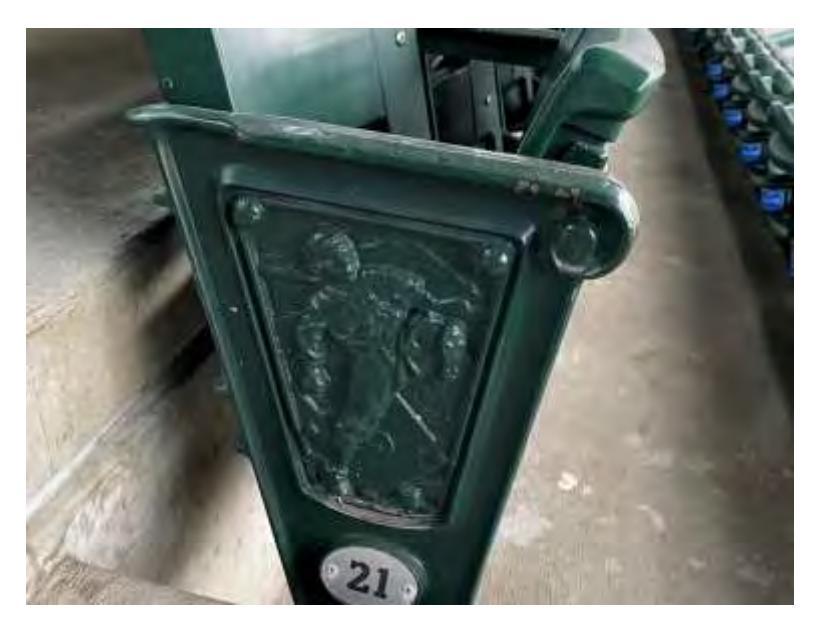
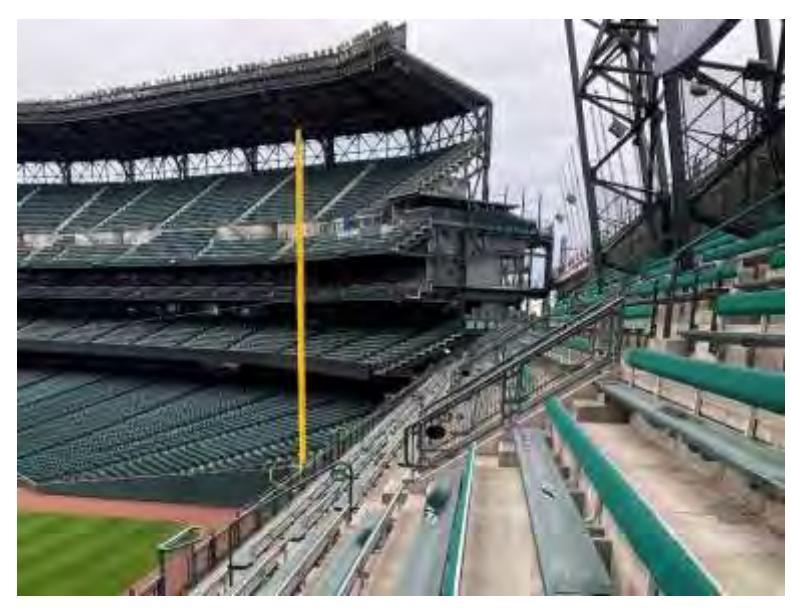
Padded seat pan at club level

Underside of seat pan at club level

Cast iron seating stanchion

Aluminum bleacher seating below scoreboard

Initiate a phased replacement of stadium seating and associated components.

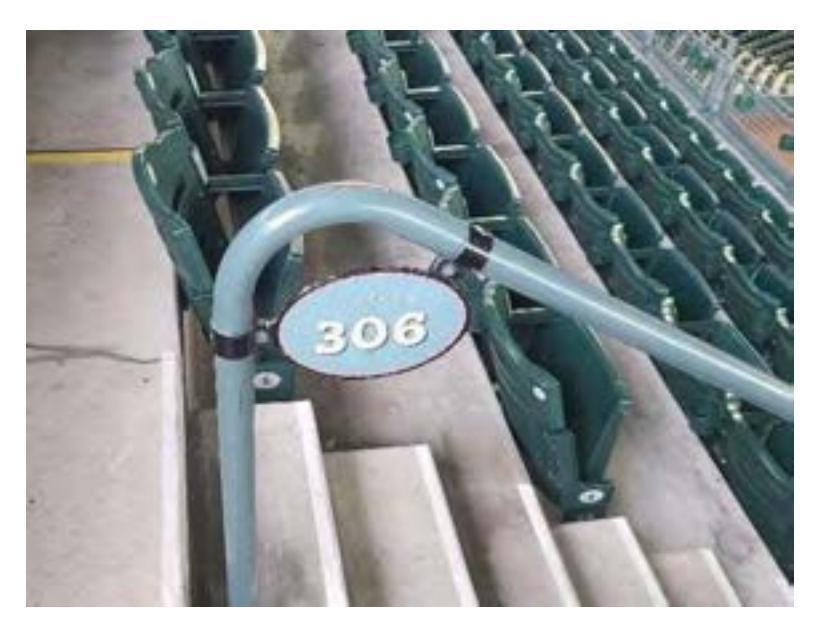
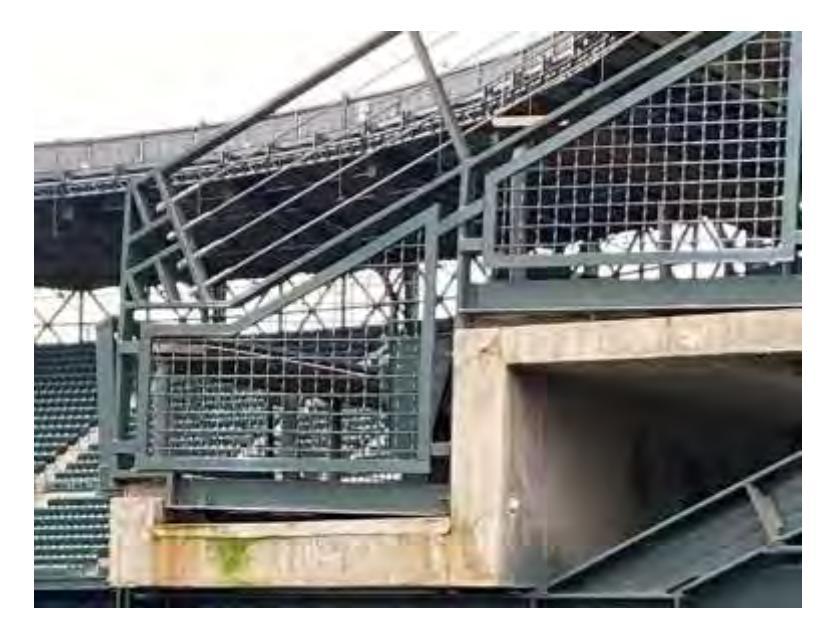
#### **Observation SB-3: Railings, Guardrails, and Fencing**

Exposed metal at handrail

Guardrails and fencing at edge of 300 level

Refurbish and repaint railings, guardrails, and fencing within the seating bowl over the next 10 years.

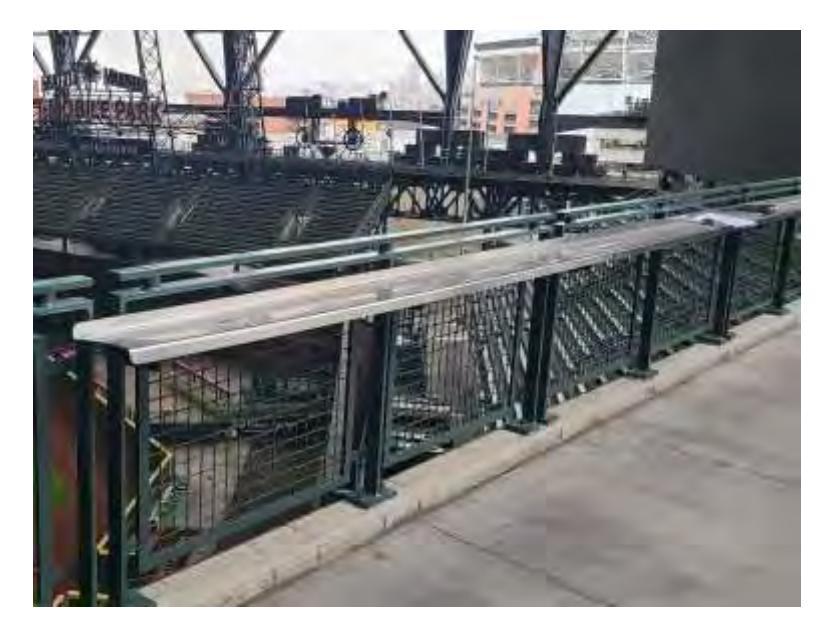
The drink rails are in generally adequate condition; however, they are damaged in certain locations.

Drink rail in centerfield

Repair or replace damaged drink rails within the first 10 years of the plan.

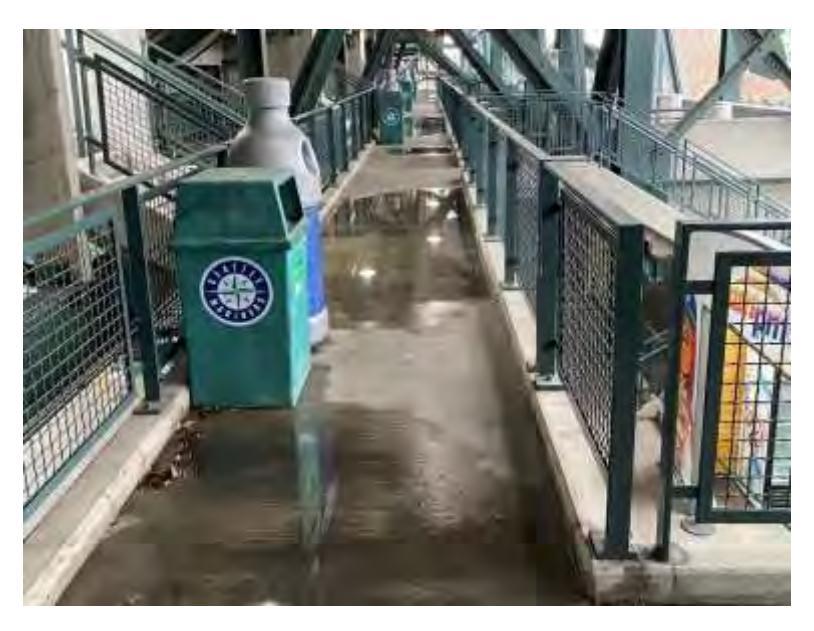
The elevated walkways below the scoreboard seating are generally in good condition. However, there is standing water in certain areas that poses an inconvenience and creates the potential for water to degrade the concrete slab and steel structure.

Standing water at elevated walkways at scoreboard seating

Prepare concrete and apply an engineered topping to existing concrete slabs to remediate areas of standing water.

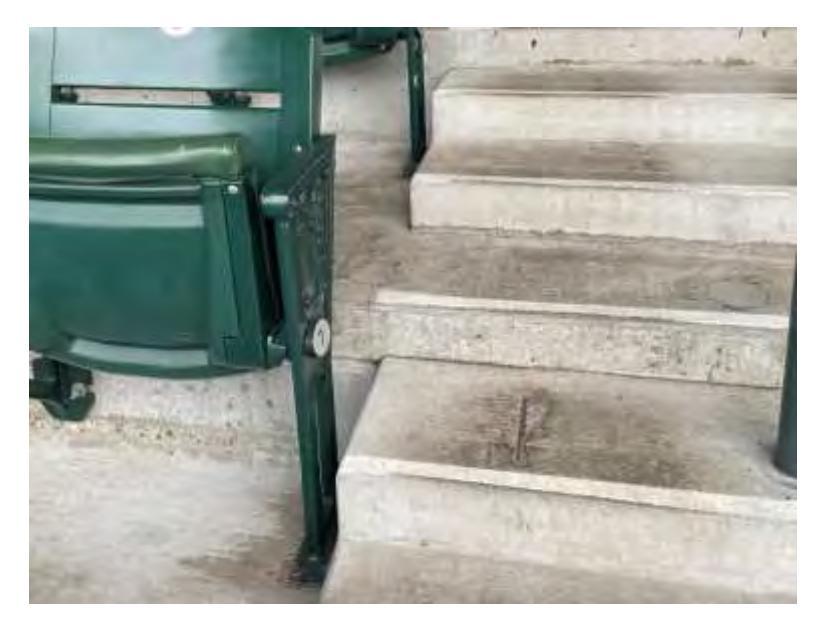
The concrete aisle steps in the seating bowl are generally in good condition, but there are cracks, spawls, and exposed reinforcing steel in certain areas that should be patched. Overall, the tread striping is faded and should be repainted.

Concrete aisle step at 200 level

Patch and restripe concrete aisle steps in seating bowl.

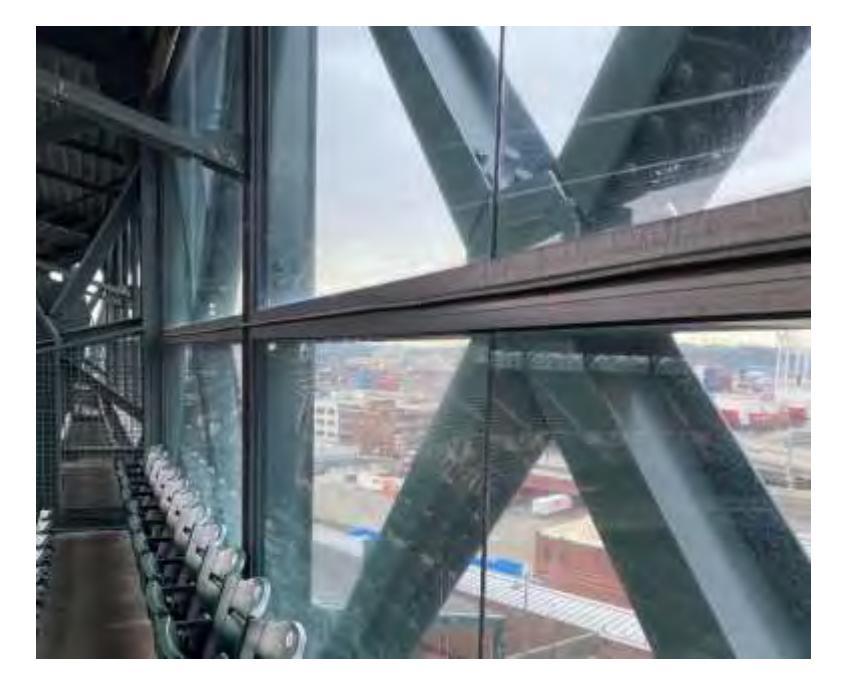
The glass panels at the top of the upper seating bowl are generally in good condition.

Glass panels at top of 300 level seating

No foreseeable improvements required.

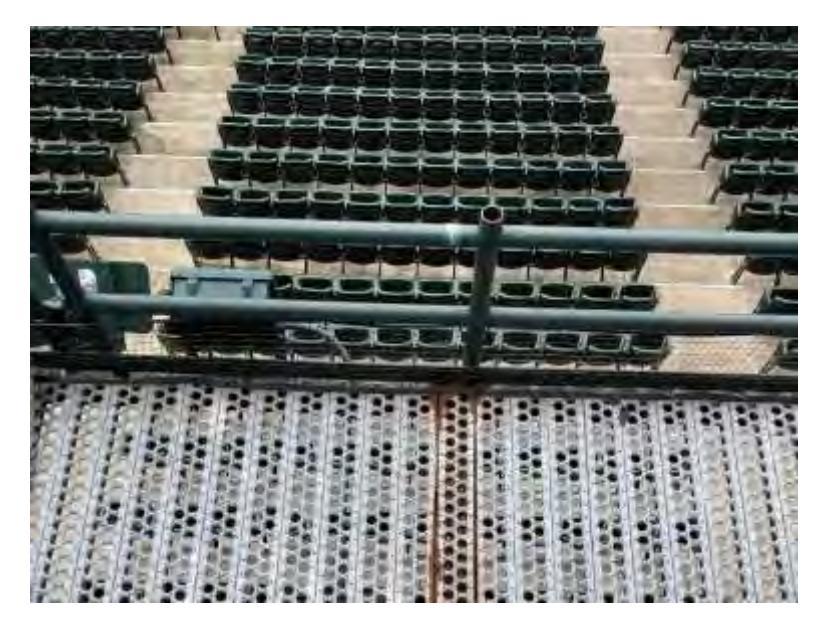
The galvanized steel grating located in camera bays, access stairs, and catwalks is in adequate condition; however, some units are rusting and potentially staining areas below.

Metal grating at first base camera platform

Refinish or replace significantly rusted galvanized steel grating units.

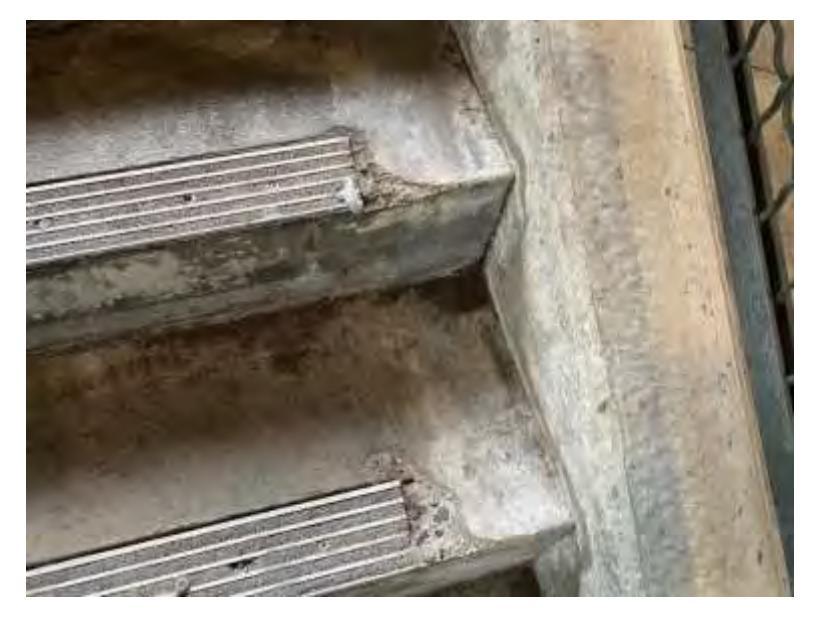
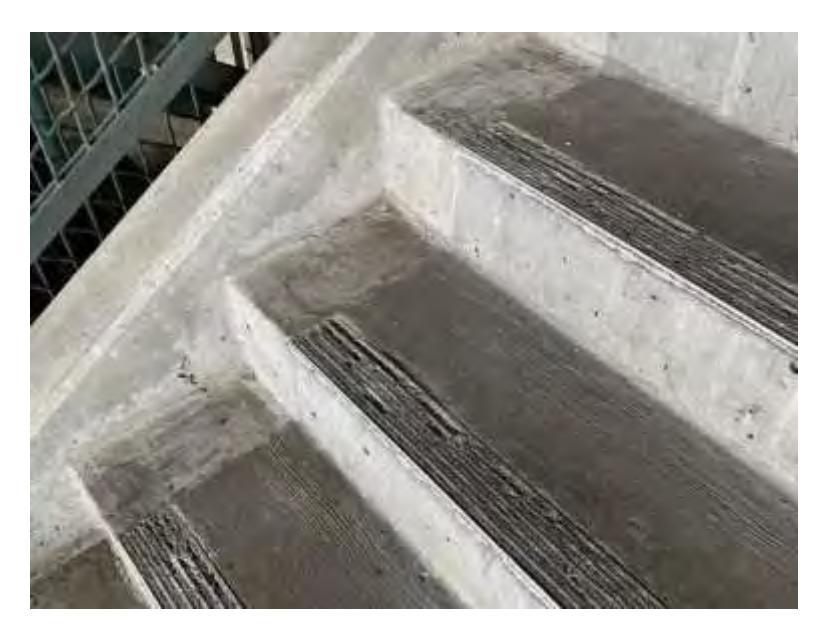
The concrete stairs in open-air stair towers are generally in good condition; however, the metal nosings embedded in the stair treads are showing signs of age and wear and should be refurbished in the near term.

Metal stair nosings at stair towers

Refurbish damaged concrete and metal stair nosings at stair towers.
