# Seattle Mariners T-Mobile Park Long-Term Capital Needs Assessment REPORT / MAY 2022

# 1.0 - PREFACE

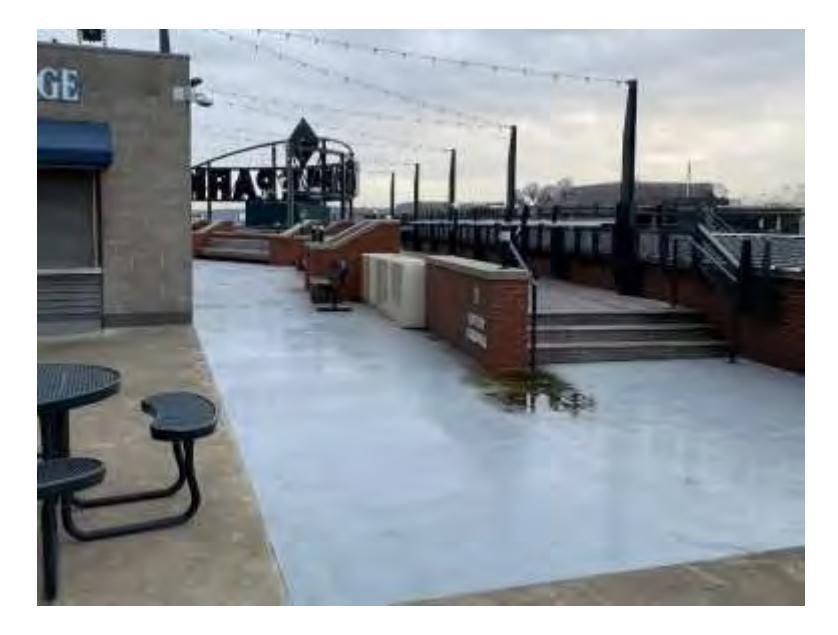
The rooftop boardwalk was recently added on the 300 level and is in excellent condition; however, certain components such as the decking and concrete sealer will need replaced in 10+ years.

Rooftop boardwalk concrete and wood finishes

Replace concrete coating and wood decking.

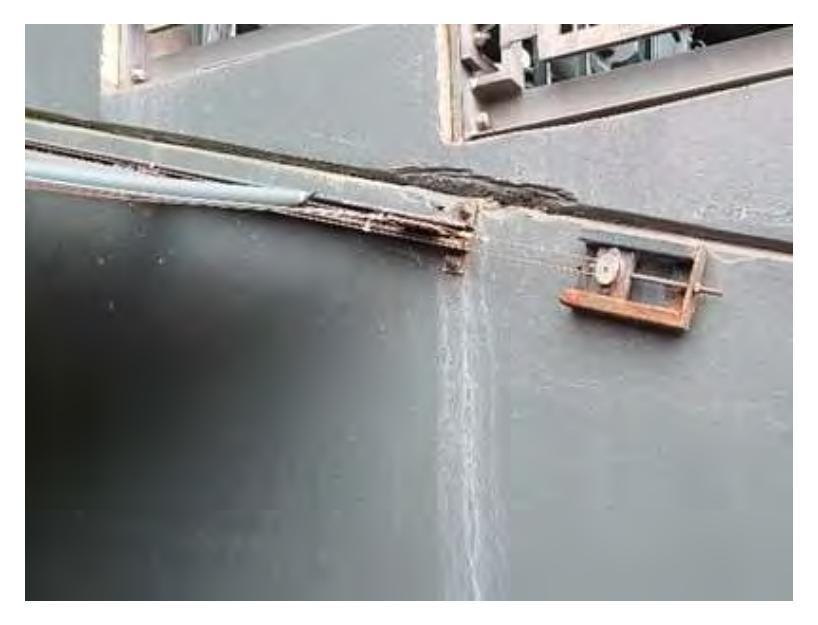
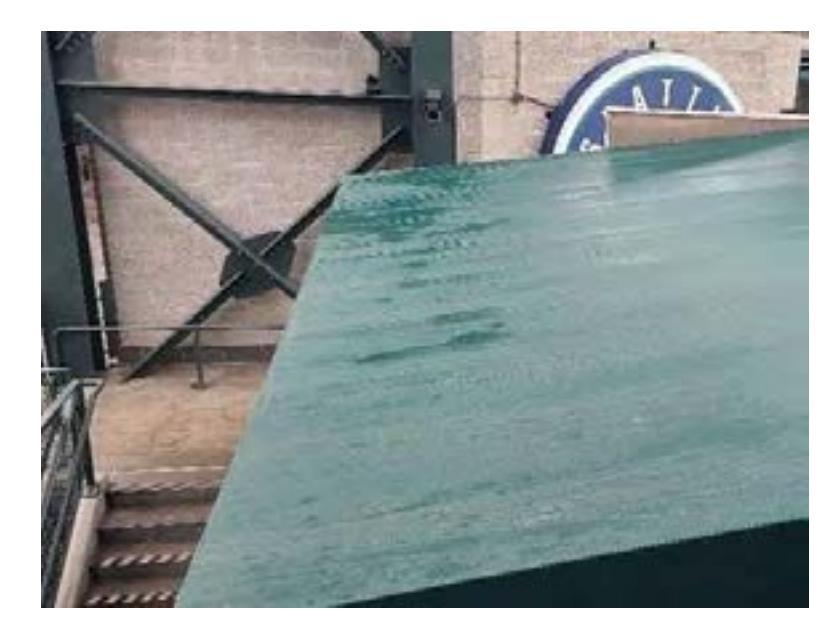
Awning at homeplate field entrance

Awning at bullpens

Replace vinyl awnings as they reach end of their useful lives.

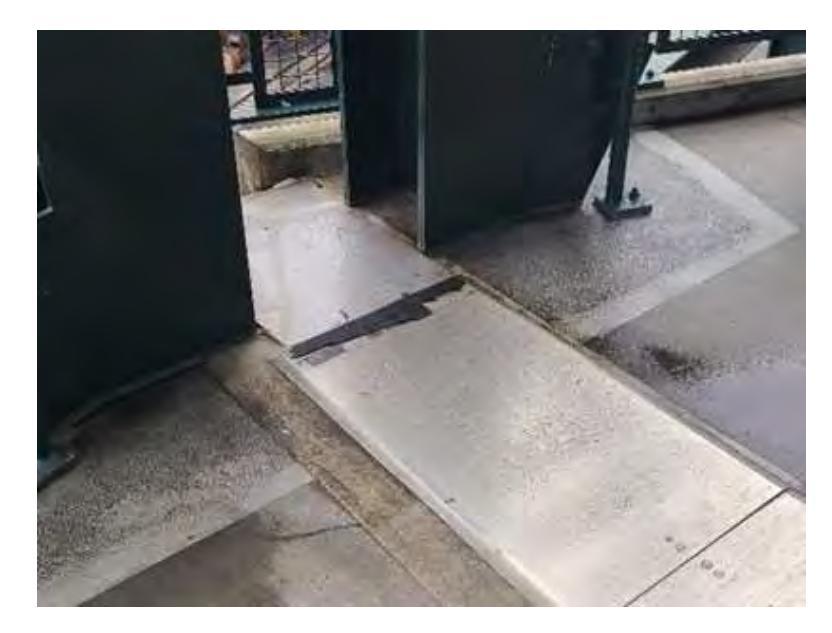
The expansion joints in the concourses have been replaced over time as they became problematic, and they are in adequate condition.

Expansion joint and cover plate at upper concourse

Create an allowance to replace concourse expansion joints and cover plates over the term of the plan.

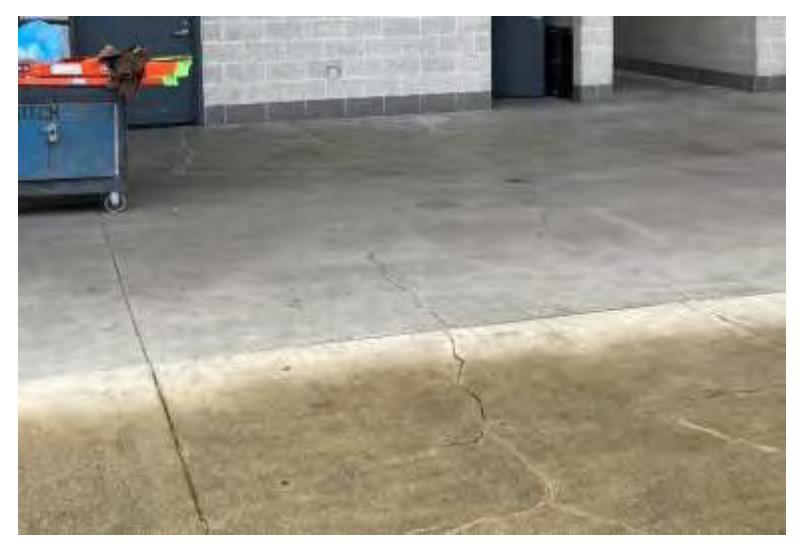
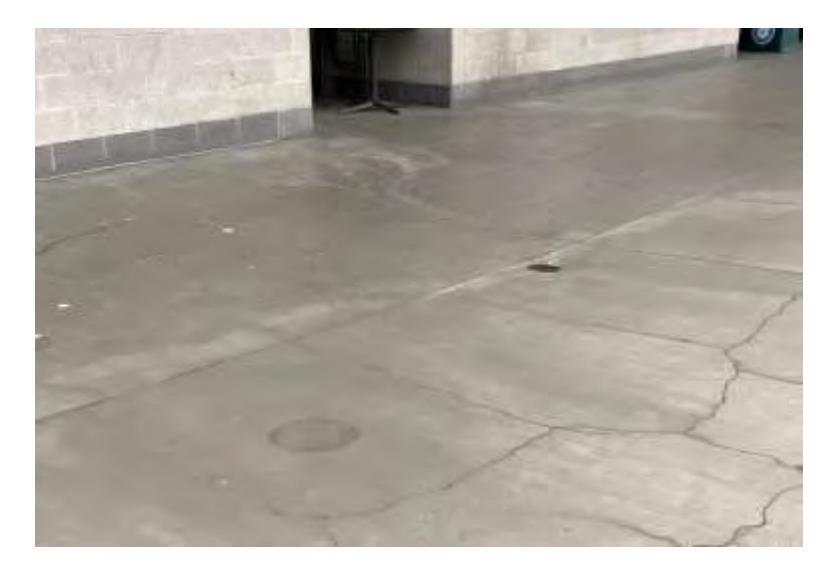
Numerous cracks were found throughout the upper concourse level concrete slabs. Most of these cracks appear to have already been infilled and mitigated.

Upper concourse concrete slab.

Monitor cracking and remove any loose material. Fill in cracks that are wider than 1/8".

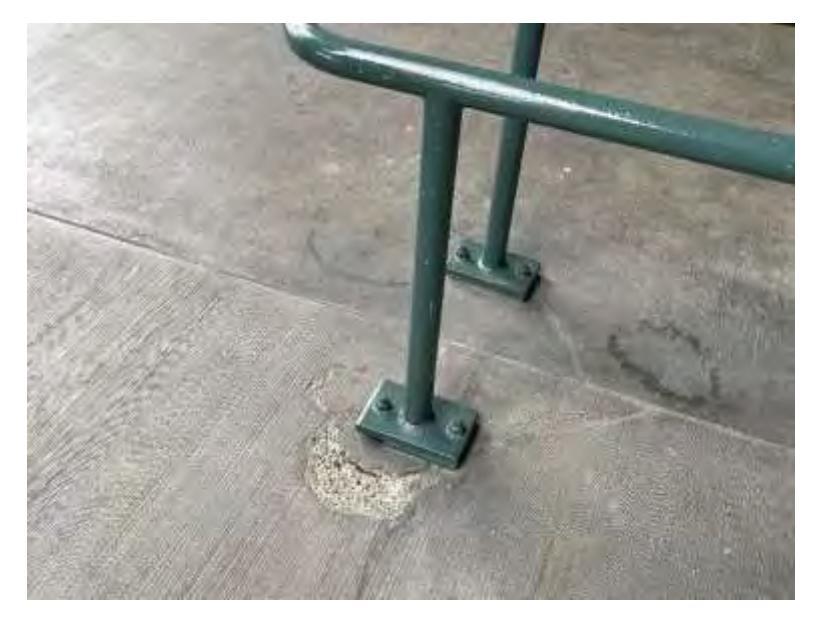
Numerous areas at the guardrail/handrail bases were observed to have spalling and cracking in the concrete.

Spalled concrete at railing post base

Monitor cracking and remove any loose material. Fill in cracks that are wider than 1/8". Spalled concrete should be cleaned of any debris and patched with an appropriate product.

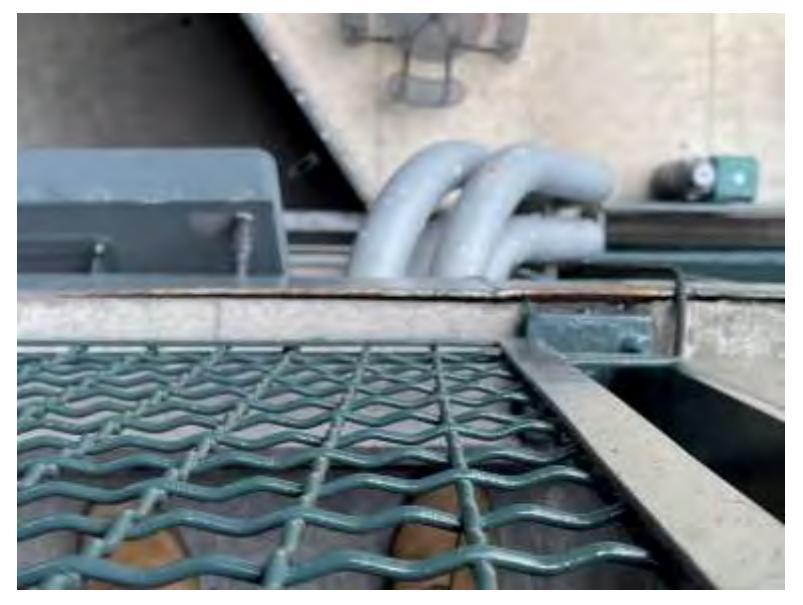
The outboard deck edges around the ballpark were observed to have a gap between the concrete deck and steel deck edge, possibly due to the shrinkage of the concrete deck. Certain locations appear to have collected water and other loose material over time and show signs of rust.

Rust observed at upper concourse deck edges

Gaps should be cleared of any loose material and excessive moisture then sealed with caulking material to prevent future intrusions. Steel elements should be removed of rust, primed with a rust-inhibited epoxy primer, and painted to match the existing structure.

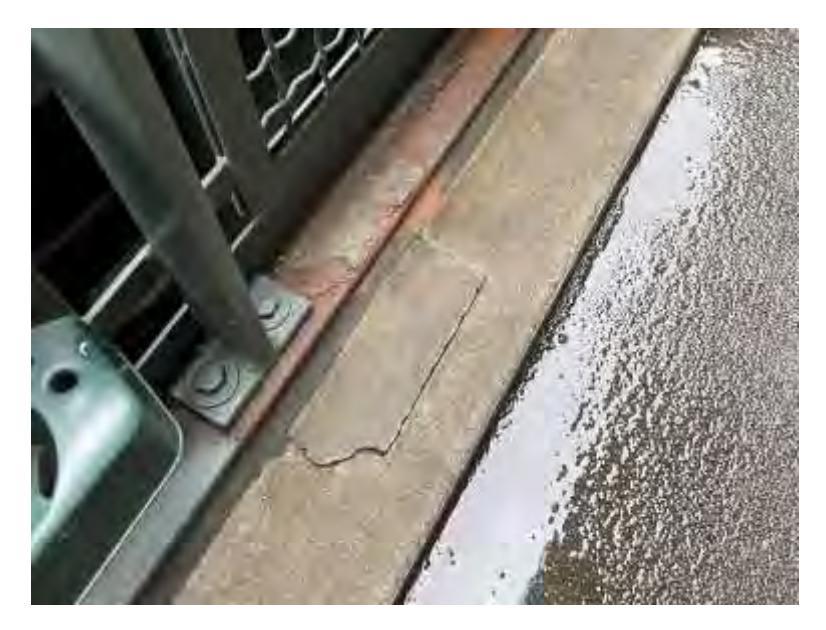
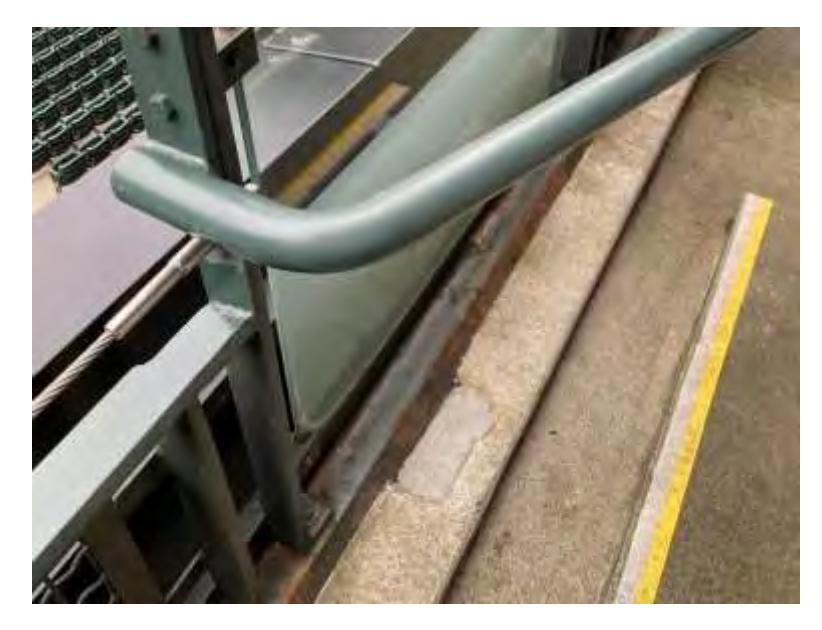
Overall, the railings in the seating bowl are in good condition; however, rust and corrosion were observed in certain locations at the front rails of the 200- and 300-level seating bowl. Additionally, areas showed signs of deterioration but only for the paint layer. Steel elements showed signs of rust, but no signs of corrosion were observed.

Rust and corrosion observed at the club and suite level guardrails

Remove deteriorated elements and clean area of debris and loose material. Steel elements should have any rust removed and cleaned, primed with a rust-inhibitive epoxy primer, and painted to match the existing structure. Remove and patch grout pockets that have deteriorated to the extent that cracks or joints could potentially allow water intrusion.

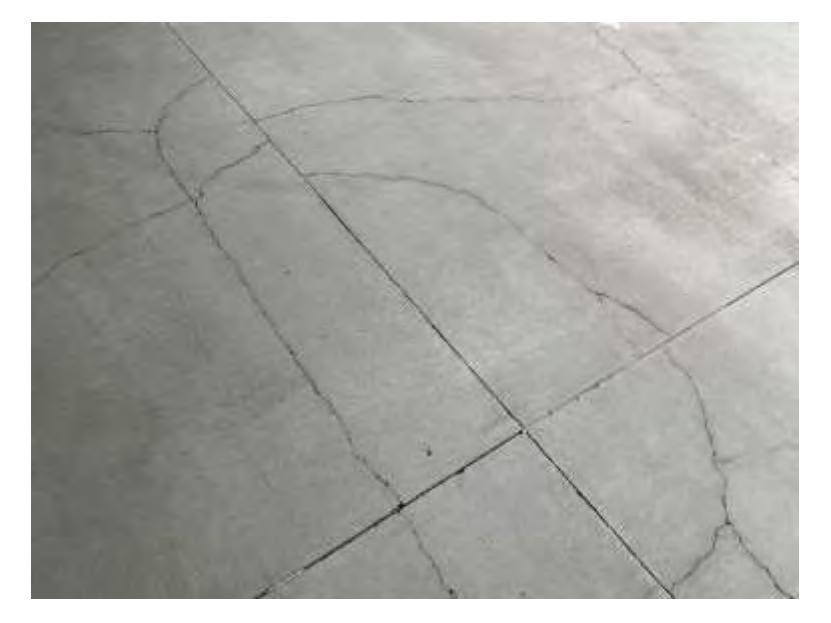
Numerous cracks were found throughout the main concourse level concrete slabs. Most appear to have already been infilled and mitigated.

Main concourse concrete slab

Monitor cracking and remove any loose material. Fill in cracks that are wider than 1/8".

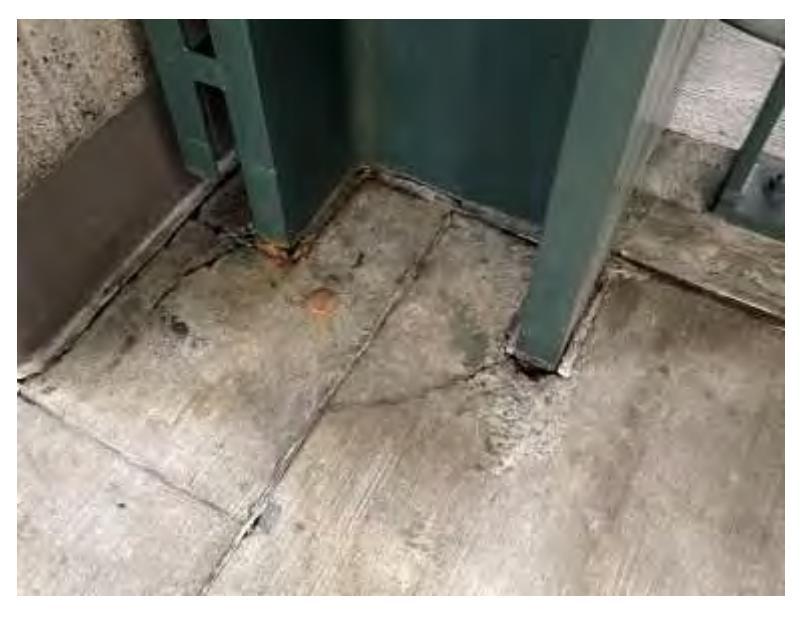
Concrete slabs at the main concourse have cracked and spalled around steel column bases and there are signs of rust.

Steel column base with signs of cracking and spalling in the concrete

Monitor cracking and remove any loose material. Fill in cracks that are wider than 1/8". Steel elements should be removed of any rust and cleaned then primed with a rust-inhibitive epoxy primer and painted to match the existing structure. Spalled concrete should be cleaned of any debris and patched with an appropriate product.

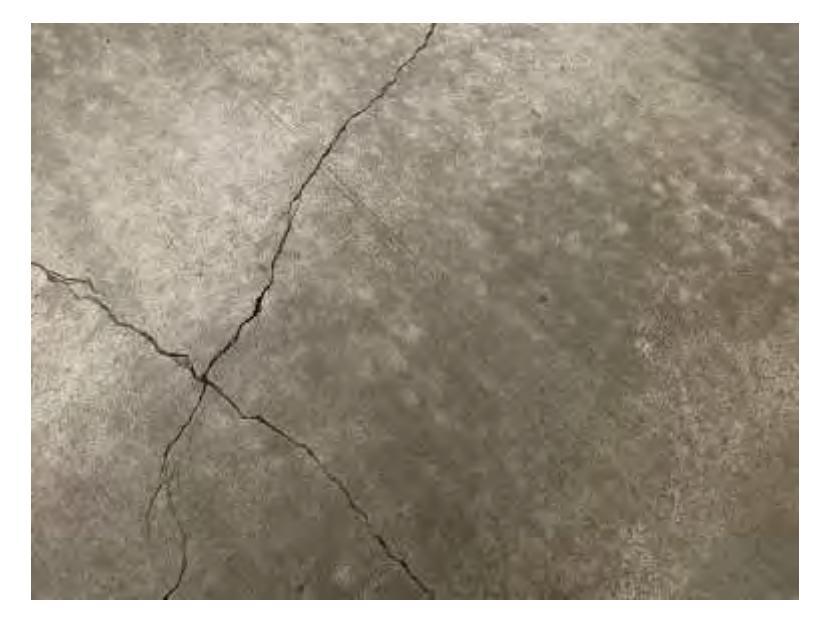
Numerous cracks were found throughout the service level concrete slabs. The majority of these cracks appear to have already been infilled and mitigated.

Cracking in concrete slab at field level tunnel.

Monitor cracking and remove any loose material. Fill in cracks that are wider than 1/8".

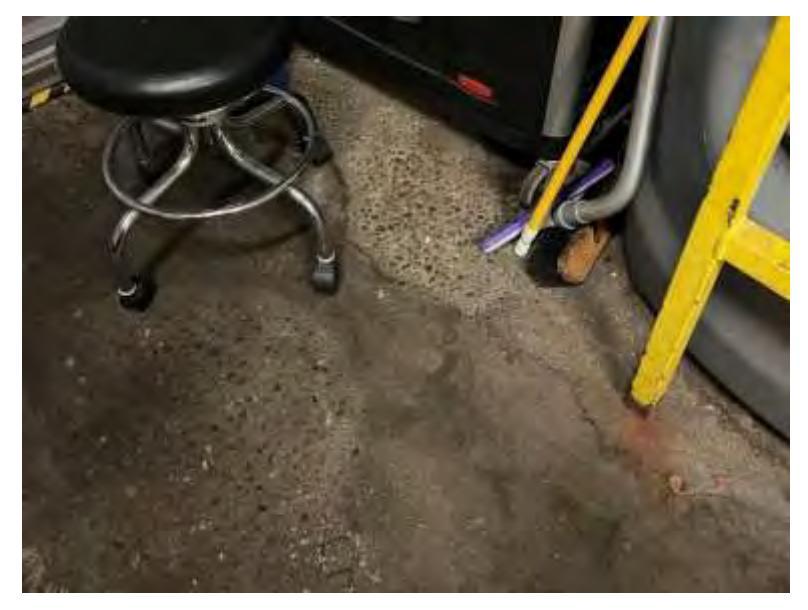
Numerous areas at the field level were found to have spalling in the concrete.

Field level slab with spalling concrete

Spalled concrete should be cleaned of any debris and patched with an appropriate product.

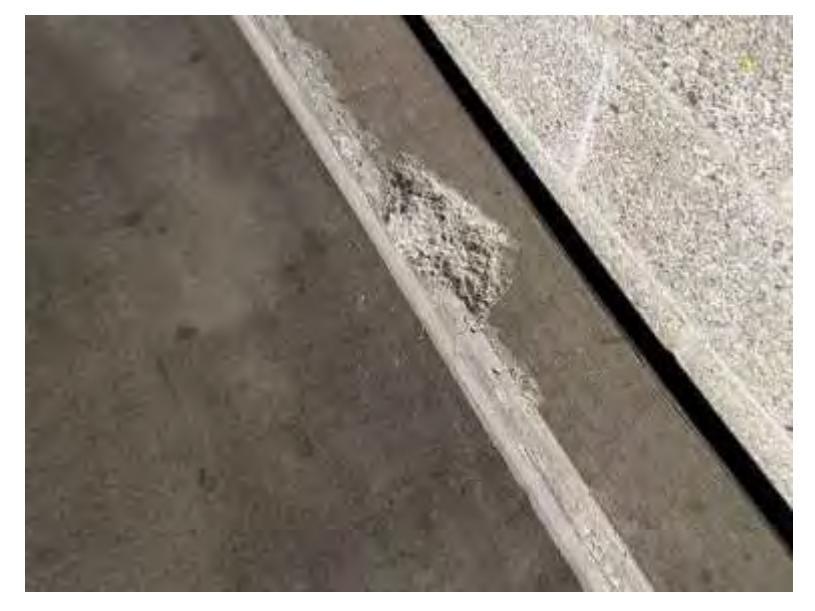
Ramp curbs are in good condition but were observed to have spalling at various locations.

Rampway curb with spalling concrete

Spalled concrete should be cleaned of any debris and patched with an appropriate product.

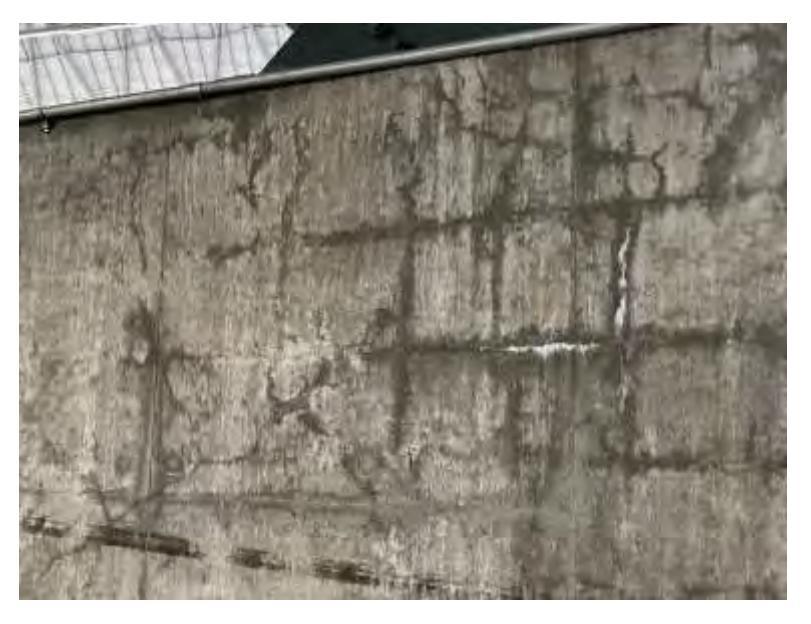
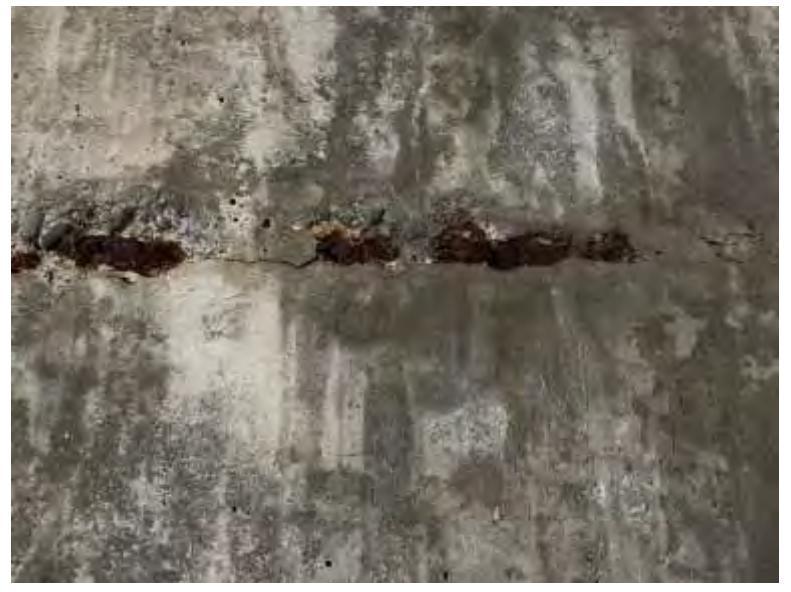
Rampway walls are in good condition but were observed to have cracking and spalling in certain locations. Exposed reinforcement was also observed.

Cracks observed in rampway walls.

Exposed rebar observed in rampway wall.

Monitor cracking and remove any loose material. Fill in cracks that are wider than 1/8". Exposed reinforcement should have any rust removed, cleaned, then primed with a rust-inhibitive epoxy primer. Spalled concrete should be cleaned of any debris and patched with an appropriate product.

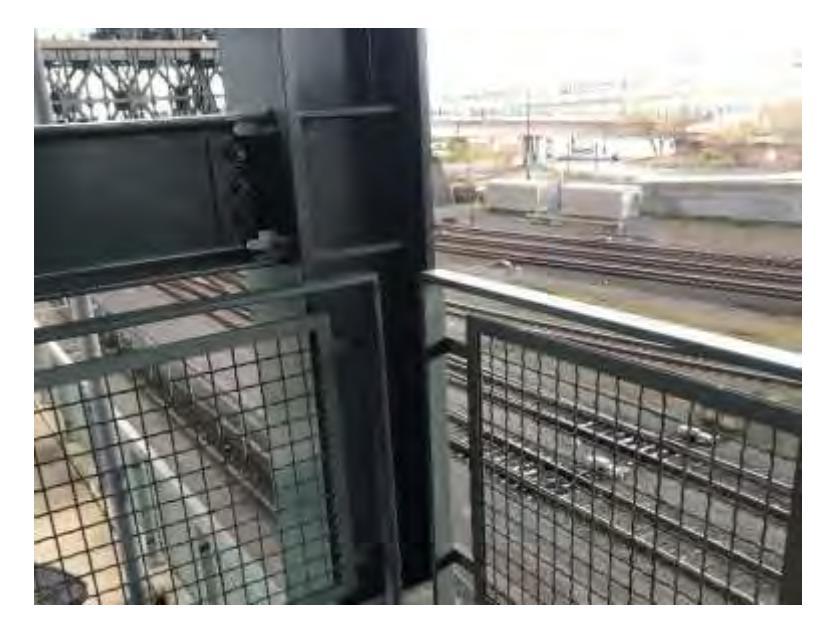
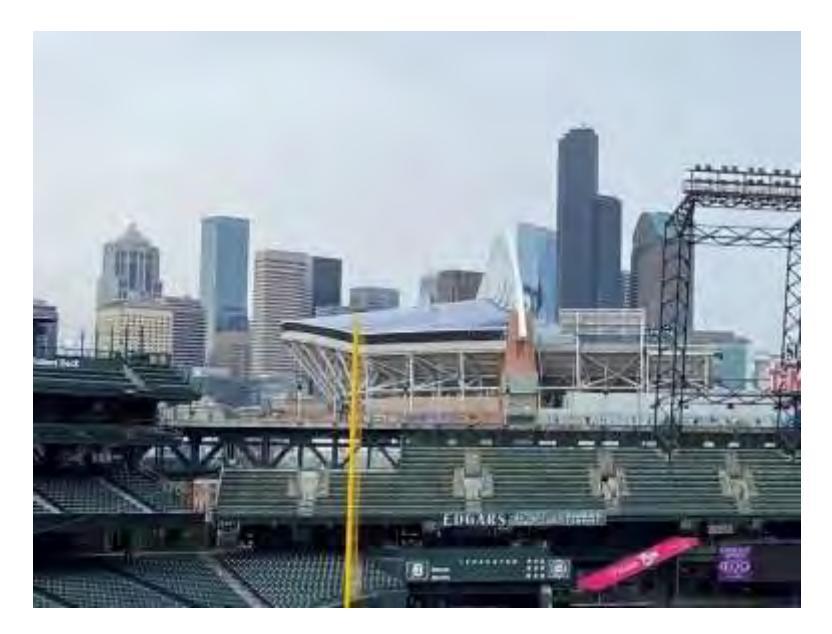
Exposed steel structural and non-structural components

**Recommendation:** All structural steel should be painted every 10 years and all non-structural components, such as handrails, guardrails, fencing, and gates, should be painted every 5 to 10 years depending upon age and wear.

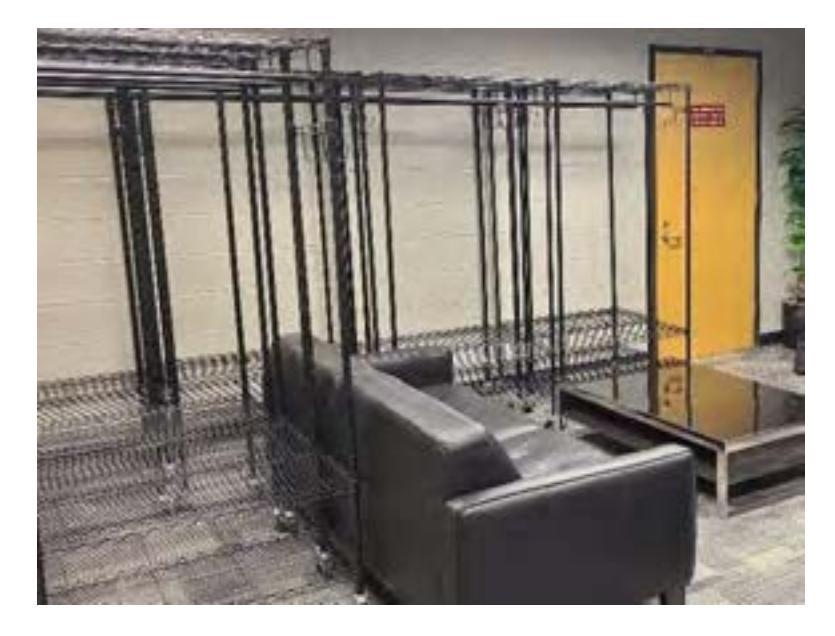
Green rooms are generally in good condition, finishes are relatively new, and the furniture is in good condition, but finished wet areas could be updated.

Replace finishes in wet areas.

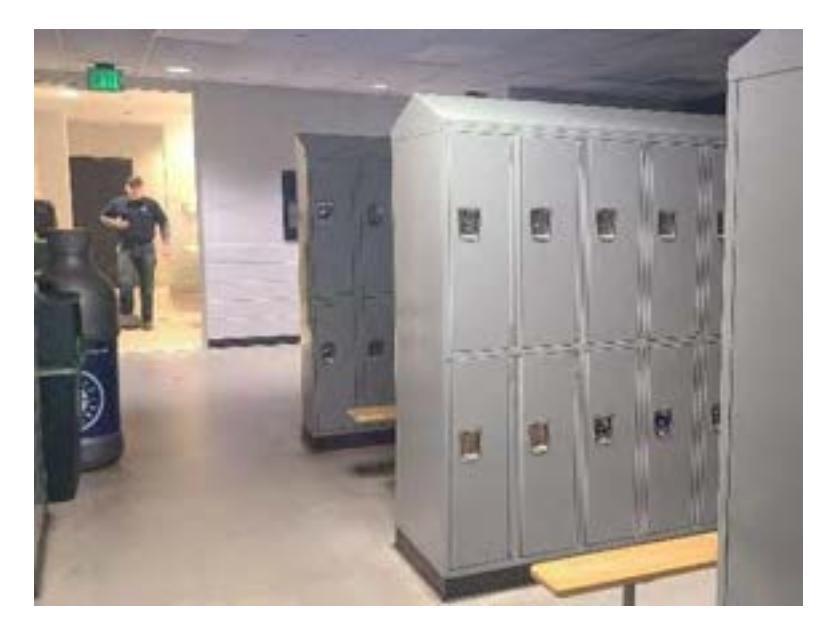
Game day staff locker area is in good condition. The flooring is in good condition and the ceiling is in adequate condition.

Repaint and replace ceiling in 10 years.

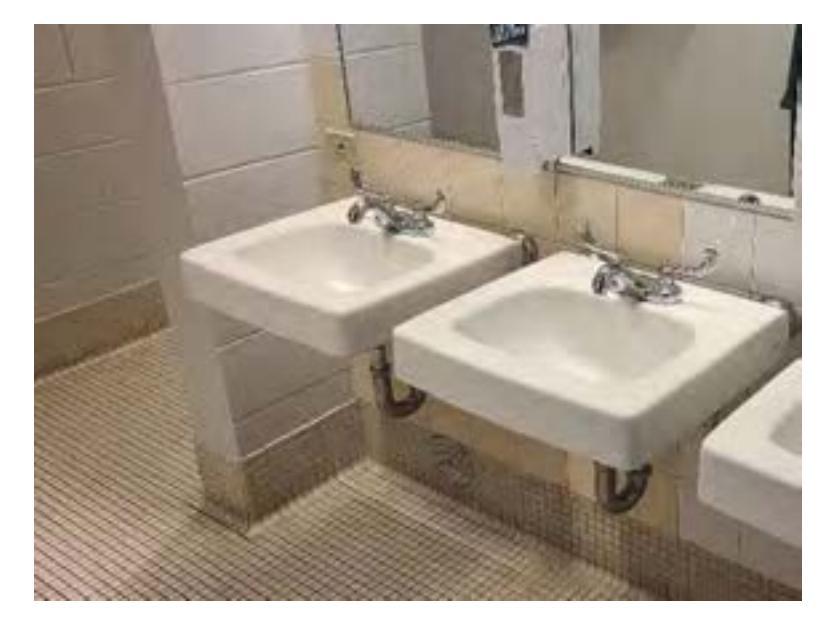
Restroom

The tile is in adequate to marginal condition, but the tile work in this area will need to be redone within the current lease period.

Replace tile and finishes in 10 years.

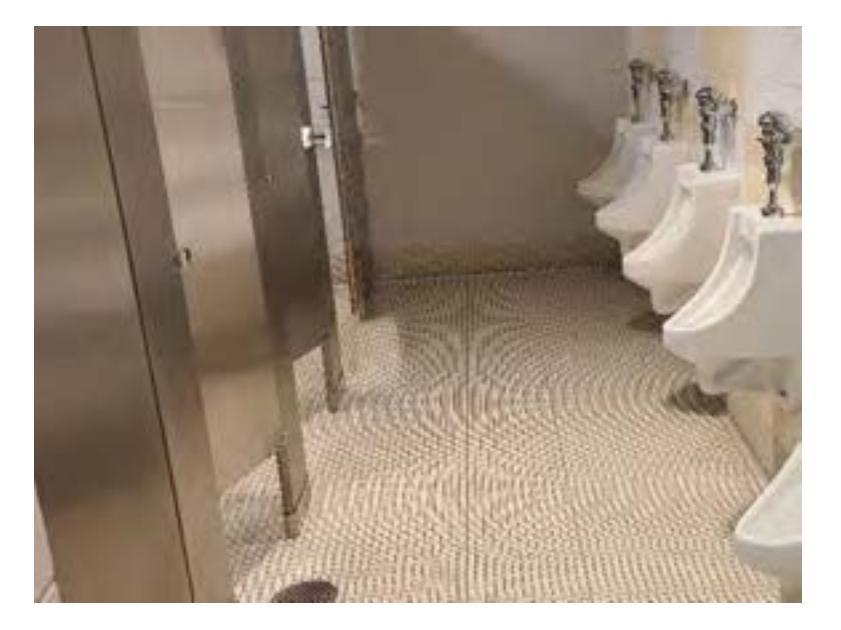
Restroom

The tile is in adequate to marginal condition, but the tile work in this area will need to be redone within the current lease period.

Replace tile and finishes in 10 years.

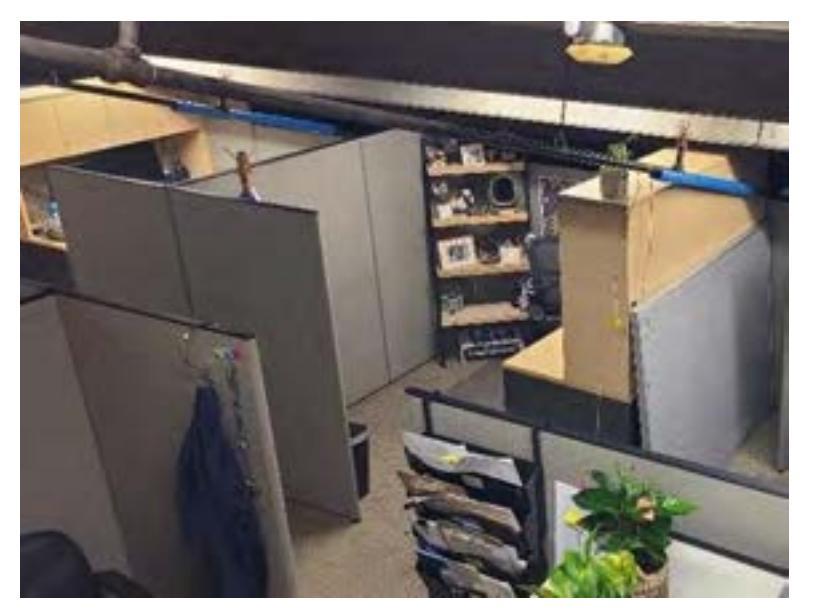
The offices are buried in the bowels of the stadium with inadequate lighting, dated cubicles, and random furniture.

Provide new workstations, lighting, and furniture.

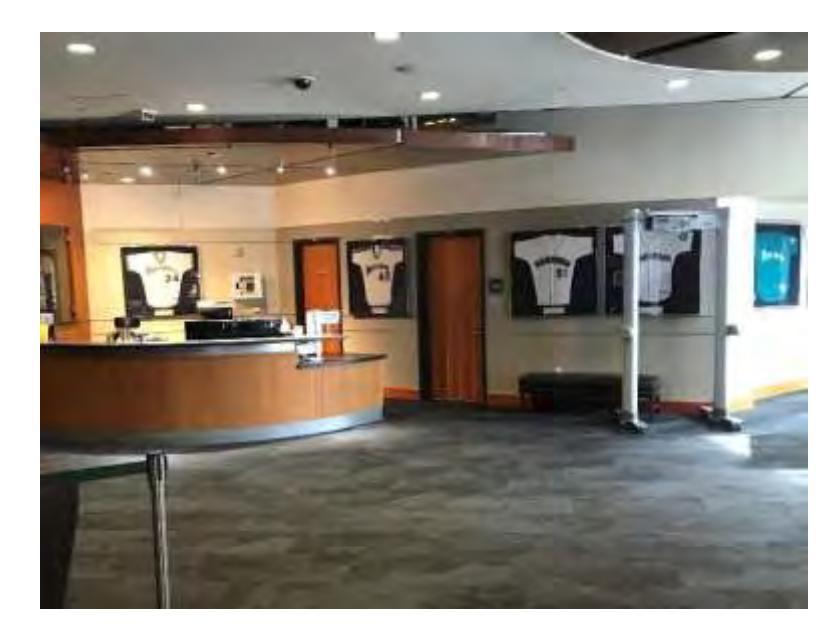
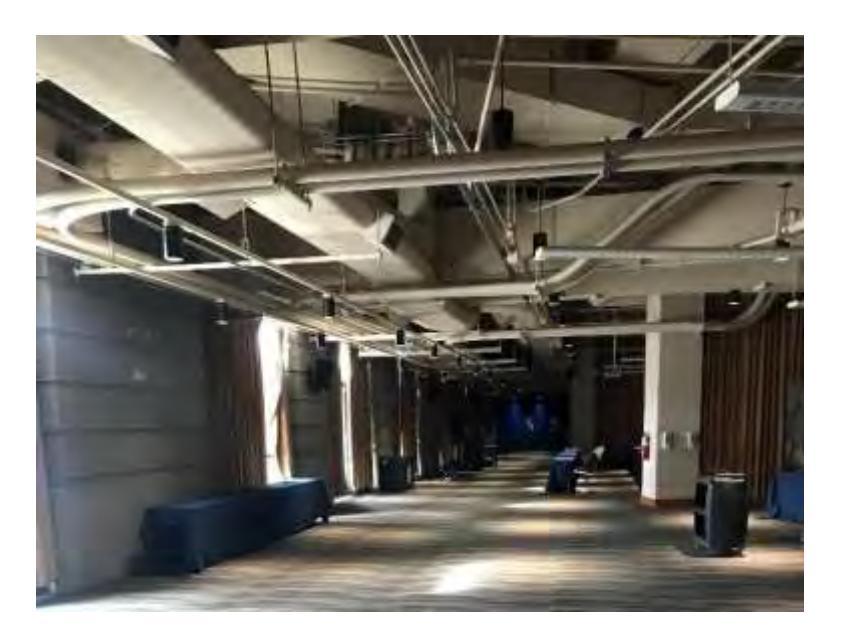
The Mariners entrance lobby and Ellis Pavilion are well maintained and in overall good condition. However, both are aesthetically dated due to limited investment to date. Ellis Pavilion received new lighting, FF&E, and audio though no improvement has been made since 2006.

Recommend a modernization or repurposing of the space for another use.

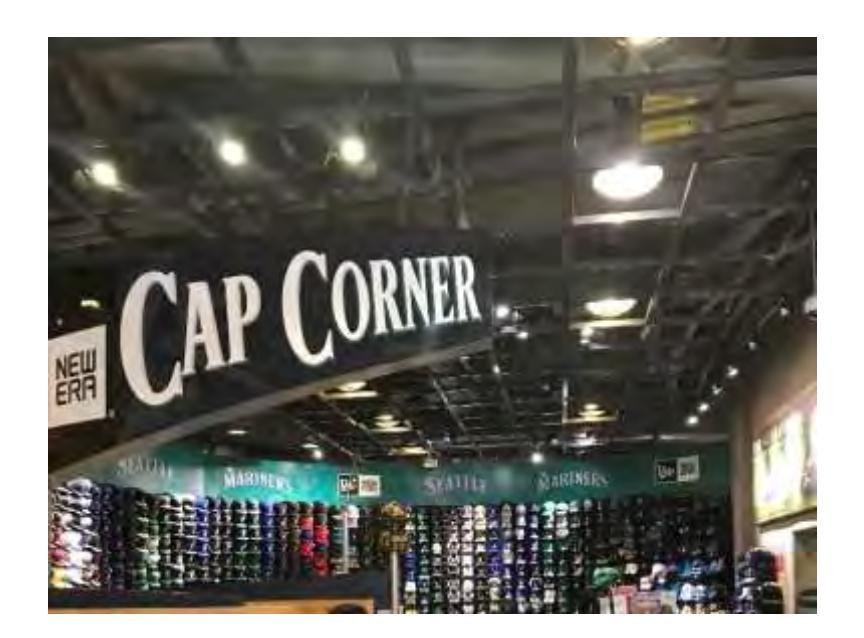
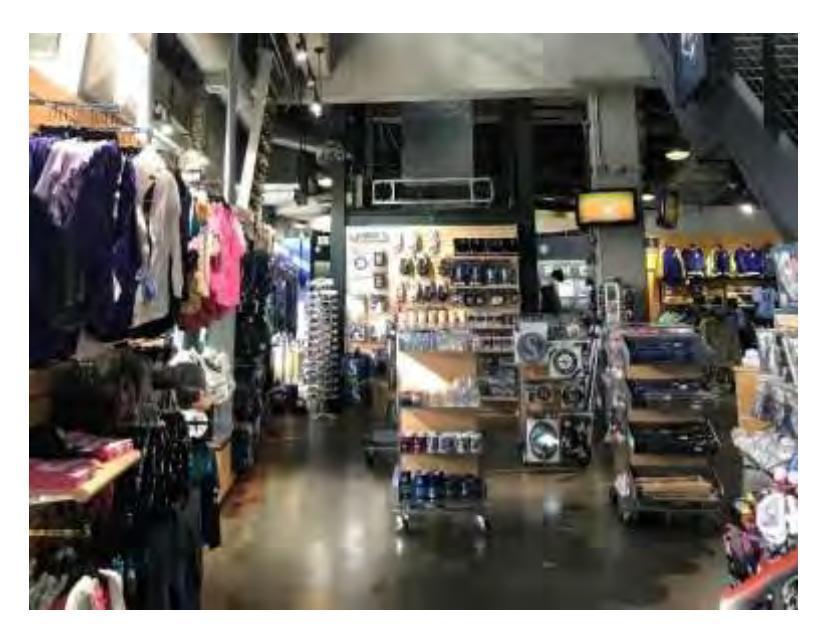
Main merchandise store

The main merchandise store on 1<sup>st</sup> Avenue is in good condition. The finishes are wearing reasonably well and are not outdated.

Recommend modernization of the store in the next 5-

10 years.

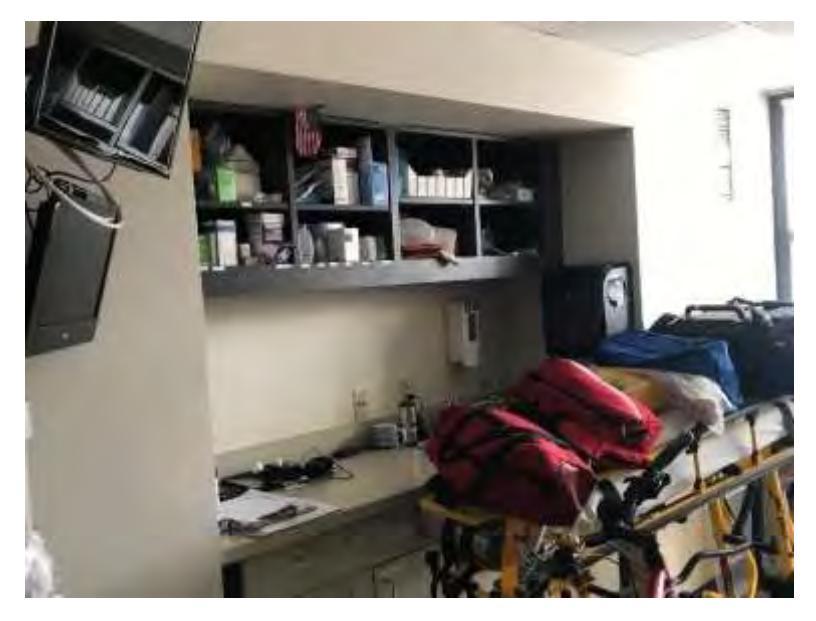
First aid room

First aid and fan accommodations are in adequate condition.

Update finishes in 5 to 10 years.

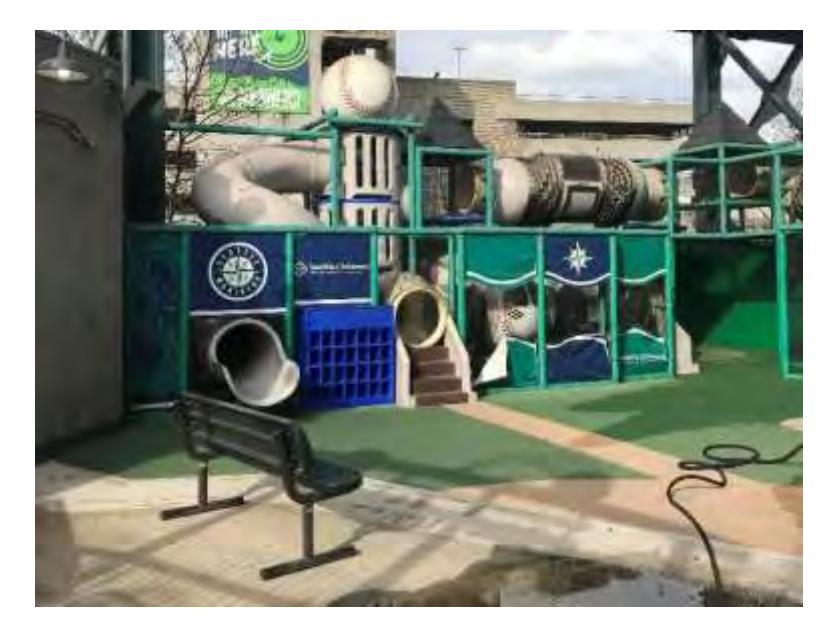
#### **Observation IN-15: Kids Area**

The kids area on the 100 level is in adequate to marginal condition but is experiencing wear and tear from use and being exposed to the elements. A new kids area was recently added on the 300 level of the ballpark.

Kids play area on 100 level
[This page is left intentionally blank.]

Recommend a full replacement and modernization in the next 5 to 10 years.

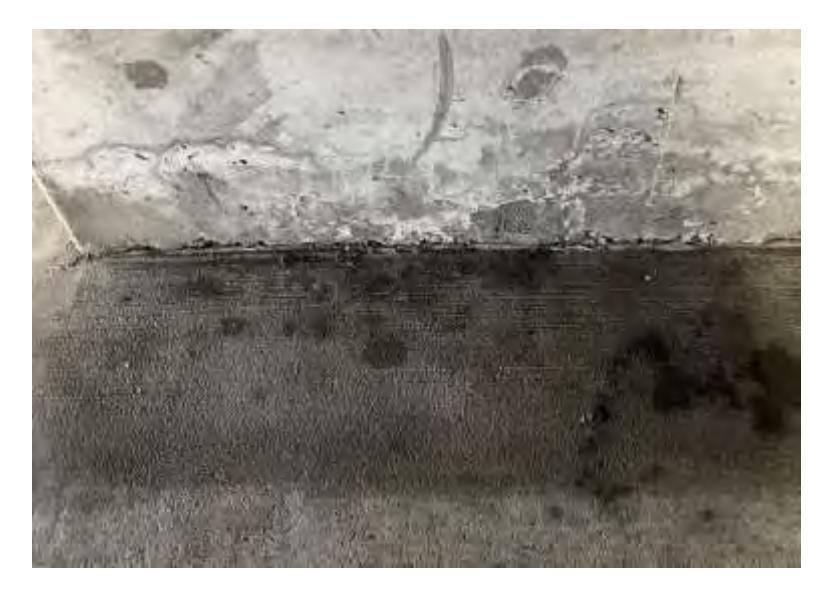
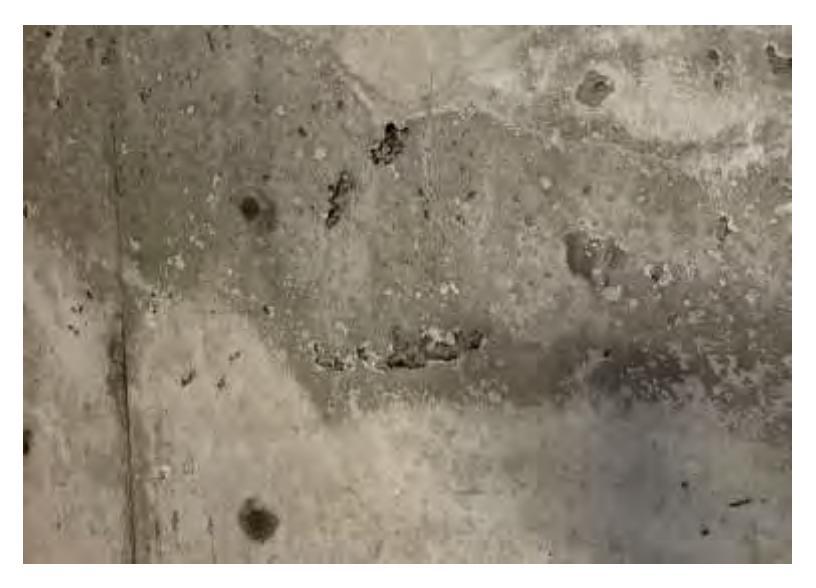
## **Observation PG-1: Spalling at Concrete Walls**

Concrete walls within the parking garage are generally in good condition; however, spalling in some areas was observed, but no signs of exposed reinforcing steel were noted.

Concrete wall with spalling observed.

Spalled concrete should be cleaned of any debris and patched with an appropriate product.

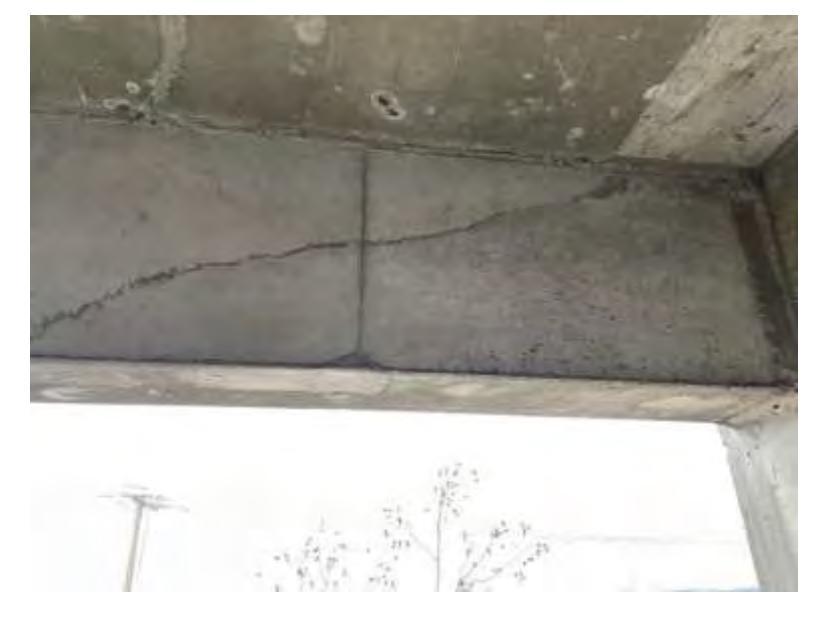
## **Observation PG-2: Cracks at Concrete Beams**

Overall, the concrete beams in the parking garage are in good condition; however, diagonal cracks in some beams were observed at various locations. These cracks were located at either the mid-span or support ends.

Diagonal crack observed at beam end.

Fill in cracks that are wider than 1/8" and monitor cracks for any increase in length or width.

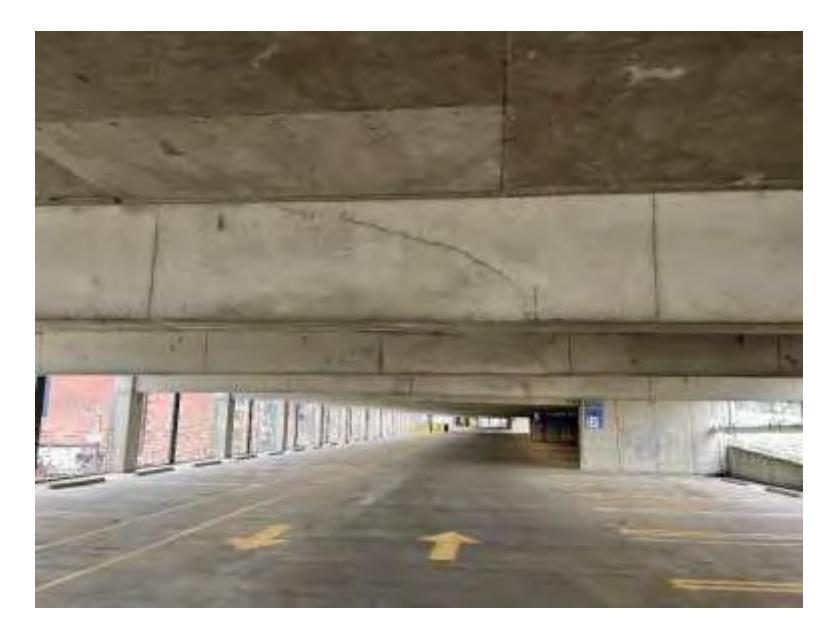
Diagonal crack observed at beam mid-span.

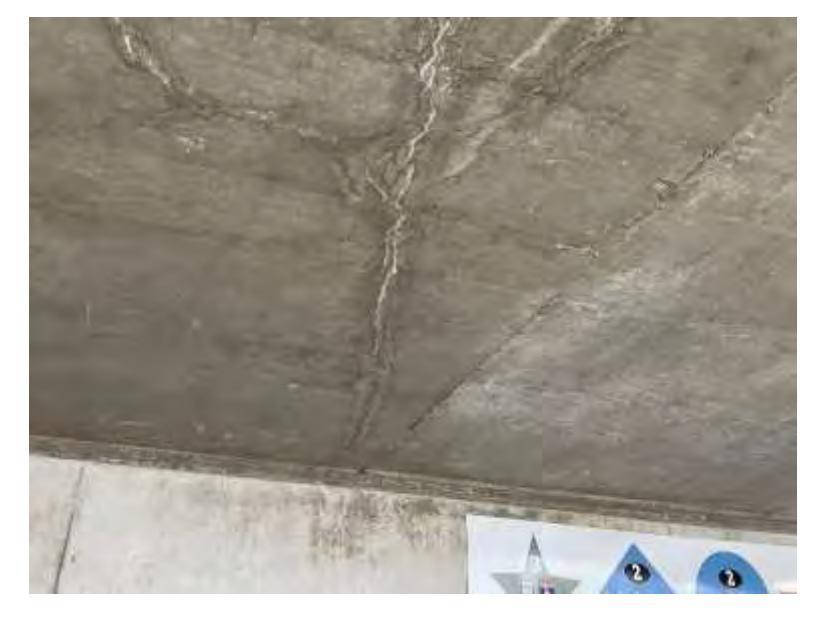
# Observation PG-3: Overhead Cracks and Spalling at Concrete Deck

Overall, the concrete decks in the parking garage are in good condition, though limited cracking and spalling was observed at various locations.

Overhead cracking and spalling observed in the concrete decks.

Loose material shall be removed to prevent any falling hazards. Spalled concrete shall be patched with an appropriate product. Fill in cracks that are wider than 1/8" and monitor for any increase in length or width.

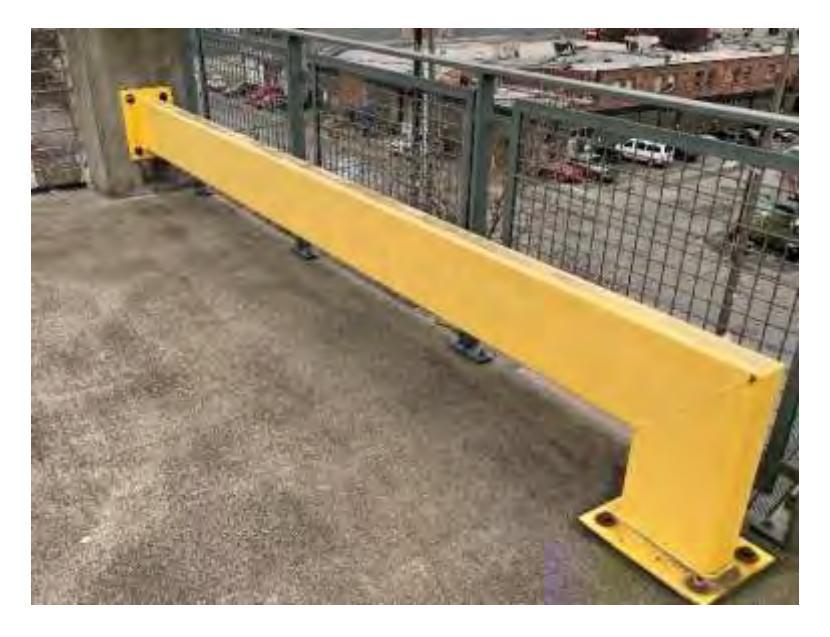
## **Observation PG-4: Rust on Anchor Bolts at Vehicle Barriers**

Overall, the vehicle barriers are in good condition; however, rust on anchor bolts in certain locations was observed. Anchors do not appear to be painted or galvanized.

Vehicle barrier with signs of rust in at the anchors.

Anchors, nuts, and washers should be replaced with hot-dipped galvanized components. Alternatively, elements should have any rust removed, be cleaned, primed with a rust-inhibitive epoxy primer, and painted to match the existing structure.

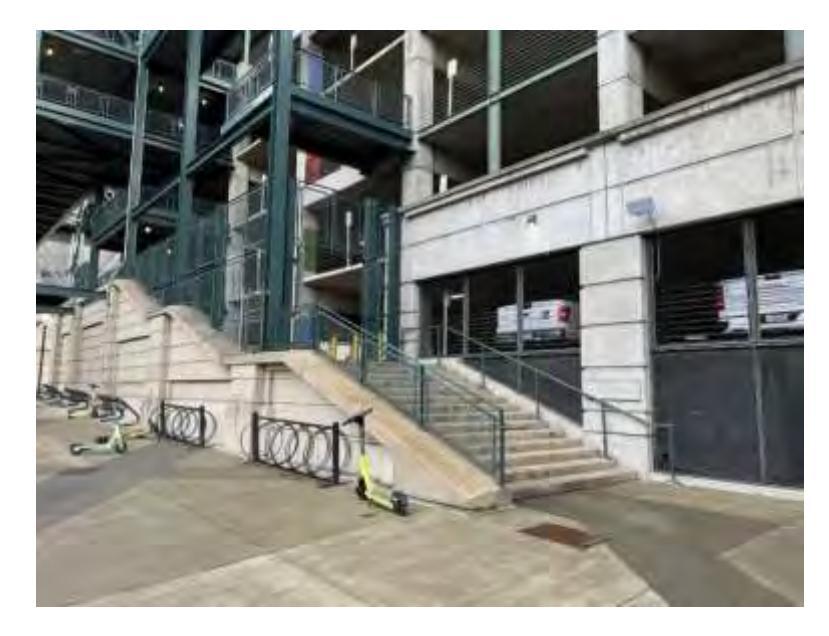
Metal fencing, rails, and structural members

In certain locations the perimeter fencing and gates are showing signs of age and wear.

Refurbish or replace damaged fence and gate components, including hinges and locking hardware. Paint exposed steel.

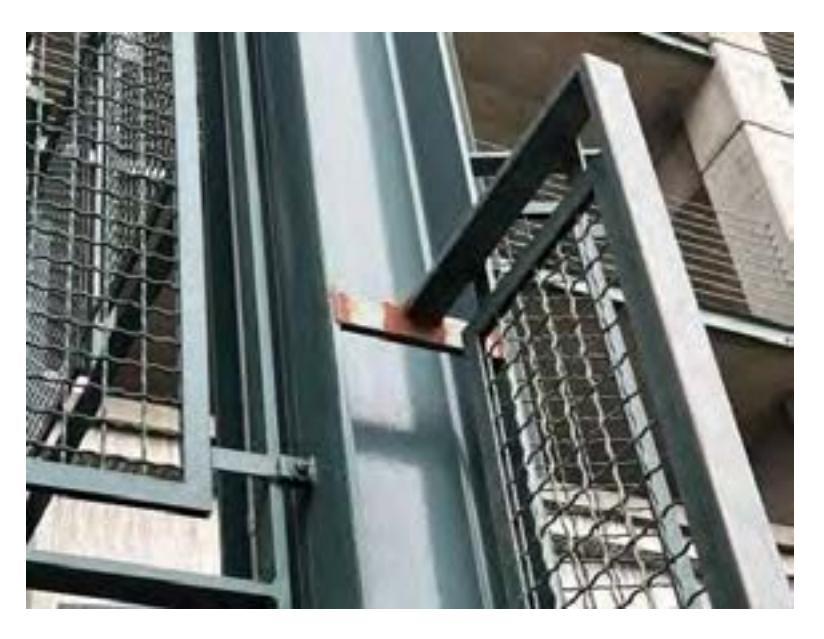
Rust on fencing

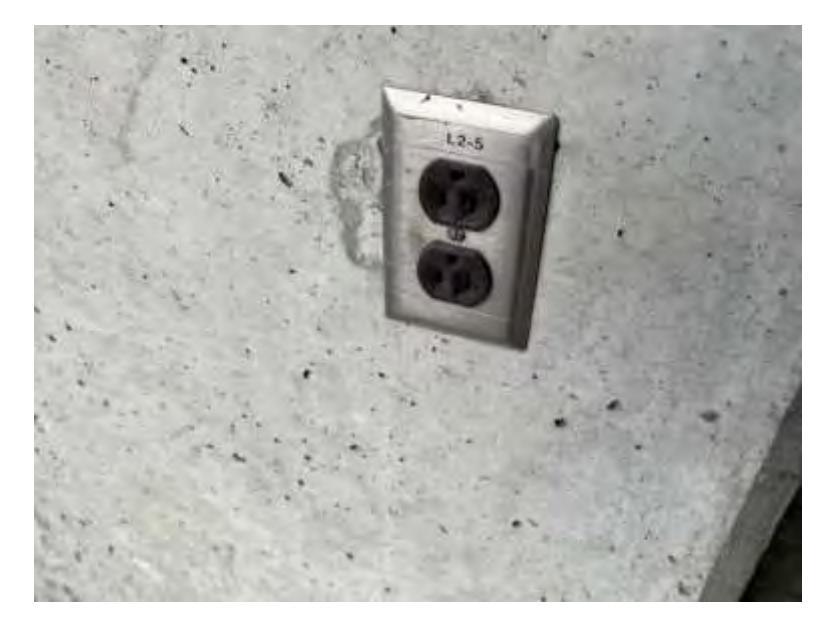
## **Observation PG-6: Missing Weatherproof Electrical Covers**

Parking garage outlet – missing weatherproof outlet cover

Verify code requirements for exterior electrical outlets in the garage and provide covers as appropriate.
