# Seattle Mariners T-Mobile Park Long-Term Capital Needs Assessment REPORT / MAY 2022

# 1.0 - PREFACE

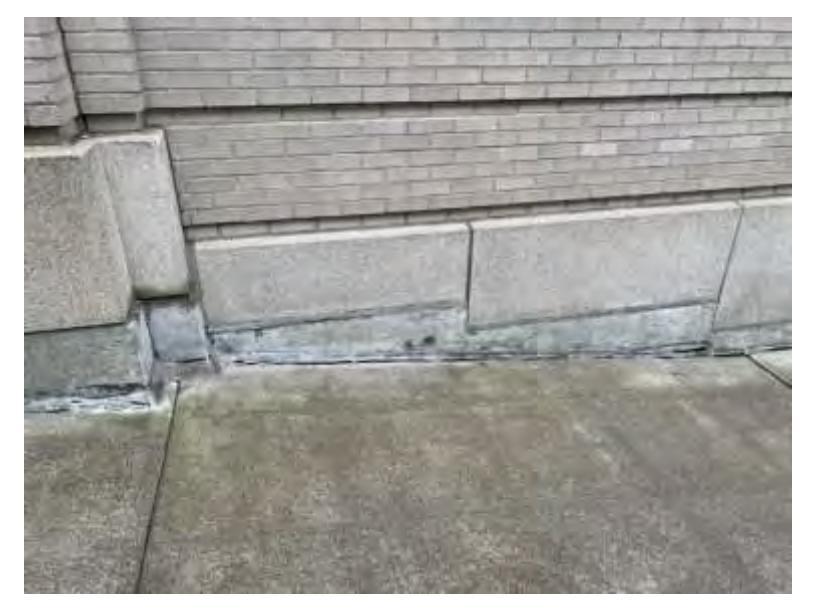
Parking garage exterior

# **Observation PG-7: Grout and Sealant at Masonry Facade**

Overall, the masonry and precast façade are in good condition; however, grout and sealant joints at certain locations have deteriorated, possibly due to water penetration and freeze / thaw cycles.

Rating: Adequate

**Recommendation:** Replace defective grout and sealant.

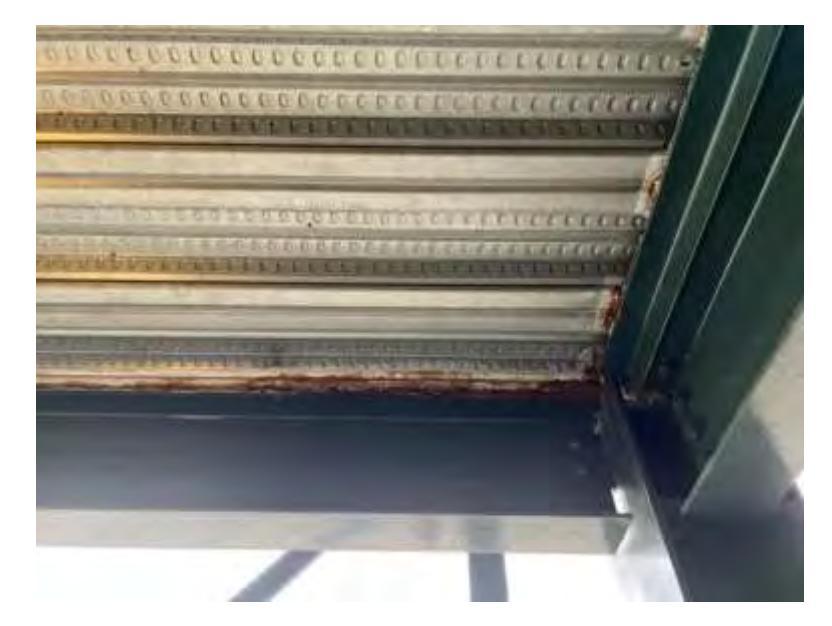
## **Observation PG-8: Rust at Exposed Metal Decking**

Rust is forming at the edges of steel members in some locations.

Rust at metal deck

Remove rust and refinish surfaces.

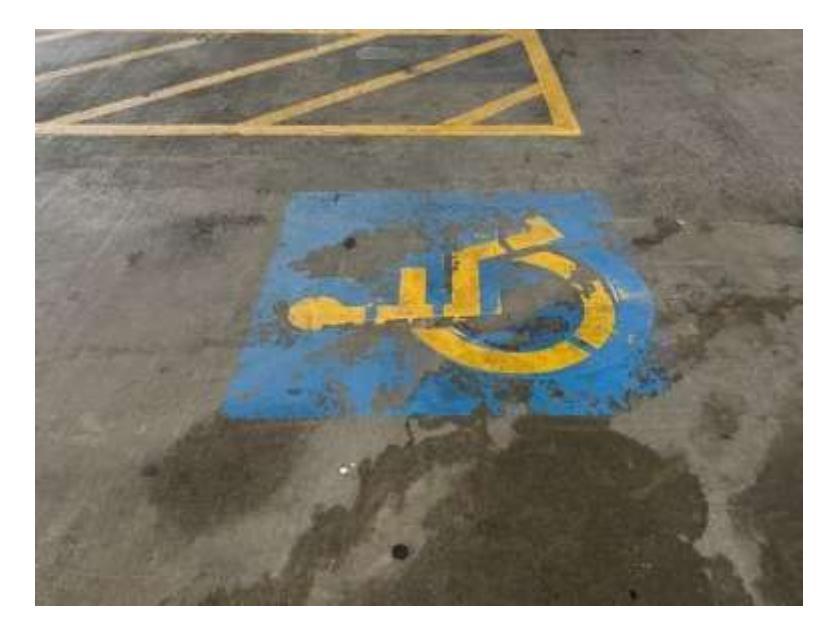
## **Observation PG-9: Parking Lot Paint and Stripping**

Parking lot paint and striping are generally in adequate to marginal condition with certain areas showing excessive wear.

Accessibility graphic in area of increased foot traffic

Repaint concrete parking striping and accessibility graphics.

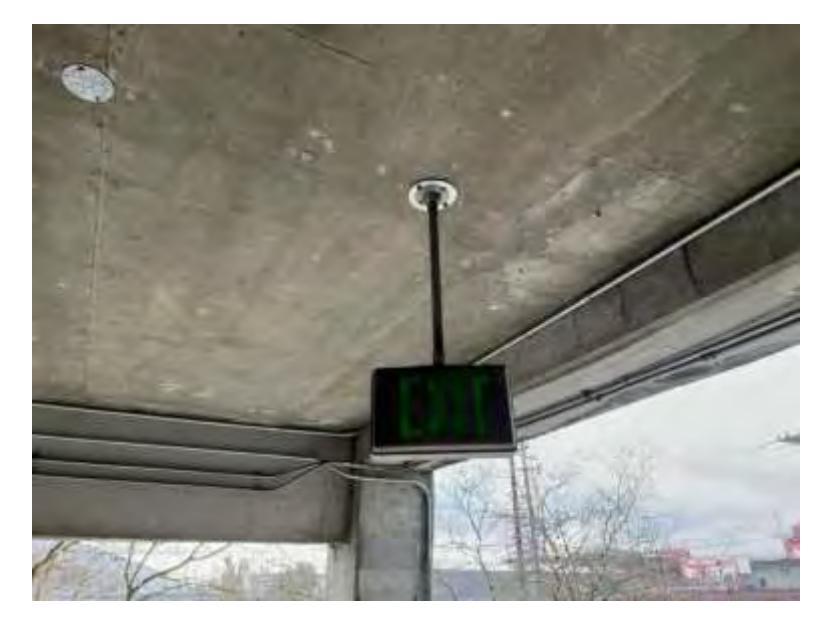
## **Observation PG-10: Illuminated Exit Signage**

Dirty exit signage

Refurbish or replace signage as needed to ensure effective egress notification.

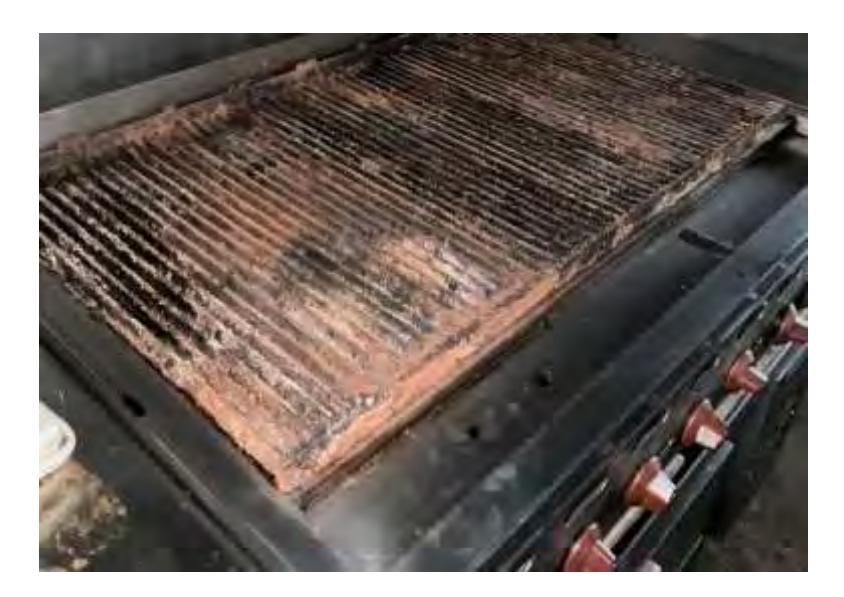
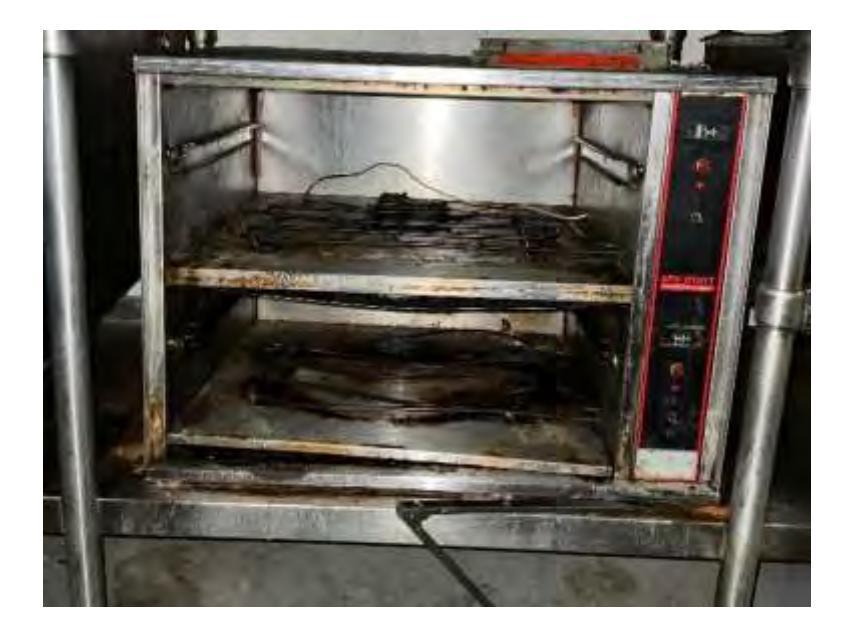
The majority of the production equipment, such as fryers, griddles, popcorn machines, hot dog steamers, concession carts, etc. are dated and have reached the end of their useful lives. They should be replaced. Some equipment has been changed out; it should be preserved and reused after the renovations.

Grill in concession stand

Drawer warmer in room M06A

Implement a phased replacement of production equipment in conjunction with planned concession and kitchen renovations. In the interim, replace equipment as it fails.

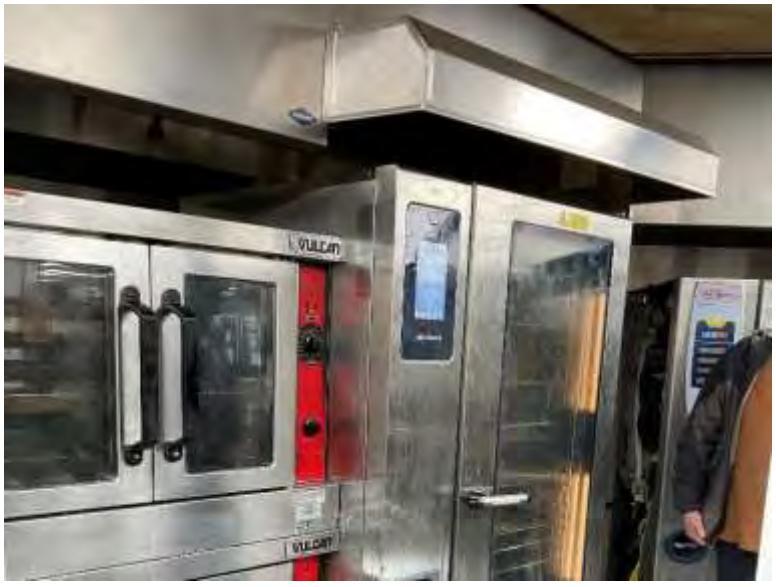
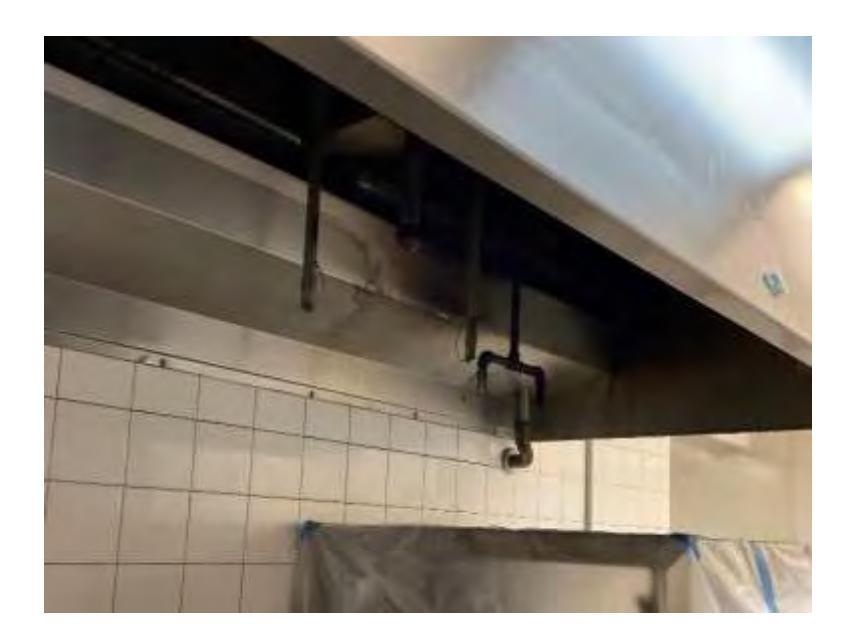
#### **Observation FS-2: Exhaust Hoods**

Exhaust hood in room C27C

Exhaust hood in concession room M01A

Perform a detailed analysis of equipment under all hoods and evaluate the hood coverage and fire systems' performance.

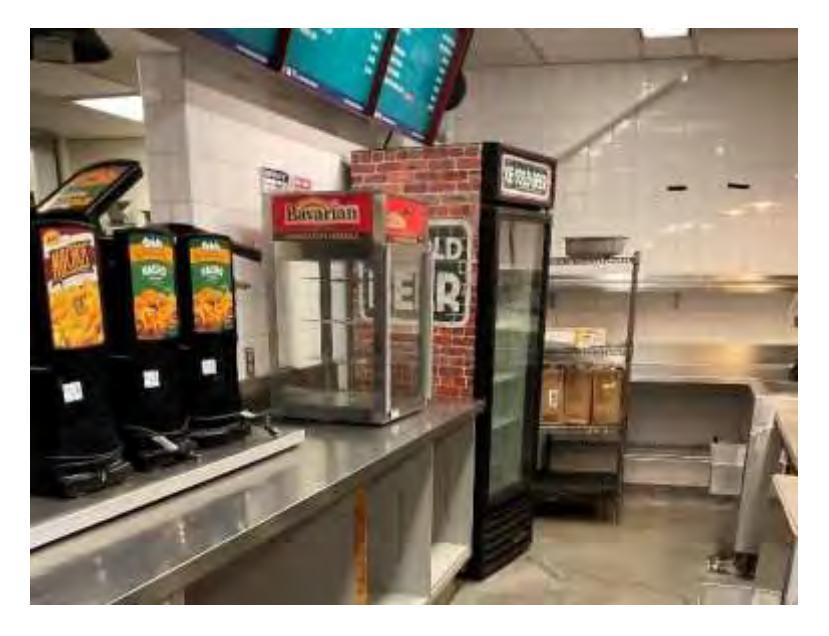
Back counter in room U16A

#### **Observation FS-4: Stainless Steel Counters**

The stainless-steel transaction counters and back counters are original and were specifically designed for an outdated operational/equipment plan and would not be useful as part of a redesign.

Implement a phased refurbishment of stainless-steel counters in conjunction with planned concession and kitchen renovations. In the interim, replace equipment as it fails.

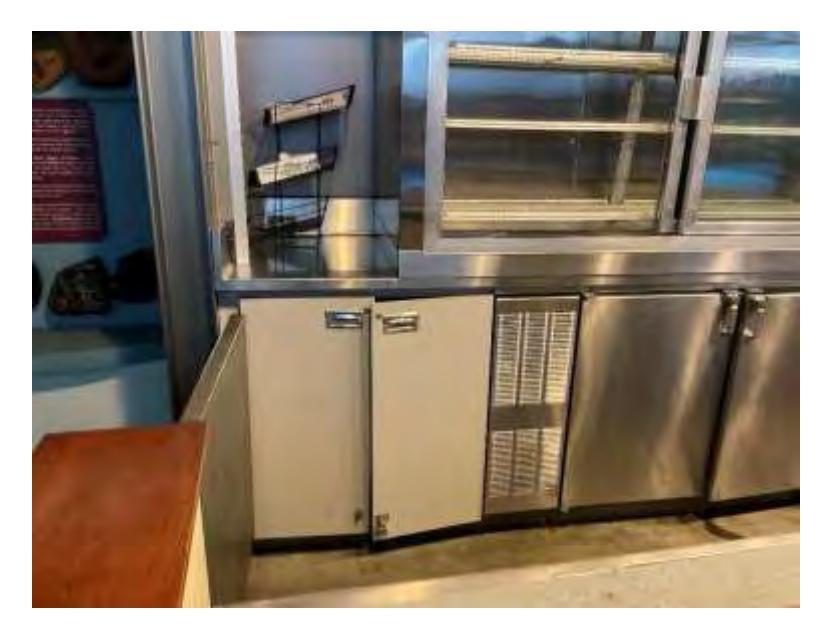
Cabinet at room UD23D

### **Observation FS-5: Millwork and Cabinetry**

The millwork and cabinetry in the concession stands are failing and should be replaced.

Implement a phased replacement of millwork and cabinetry in conjunction with planned concession and kitchen renovations. In the interim, replace items as they fail.

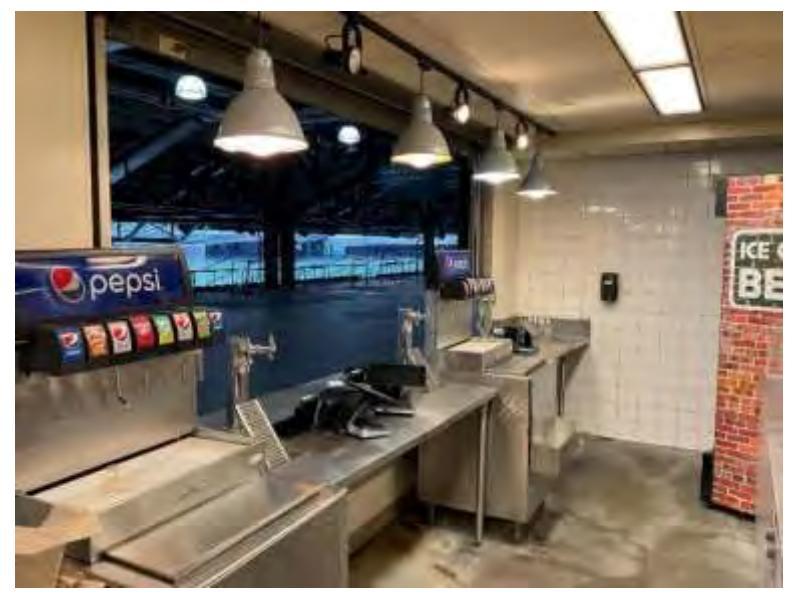
Concession room M07A

## **Observation FS-6: Concession Lighting**

Implement a phased replacement of lighting at concessions in conjunction with planned concession and kitchen renovations.

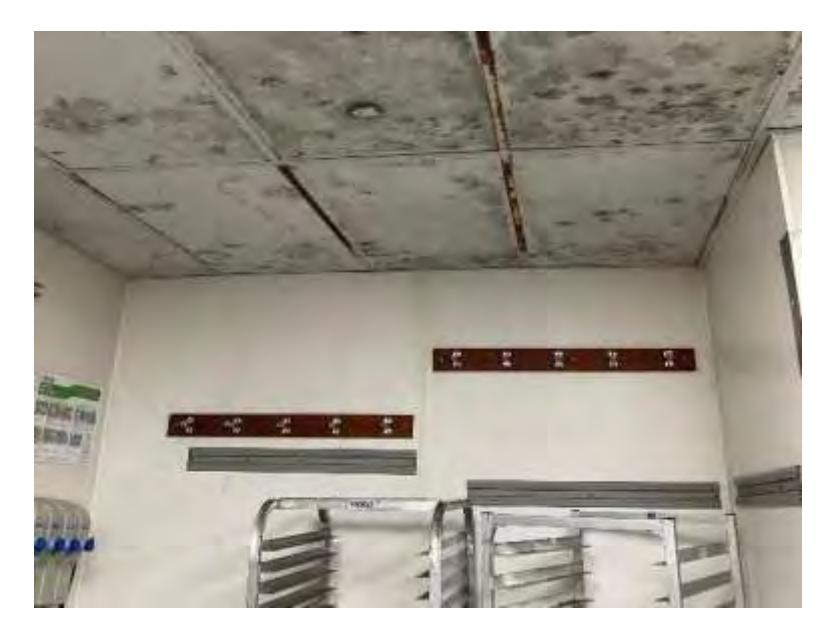
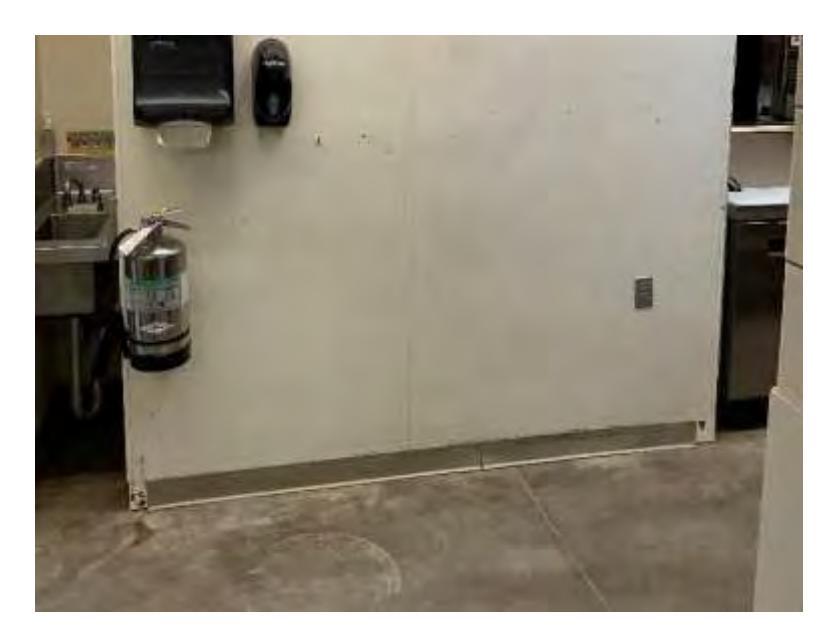
#### **Observation FS-7: Concession Floor, Wall, and Ceiling Finishes**

The Mariners have been replacing or refurbishing floor, wall, and ceiling finishes in the food service areas, but these finishes in some areas have reached the end of their useful lives and should be replaced. Ceiling conditions include uncleanable, grease-laden ceiling tiles and rusting ceiling grids, which are sometimes above food preparation areas. These conditions should be addressed as soon as possible.

Ceiling in dish room – room C27C

Flooring, wall, and cove base in M01A

Address ceiling deficiencies as soon as possible. Implement a phased replacement of architectural finishes, including a review of potential deficiencies such as ADA access and hard-to-clean areas in conjunction with planned concession and kitchen renovations.

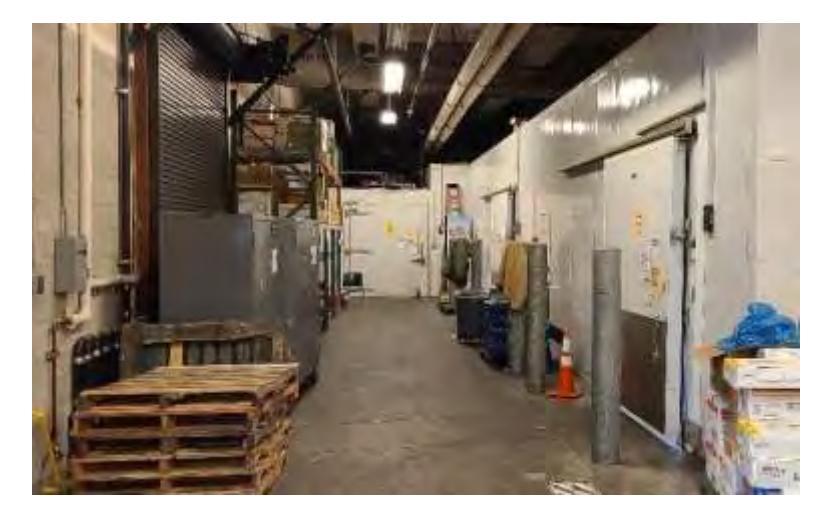
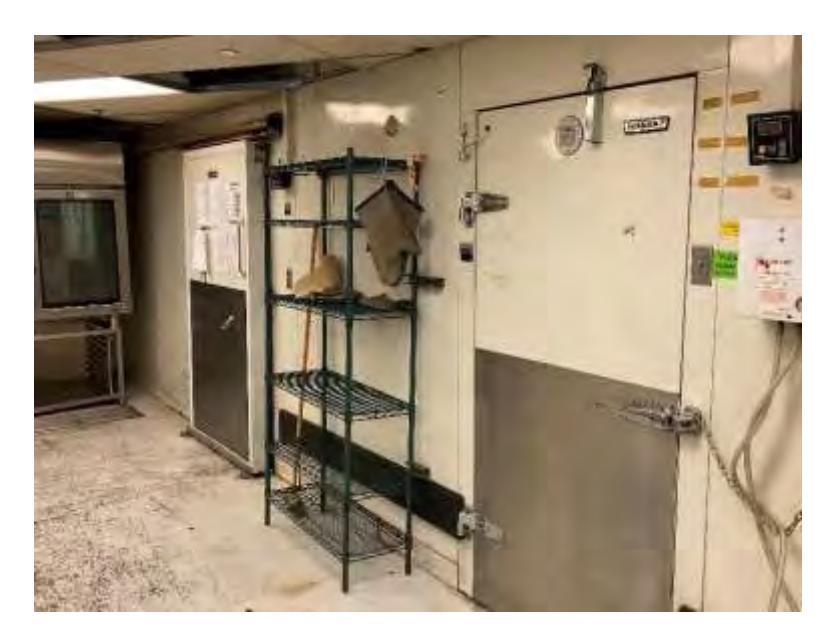
Walk-in freezers and coolers are in adequate condition and, with the exception of hardware components, can continue to be used. Most of the units are original and refrigeration components will need to be replaced as they fail.

Walk-in freezers at commissary

Walk-in cooler and freezer in room M40B

Because of current supply chain delays and long equipment lead times, consider a proactive, phased replacement of existing condensing units and general refurbishment within the first ten years of the plan.

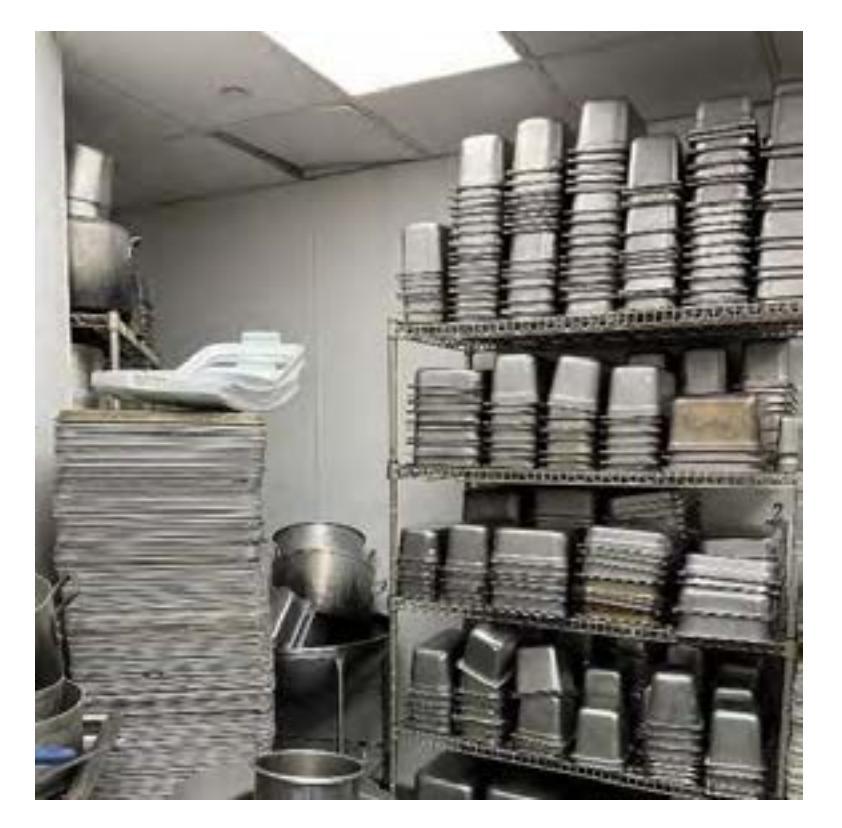
Concession storage in room C27C

#### **Observation FS-9: Storage Space and Equipment**

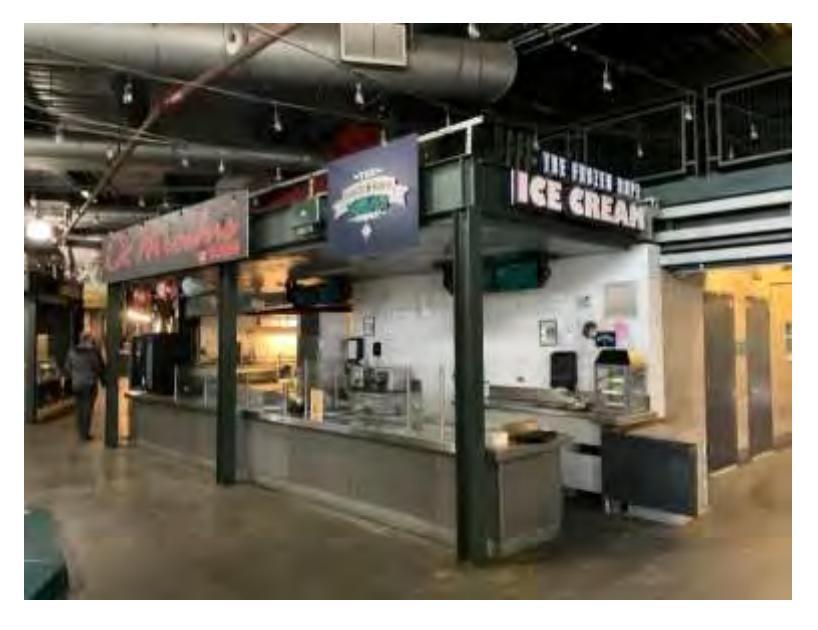
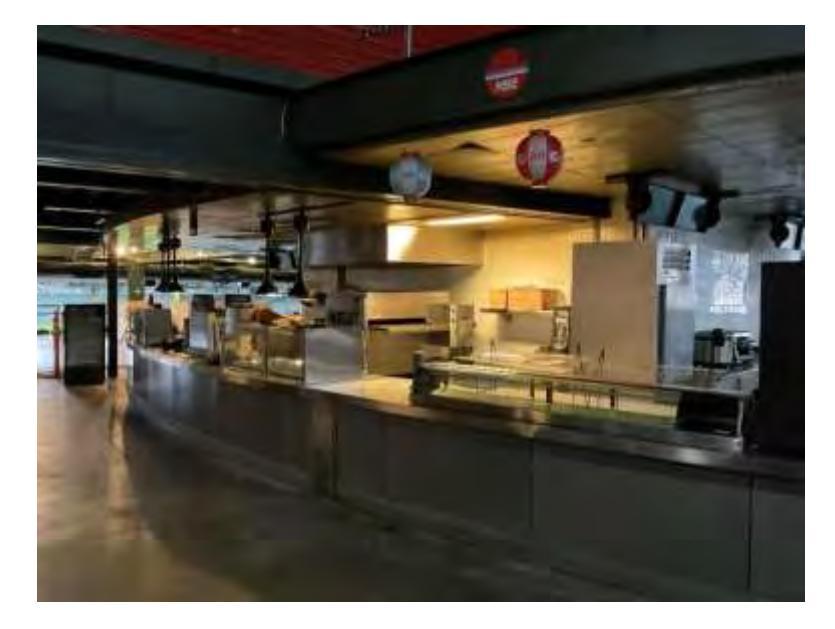
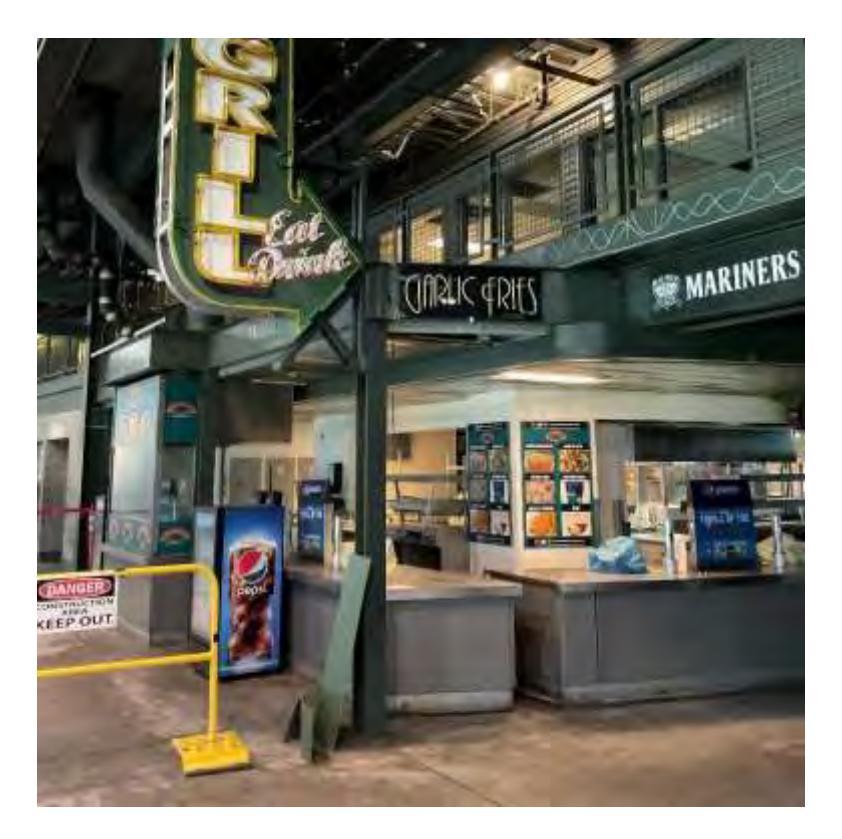
# Observation FS-10: Open Concession Stands at Main Concourse and Pen

Open concessions room M13B

Open concessions room M10A

As part of renovation planning, consider enclosing these stands or creating front market area pick-up stations with back-of-house spaces enclosed.

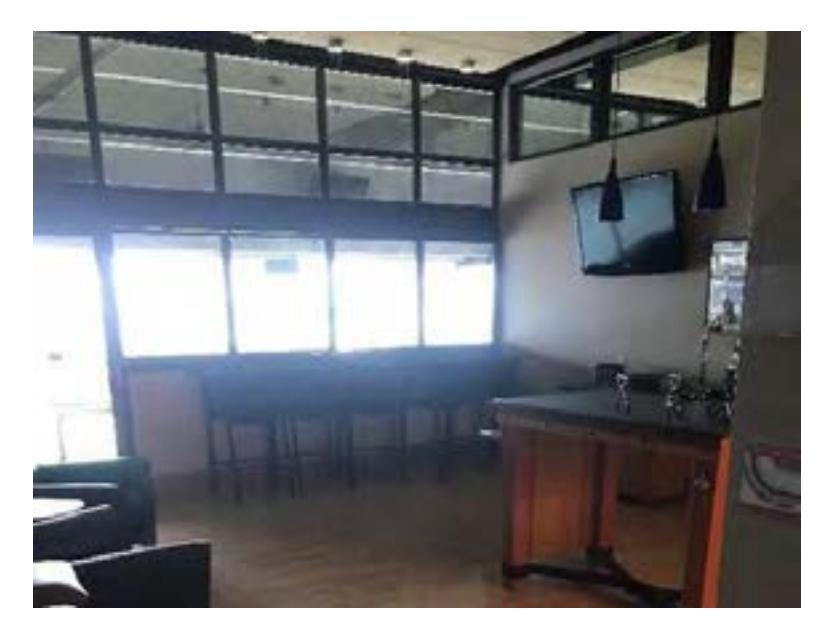
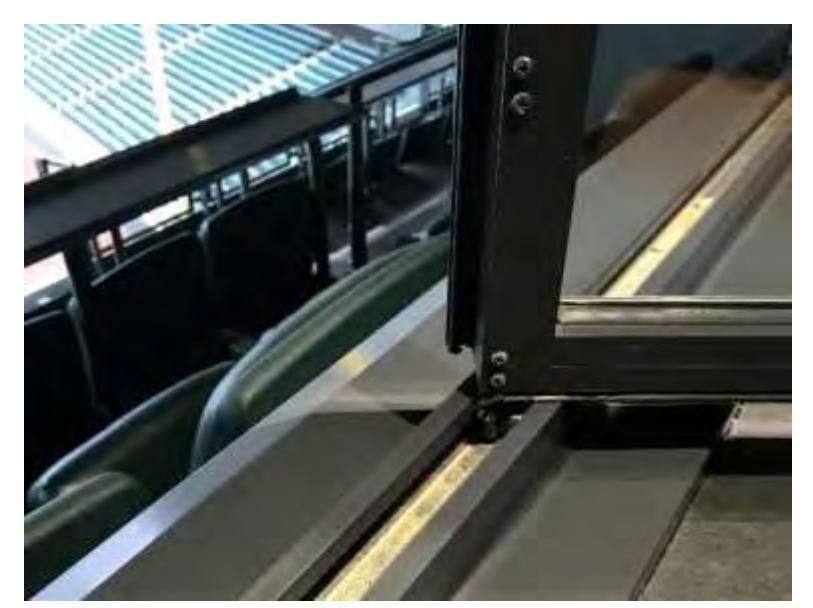
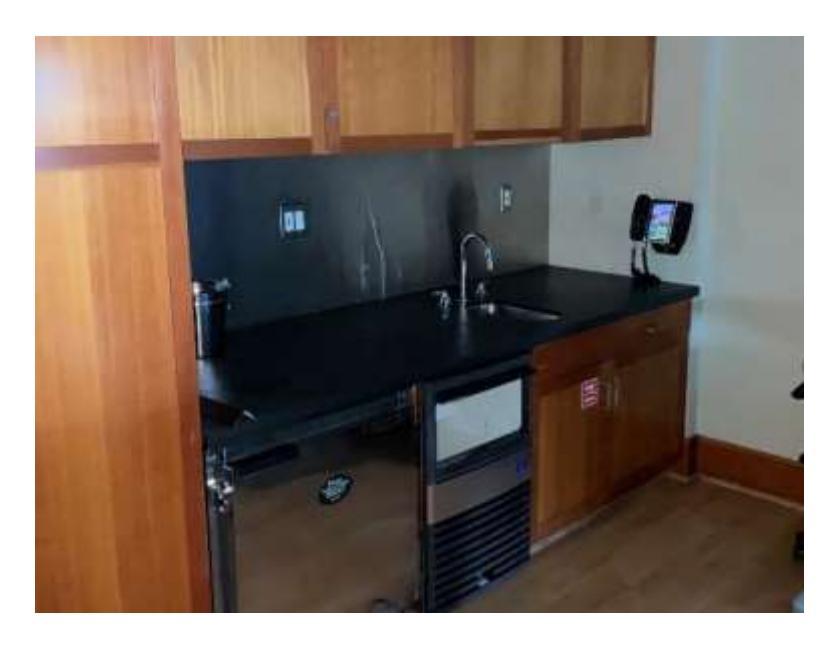
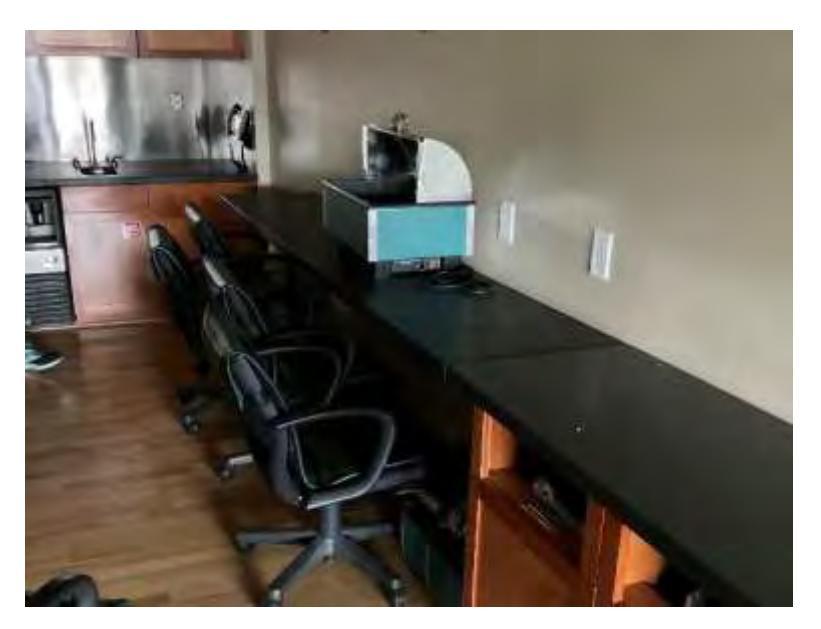
Architectural finishes and food & beverage equipment within premium spaces are essentially what would be expected in a ballpark of its age, with conditions ranging from adequate to marginal. The Mariners are in the process of renovating the Diamond Club and are constructing a new premium club on the press level behind Homeplate (Press Club). Beyond these two assets, the architectural finishes and food & beverage equipment in the premium spaces are dated and nearing or at the end of useful life. Consideration should be given to modernizing these spaces as part of an overall renovation plan.

Modernize architectural finishes and food & beverage equipment in the Suites within the first 3 to 5 years of the plan. Coordinate with electrical, lighting, and FF&E.

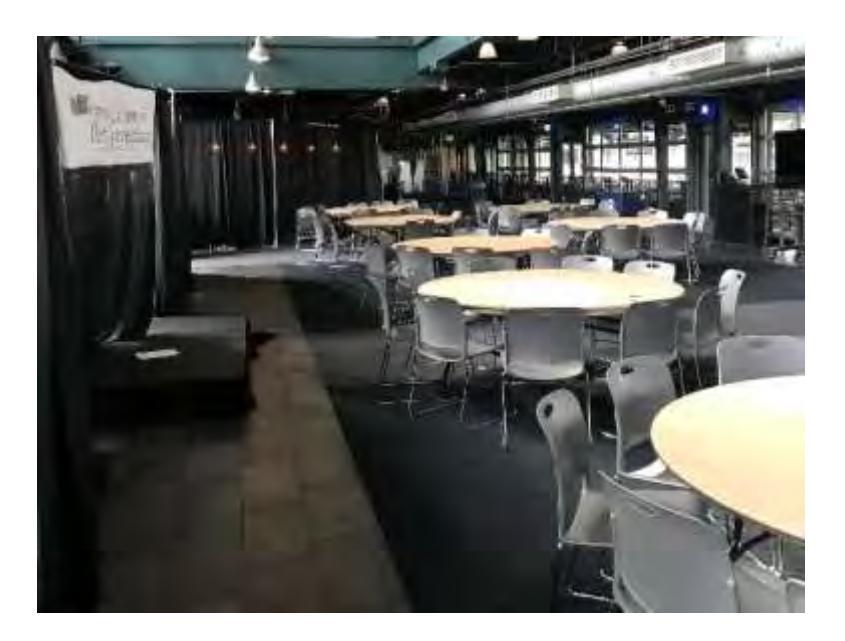
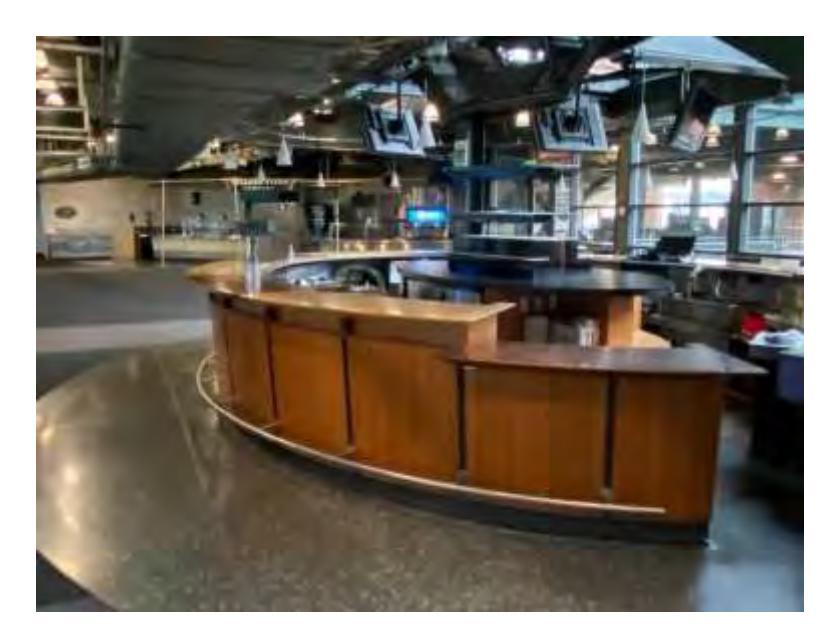
Terrance Club seating

Terrace Club bar

Modernize architectural finishes and food & beverage equipment in the ROOT SPORTS Terrace Club within the first 5 to 10 years of the plan. Coordinate with electrical, lighting, and FF&E.

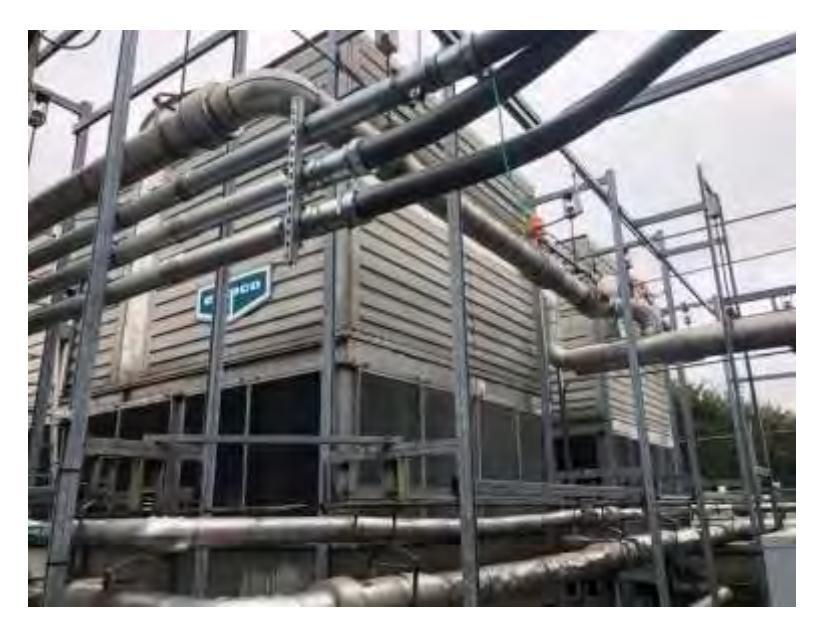
The Evapco cooling towers are original equipment. There are three towers serving the facility. Overall, the towers are in good structural condition. The evaporative media has been replaced in all towers. One is currently undergoing a fan motor replacement.

Cooling Towers

Complete motor replacement and monitor towers for basin corrosion and leaks.

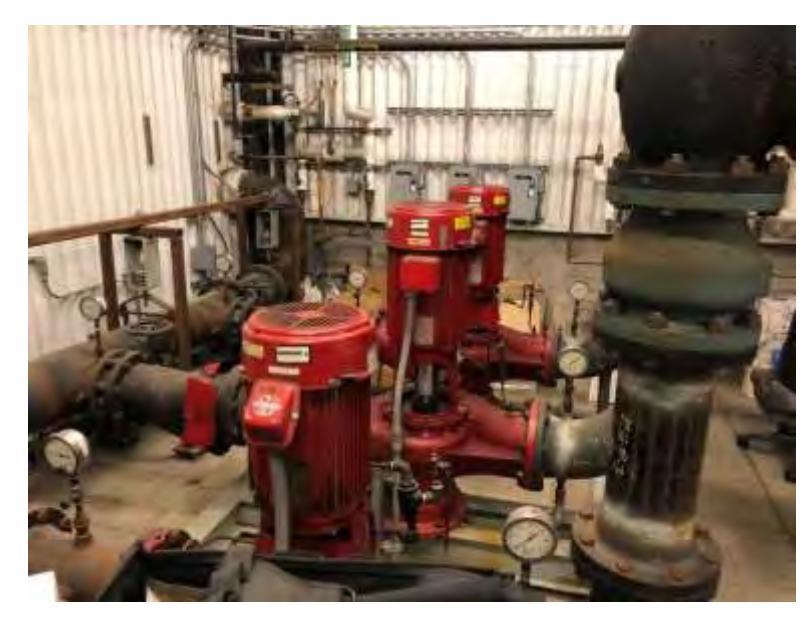
Cooling tower pumps are operational. There are three Armstrong vertical inline pumps serving the cooling towers, two serving the building condenser water distribution, and 4 serving the heating water loop. They are in good condition and have been well maintained, including seal replacement as needed. No repairs associated potential corrosion were noted.

**Cooling Tower Pumps**

Continue with regular maintenance and normal repairs. Pumps should be replaced in the next 10-15 years.

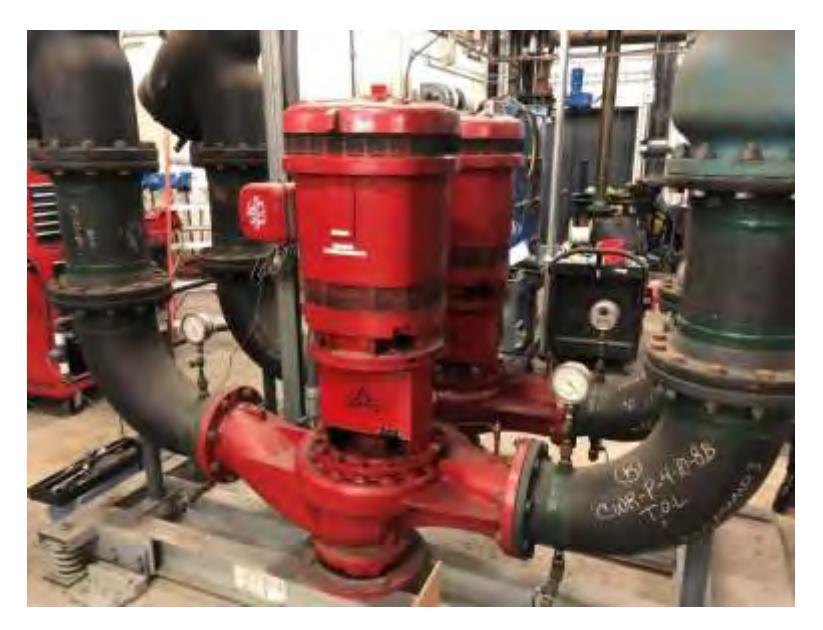
Building Condenser Water Pumps

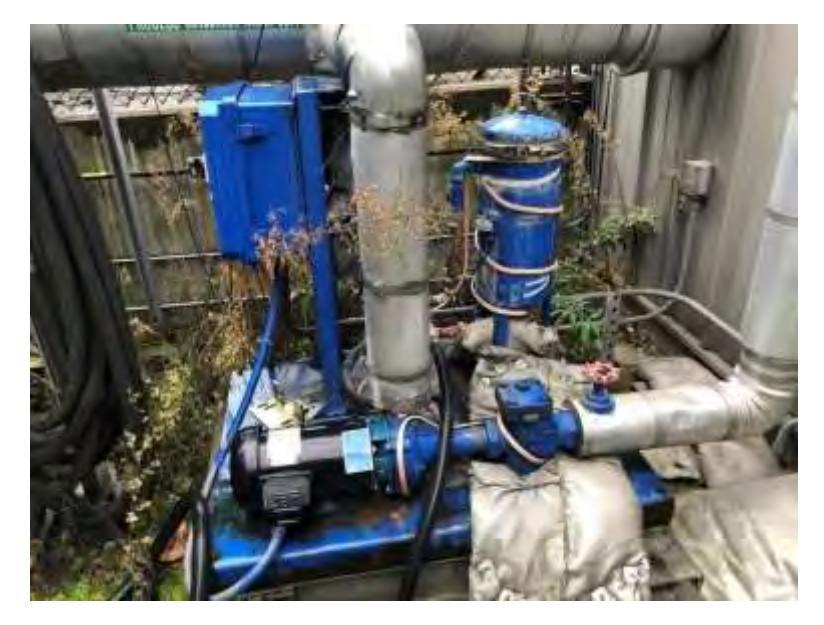
A Lakos tower water separator system is currently used to remove sediment from the tower water. The system pump motor is being replaced. Overall, it appears to be in good working order.

Solids Separator

The system is aging, though it is not a critical system and has few moving parts so it can wait for replacement. Recommend full replacement in 5-10 years.

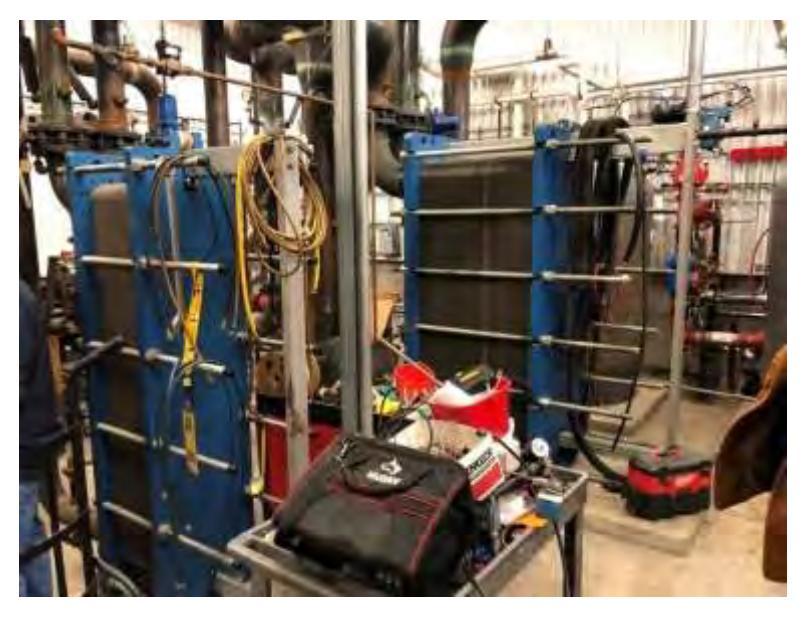
The plant incorporates two Polaris plate and frame heat exchangers to separate the cooling tower water from the building condenser water loop. They appear to be in good condition.

Condenser Water Heat Exchangers

The service life of heat exchangers is about 25 years. Given that these are stainless steel plates, they may well outlast that standard. The heat exchanger plates should be opened and cleaned every 10 years unless pressure drop increases significantly.

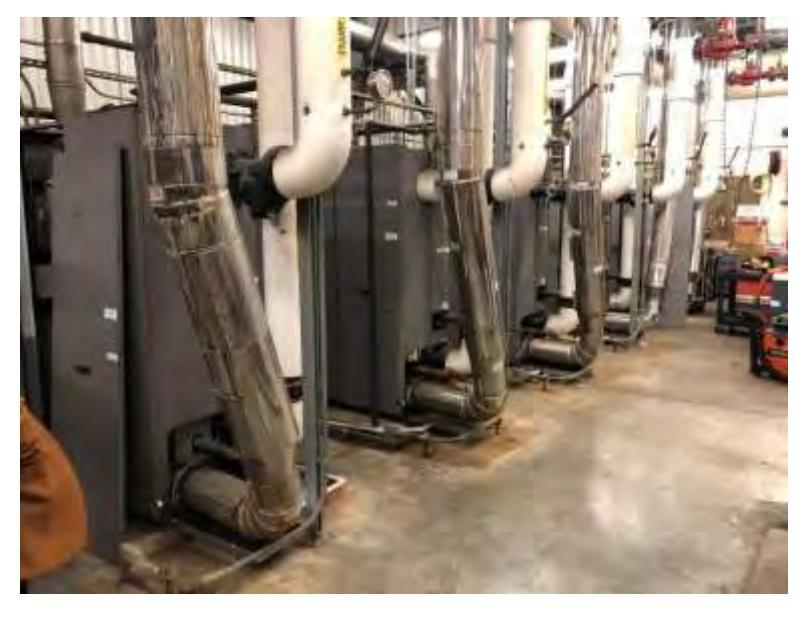
There are five 2-million Btu Aerco Benchmark 2.0 boilers providing heating water to the ballpark. Two are currently down due to cracked internal heat exchangers. They are original equipment and have reached the end of their service life. The Mariners were in the process of replacing these hot water heaters in advance of the 2022 season.

Heating Water Boilers

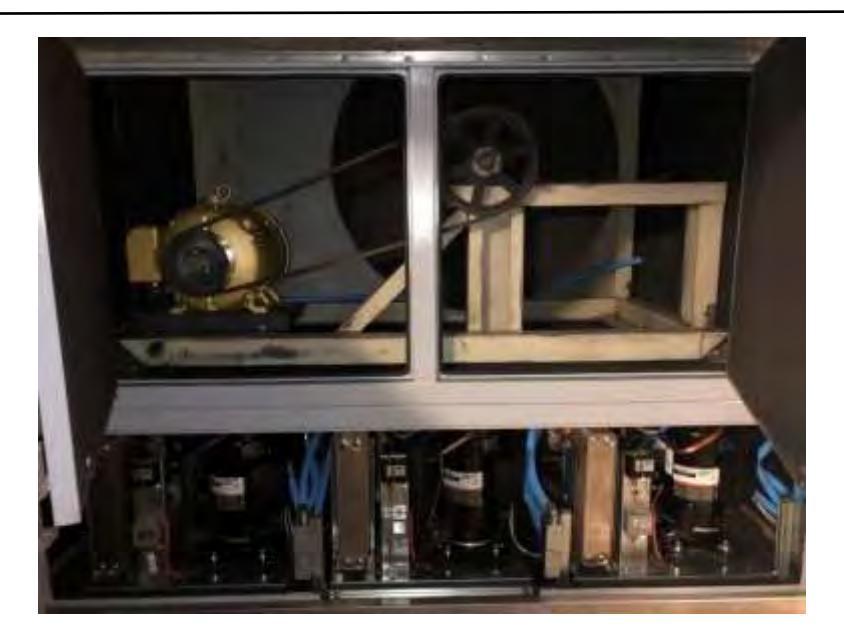
The original Mammoth air handler has recently been fully rebuilt, including replacement of cooling scroll compressors, controls, motors, and various internal parts.

Mammoth Unit Serving Locker Room

With the rebuild complete, this piece of equipment should continue to function for another 15-20 years. Door and panel seals should be monitored for leaks.

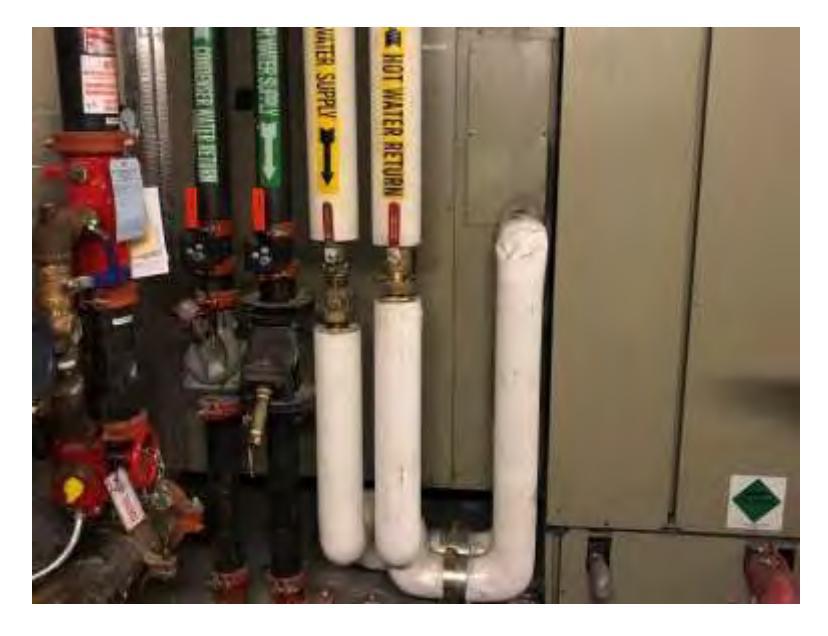
Four Pipe Air Handler

The service life on these AHUs typically 20 years. If the casings are solid, then rebuilds may be possible. These are not built as stout as the Mammoth unit so replacement may be the better option.

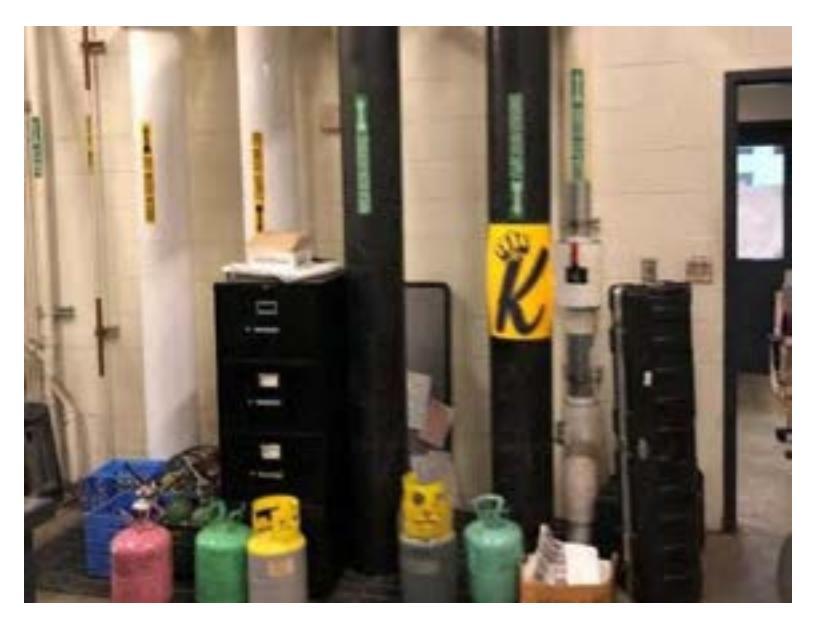
Circulation Piping entering and leaving Central Plant

With good anti-corrosion chemical treatment, the piping should last another 15-20 years. All piping should be monitored for leaks to be sure a systemic problem does not arise.

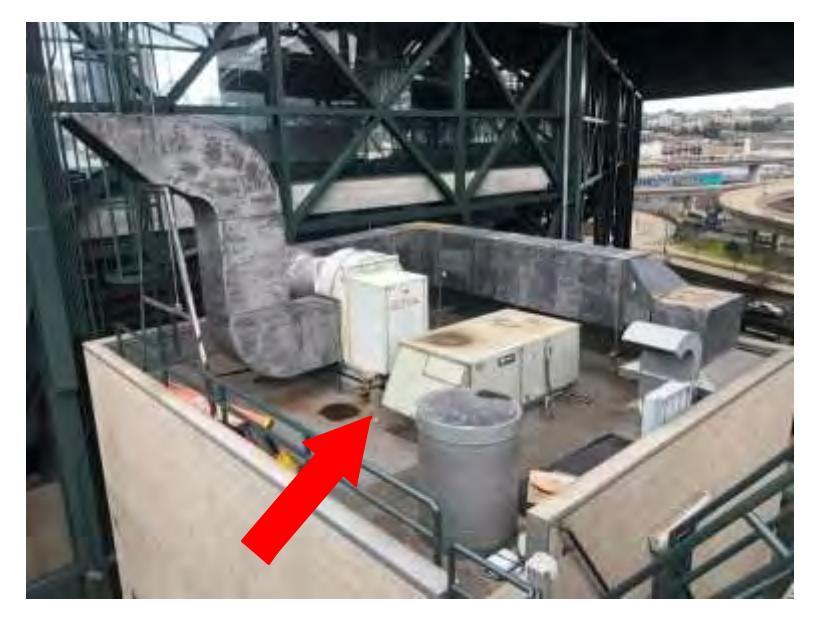
Utility set and upblast rooftop grease exhaust fans are located on rooftops around the ballpark. Service life is generally 20-25 years for these fans. Grease systems are cleaned annually which has left this equipment in good condition.

Right Field Stair Tower Roof

With regular service and occasional repairs these fans should last another 5-10 years. Replacement should take place whenever updating kitchen and concession hoods.

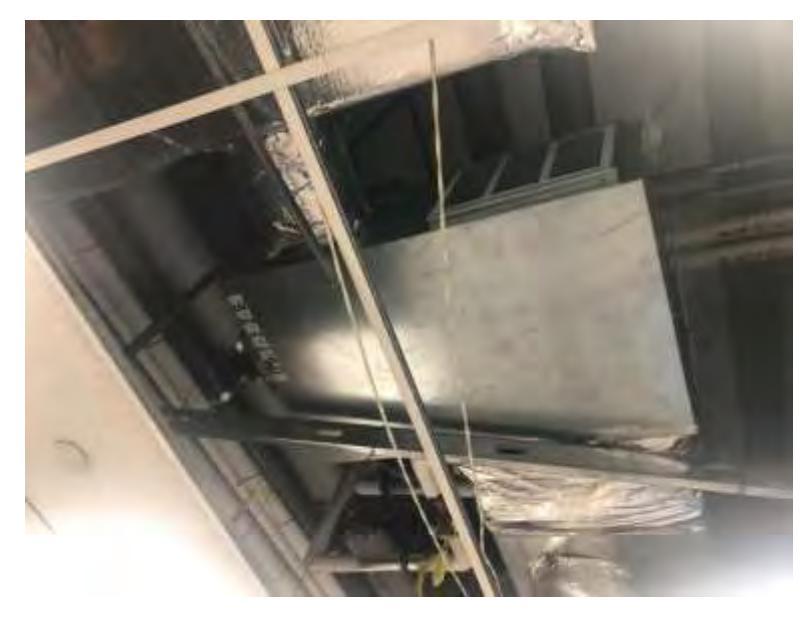
The original Trane terminal boxes are still in place throughout the ballpark. Service life is generally 20 years. These boxes are reportedly in good working condition.

Fan Powered VAV Box in Weight Room Ceiling

Due to their age, parts (seals, actuators, fan motors, etc.) and controls for these boxes may become unavailable in the coming years. Replacing the boxes as areas are remodeled is recommended, as is a phased plan to replace the boxes over the next 10-15 years.

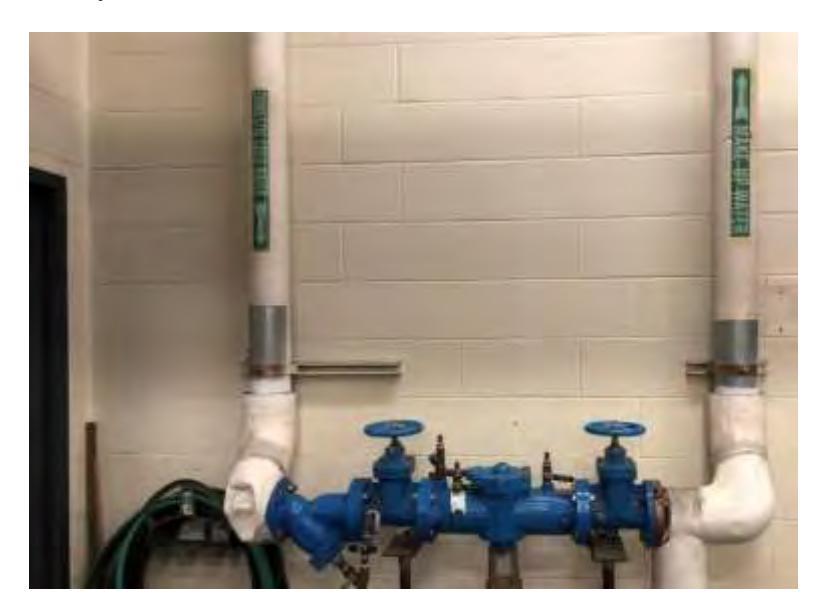
Reduced Pressure Backflow Preventer in Central Plant

With regular tests and inspections these backflow devices can last another 10-15 years.

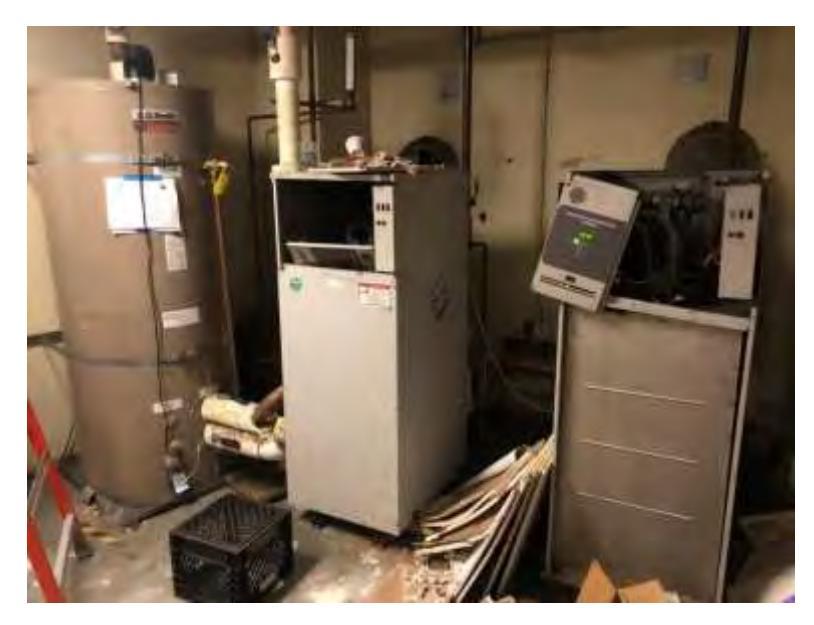
The original Aerco water heaters serving two main kitchens are beyond their service life of 15-20 years. They are in poor condition and have had frequent repairs needed. The Mariners were in the process of replacing these hot water heaters in advance of the 2022 season.

Central Kitchen Water Heaters
