# Seattle Mariners T-Mobile Park Long-Term Capital Needs Assessment REPORT / MAY 2022

# 1.0 - PREFACE

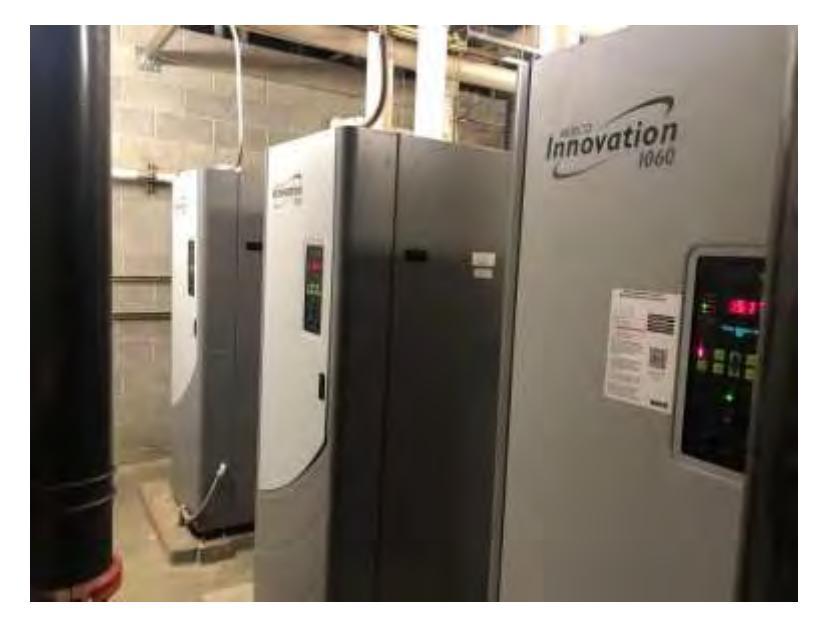
Ballpark Domestic Water Heaters

Continue maintenance and service as needed. These heaters should last another 10-15 years.

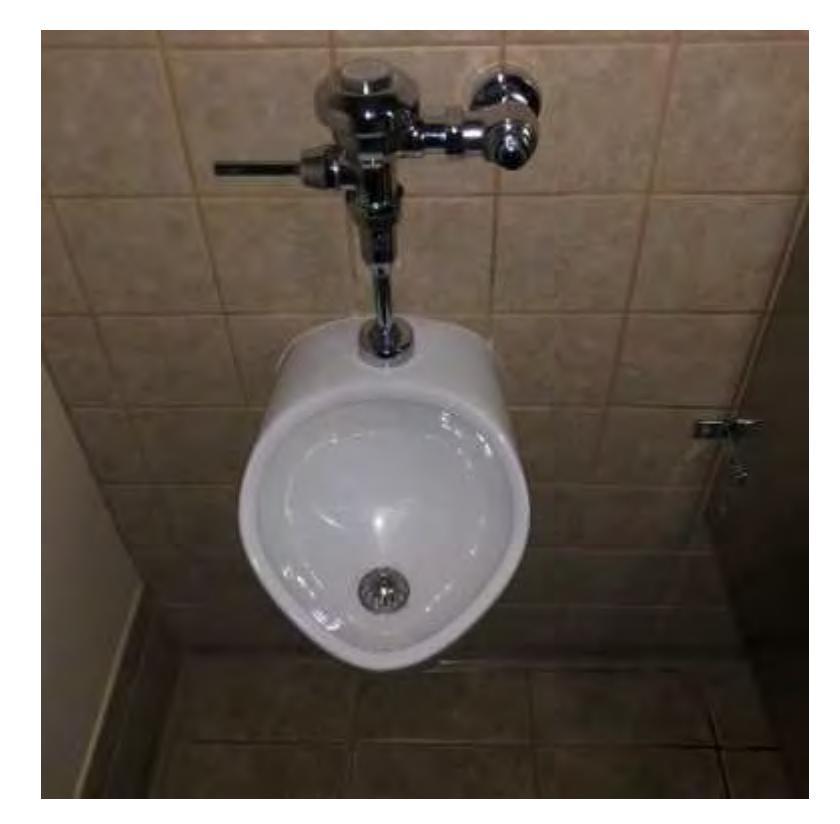
Most public restroom urinals have been replaced with new 0.5 gpf fixtures. They are in good working order.

Public Restroom Urinals
#### **Observation MP-17: Public Restroom Lavatories**

Continue maintenance and service as needed. These fixtures should last another 15-20 years.

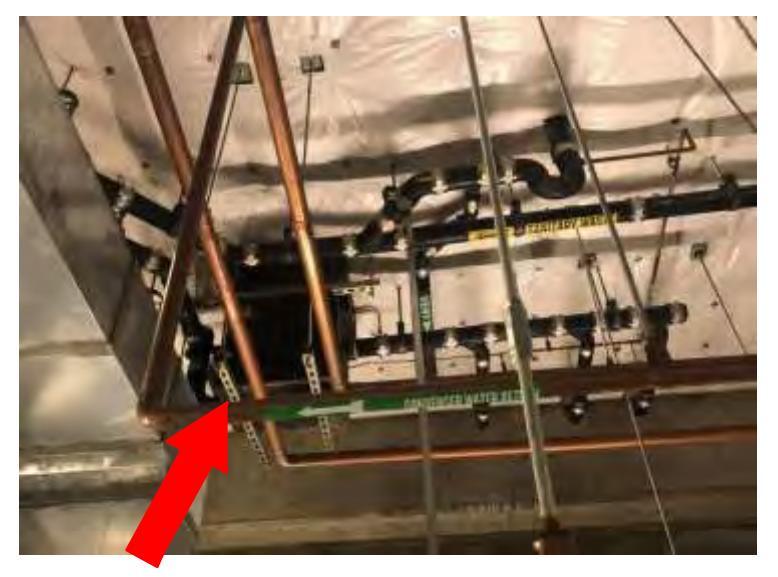
Concession Grease Trap in Main Concourse Deck

Monitor grease traps for corrosion and replace, as necessary. There are no moving parts so these traps may last as long as the piping system.

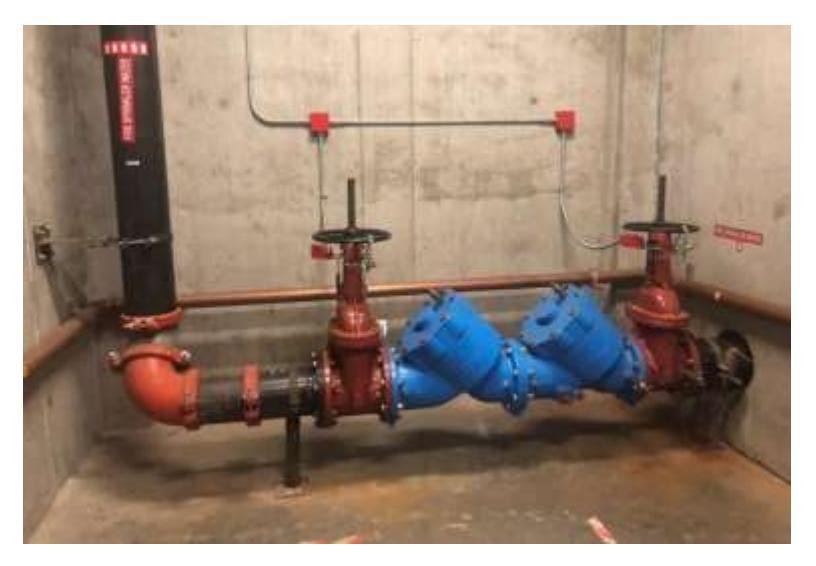
Fire Sprinkler Water Service (one of two)

With regular service and inspection these backflow preventers should last another 20 years. Heat trace will need replacement about every 10 years. Heat trace system should be monitored and alarmed at BMS.

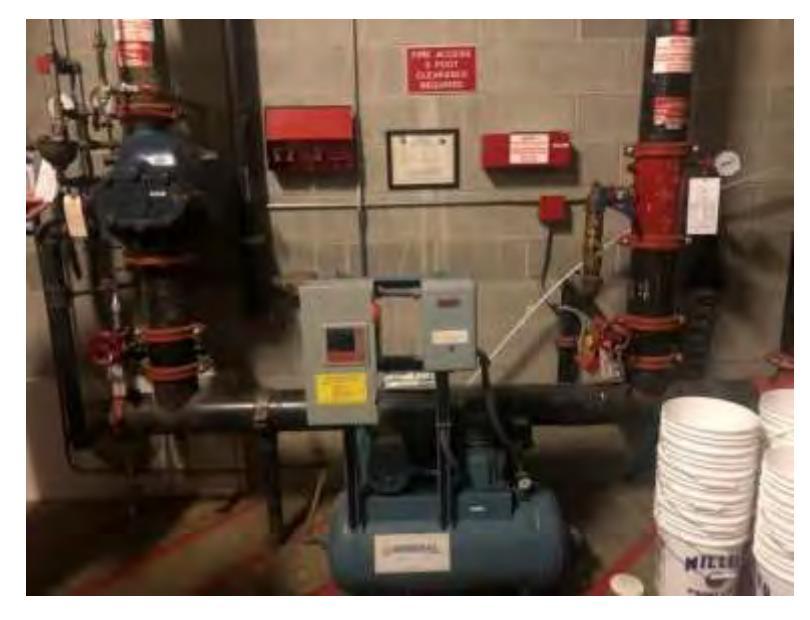
Dry Pipe Zone Valve and Air Compressor

There were no reports of issues with the dry valves themselves. They have at least a 20–25-year service life. With regular inspections and maintenance, they should provide at least 10 more years. Most of the air compressors are at or nearing the end of their service life. A systematic replacement should take place over the next 5-10 years.

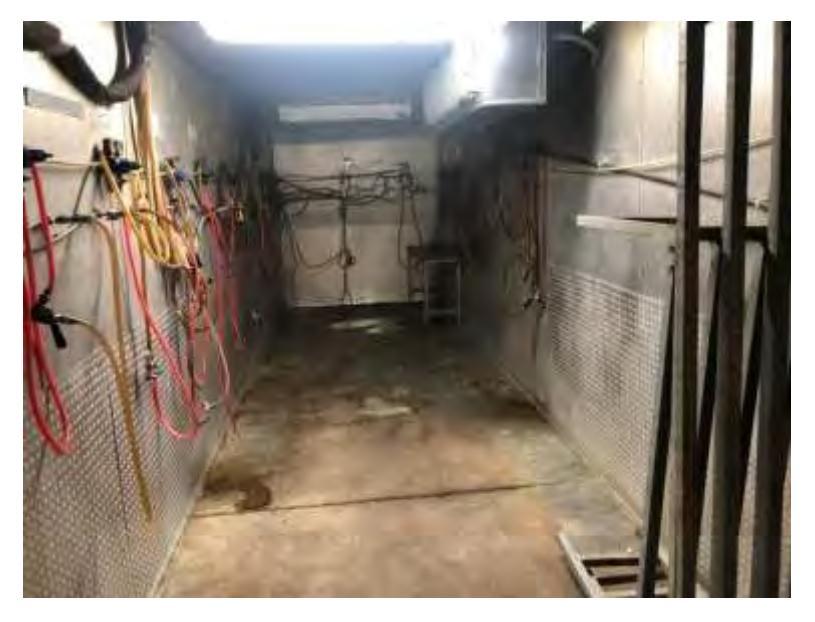
Beer Distribution Cooler Without Sprinkler Coverage

Verify code requirements for sprinklers in coolers and freezers in existing buildings.

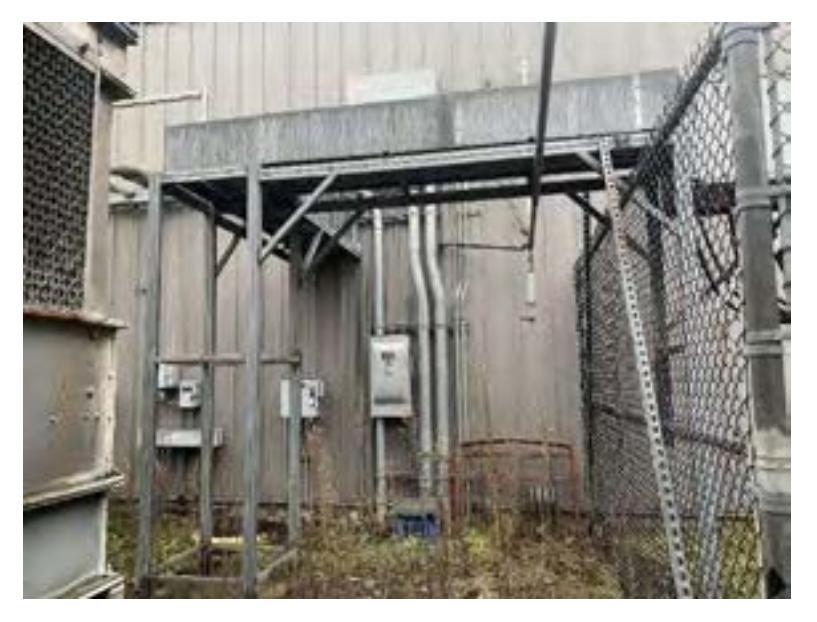
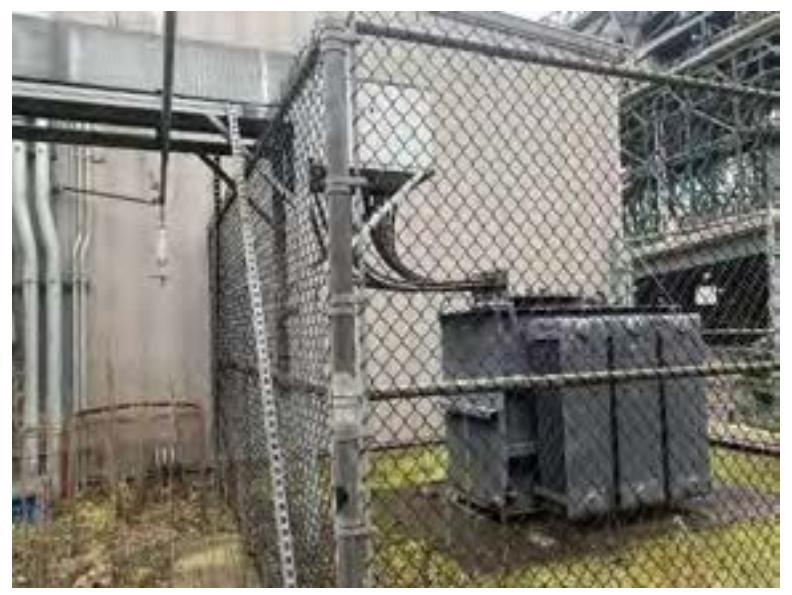
Overhead buss duct

Exterior buss duct, even with the galvanized flashing on top, is subject to corrosion. Regular inspection of the surface, splices, and terminations are recommended to ensure there is not a fault within the buss duct causing an extended outage of the central plant and a potentially unsafe condition.

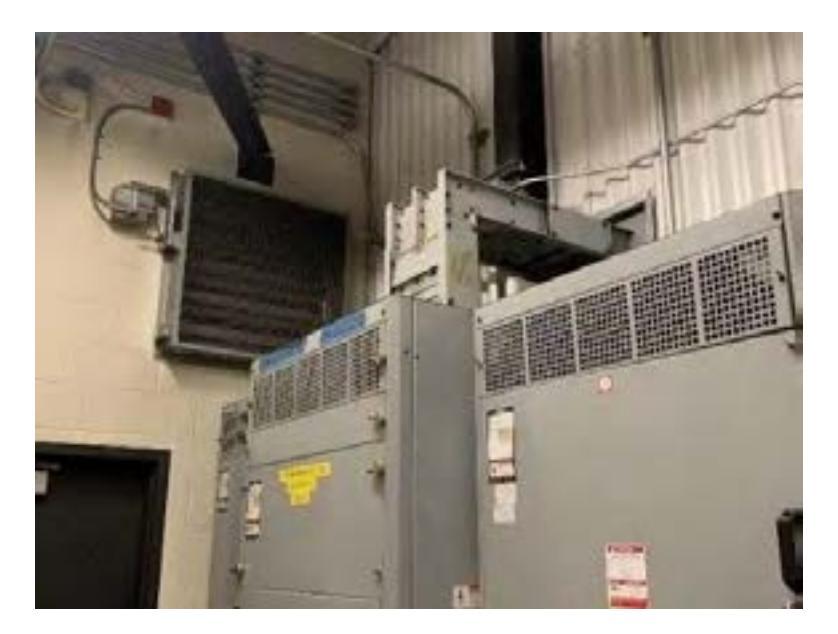
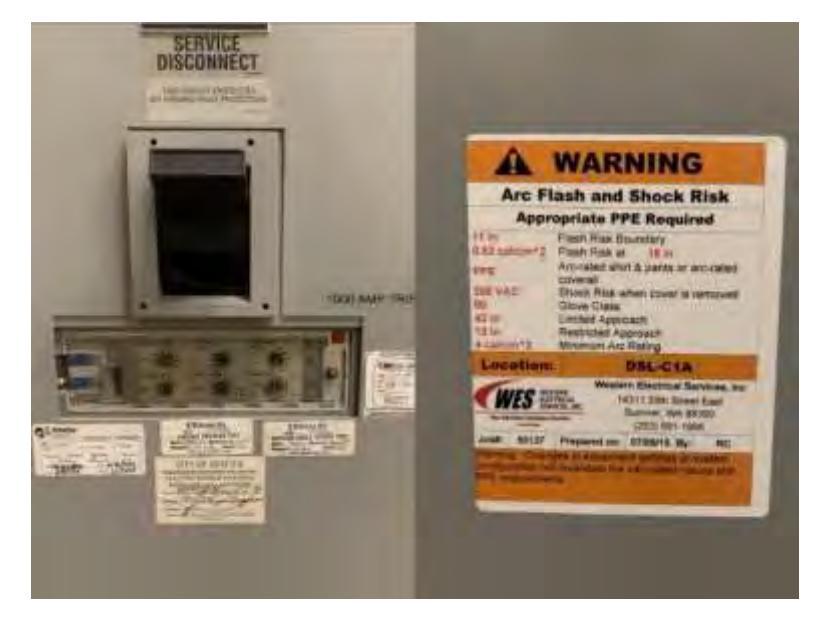
Incoming buss duct

Incoming service

The main service has been well maintained and is generally in good shape, making continued use of this aging equipment viable for now. Testing is being performed on the breakers for torque, ground fault, etc.

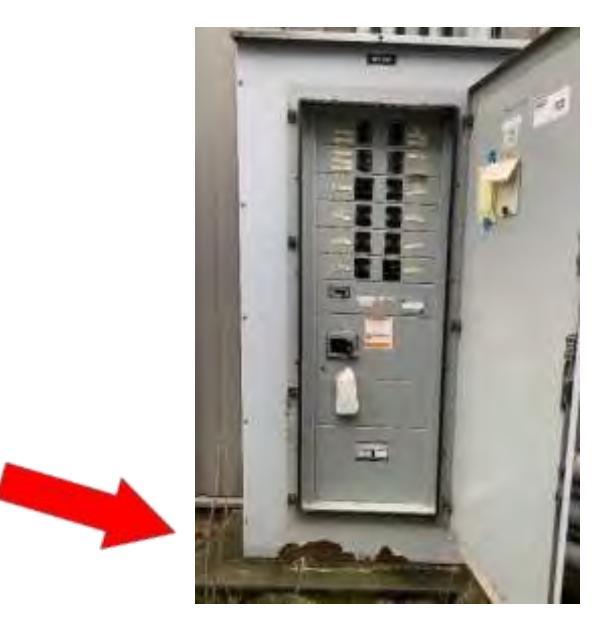
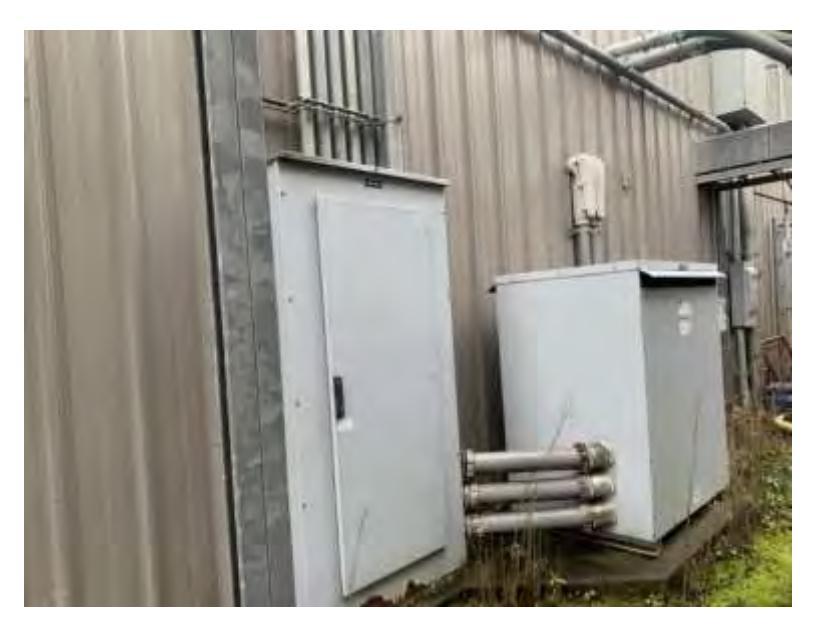
There is electrical distribution equipment serving the exterior central plant equipment. The equipment is exposed to the elements and showing significant sign of corrosion.

Central Plant Exterior Equipment

Replace the distribution equipment on the exterior of the Central Plant prior to failure. Recommended replacement in 1 to 5 Years

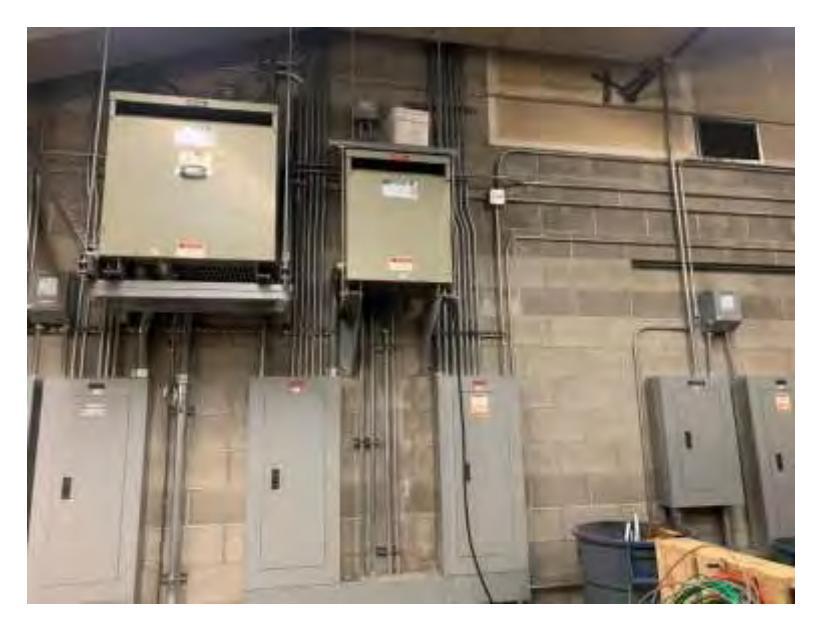
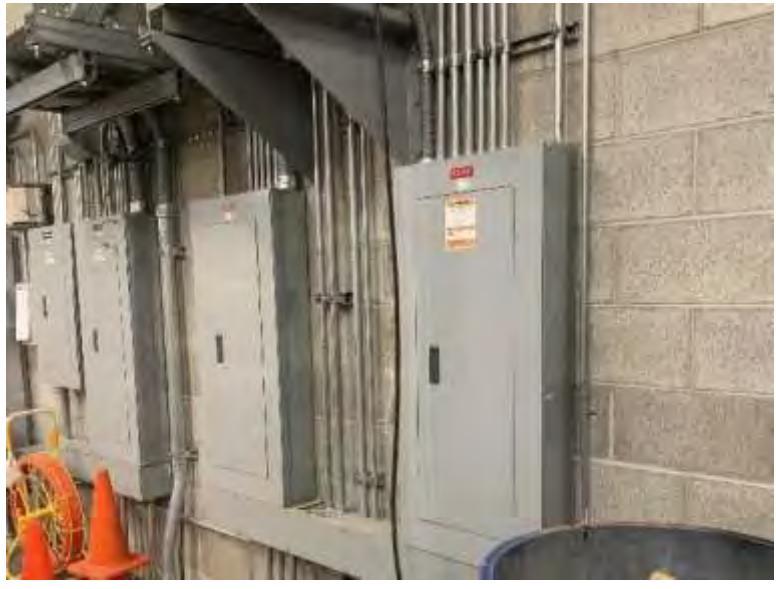
There is a known leak above an electrical transformer adjacent to emergency panels. Currently, there is a bucket that catches water and drains it to a lower bucket. It appears the leak is caused by a building expansion joint above the panels that has failed.

3rd Base Main Electrical Room Leak

Repair leak immediately to ensure the is not an unsafe condition.

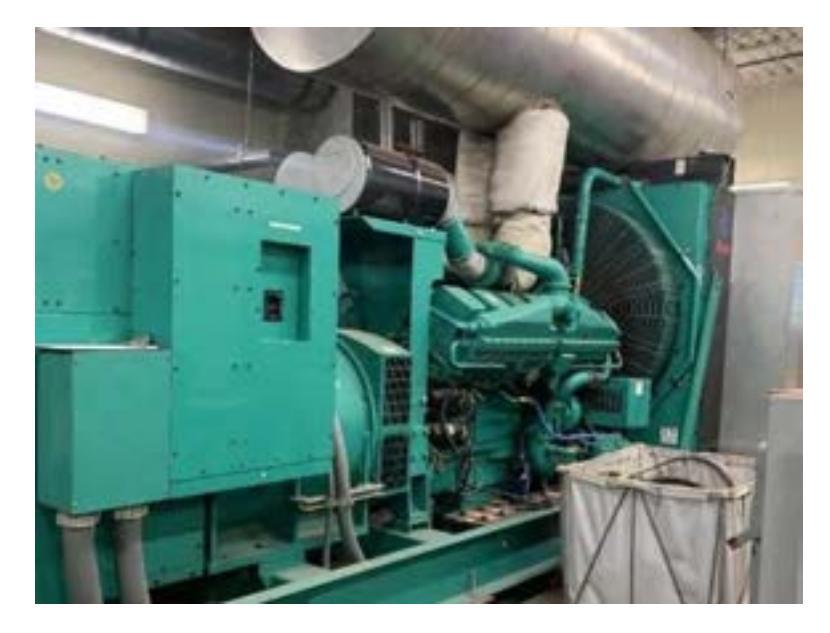
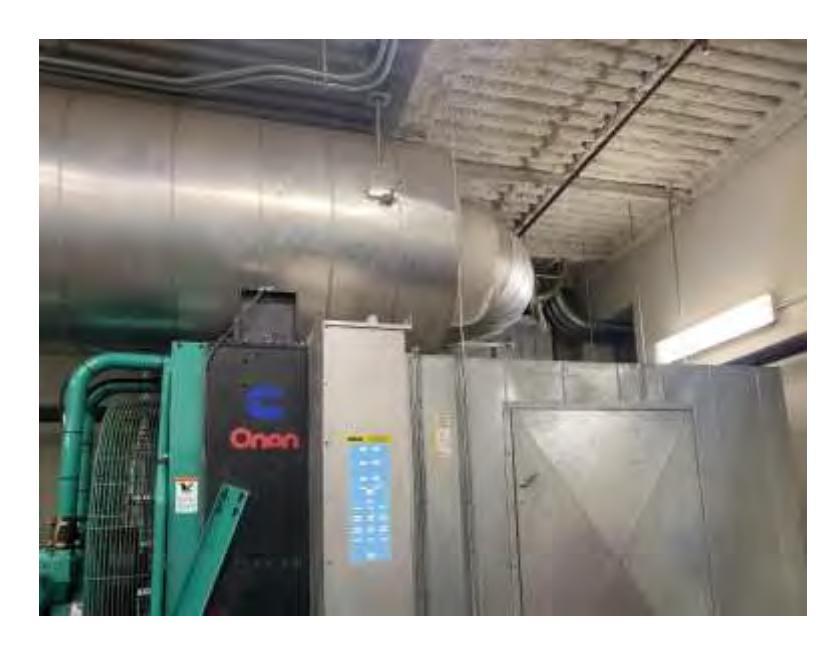
Right Field Generator Room

Continue regular maintenance of the generator on the load bank. Operate the generator under building load to ensure the Automatic Transfer Switches adequately transfer the load to the generator. The generator should operate reliably for 3-10 years without major service, at that point more invasive rebuild of components may be required

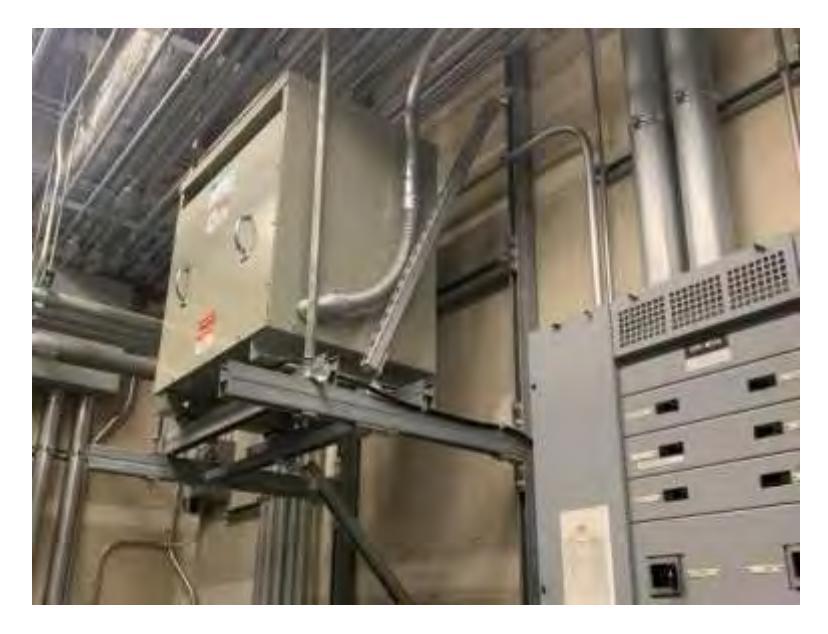
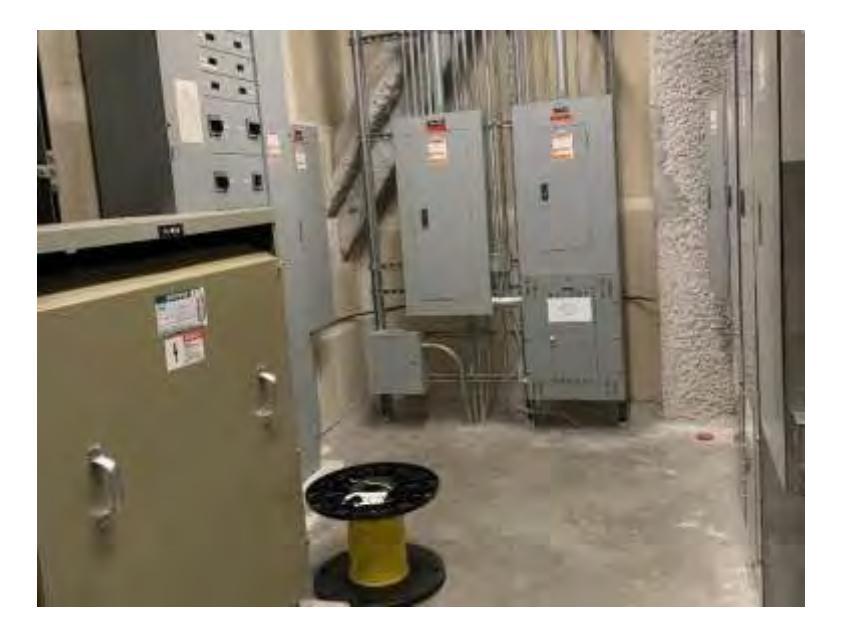
#### **Observation EL-9: Typical Electrical Riser Room**

Many of the riser rooms have little-to-no room for additional panels. The equipment in the room is in good condition and well maintained.

Typical Electrical Riser Room

Continue regular maintenance of equipment and consider a phasing of panel and transformer replacement starting in 10 years. The phasing could occur by electrical room, riser, level etc. Additionally, if extensive renovations occur within a portion of the building, consider replacing the distribution equipment associated with the renovation ILO repurposing electrical distribution.

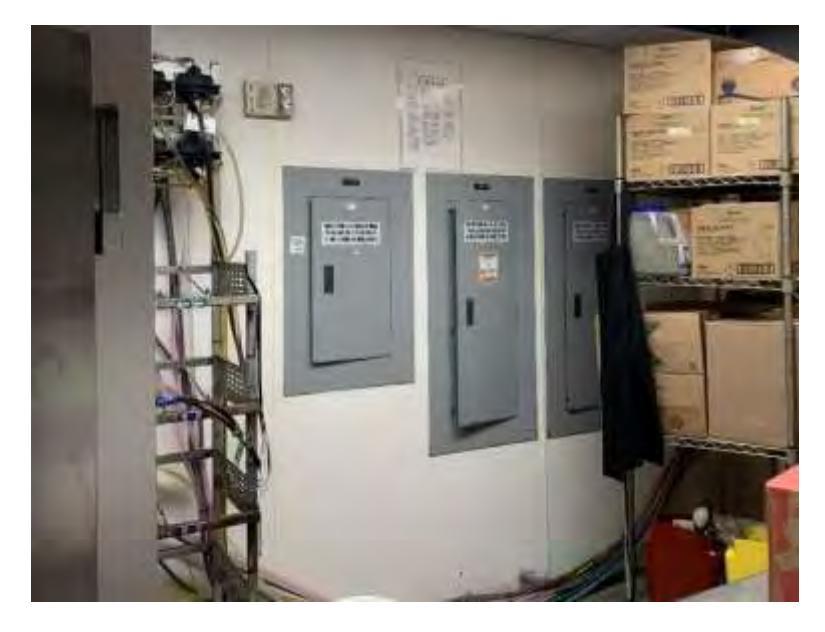
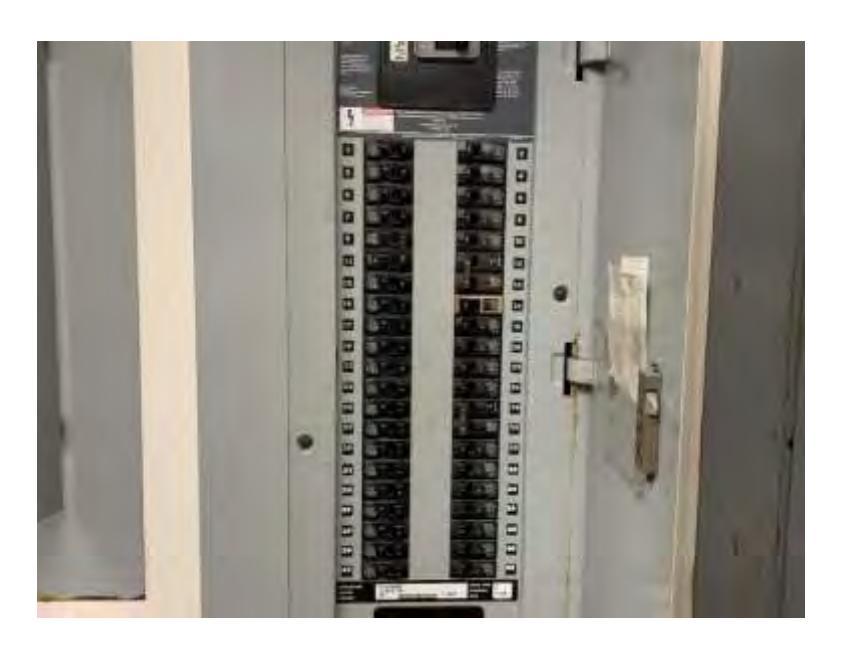
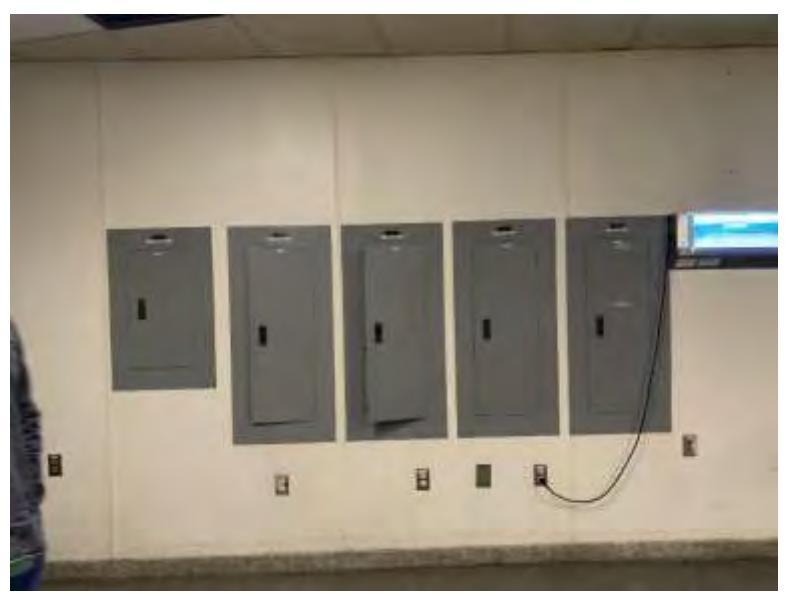
#### **Observation EL-10: Concession/Kitchen Electrical Panels**

Electrical panels within the concessions areas are showing corrosion on the exterior of the panels due to moisture and cleaning agents.

**Concession Electrical Panels**

Upper Concourse Kitchen Electrical Panels

Replace panels in in conjunction with planned concession and kitchen renovations.

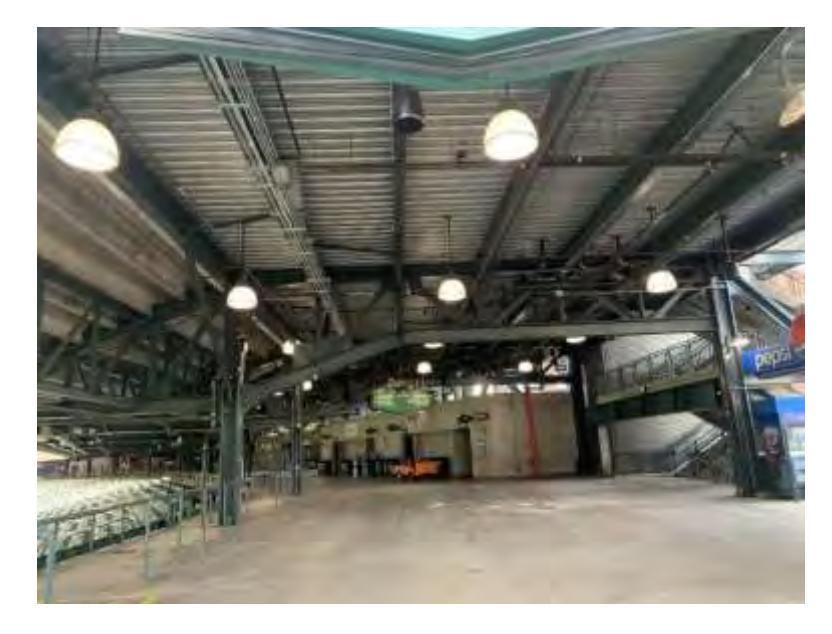
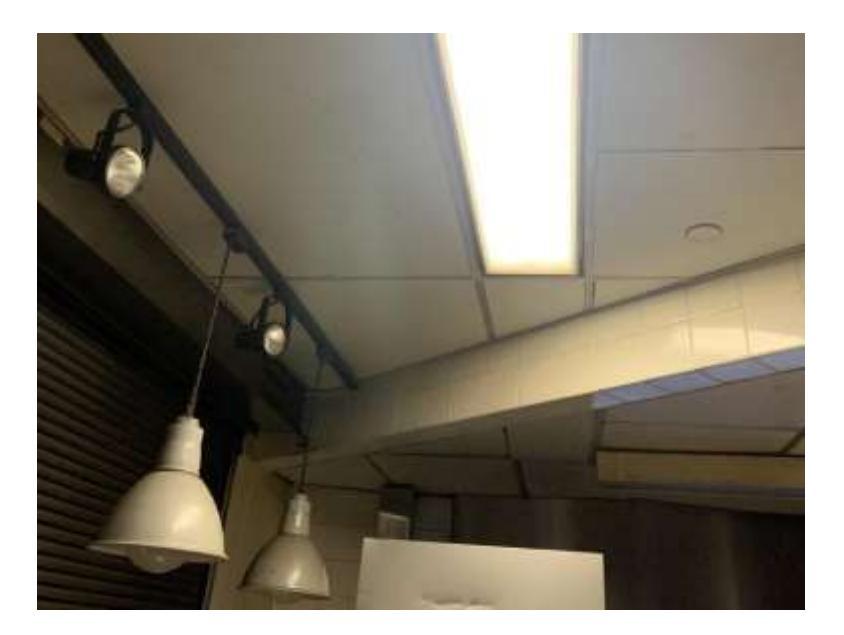
A majority of the public-facing spaces have been converted or replaced with LED. There are back-of-house and front office spaces that still should be converted from linear/compact fluorescent to LED.

Concourse LED Lighting

Concession Fluorescent Lighting and Incandescent Track Lighting

Continue replacing the fluorescent lighting with LED in a phased approach or as spaces are renovated.

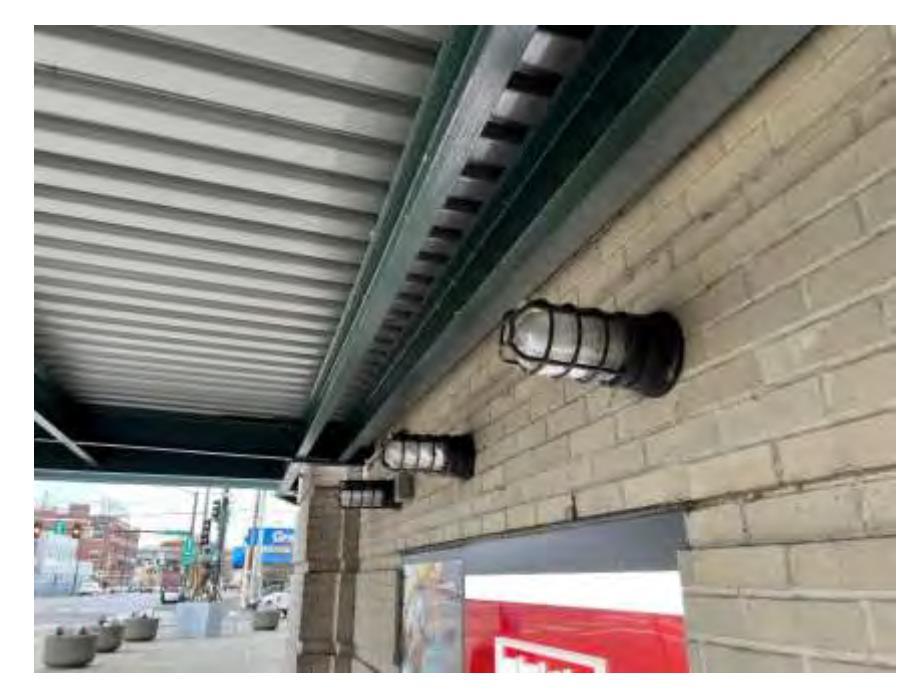
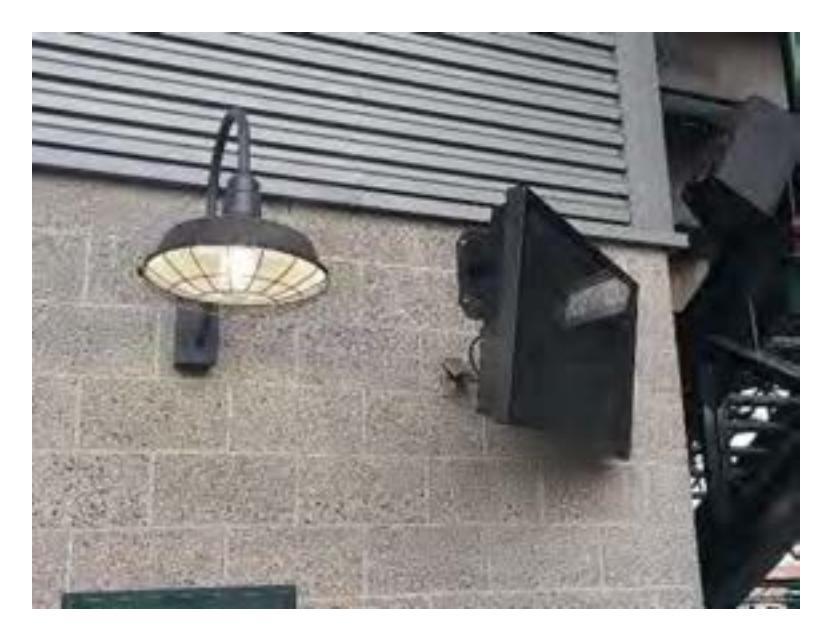
#### **Observation EL-12: Exterior Building Mounted Lighting**

The lighting fixtures at the exterior façade are original construction and generally in adequate condition but nearing the end of their useful life.

Exterior lighting near Homeplate entrance

Exterior lighting on Upper Concourse Level

Verify quality of lighting and potential for modernizing with LED bulbs.

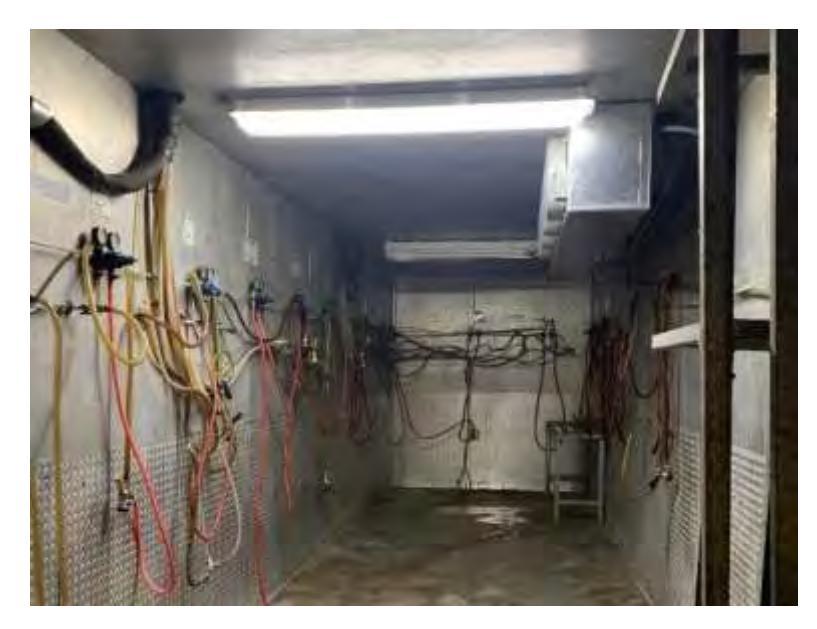
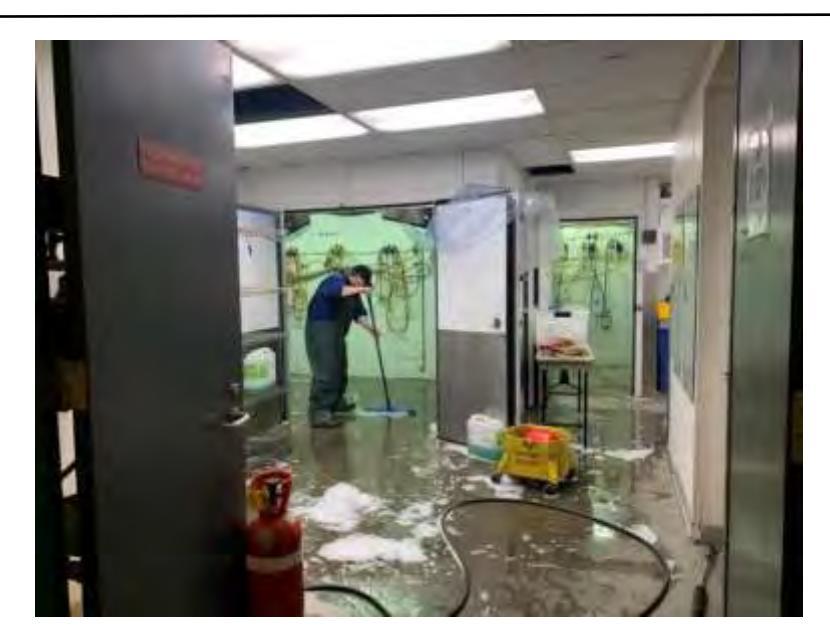
Keg Distribution Room (3rd Base)

Keg Distribution Room (Left Field)

Verify code requirements for CO2 detection in coolers and freezers in existing buildings. CO2 detection in this space should be strongly considered for the safety of personnel in these areas of distribution.

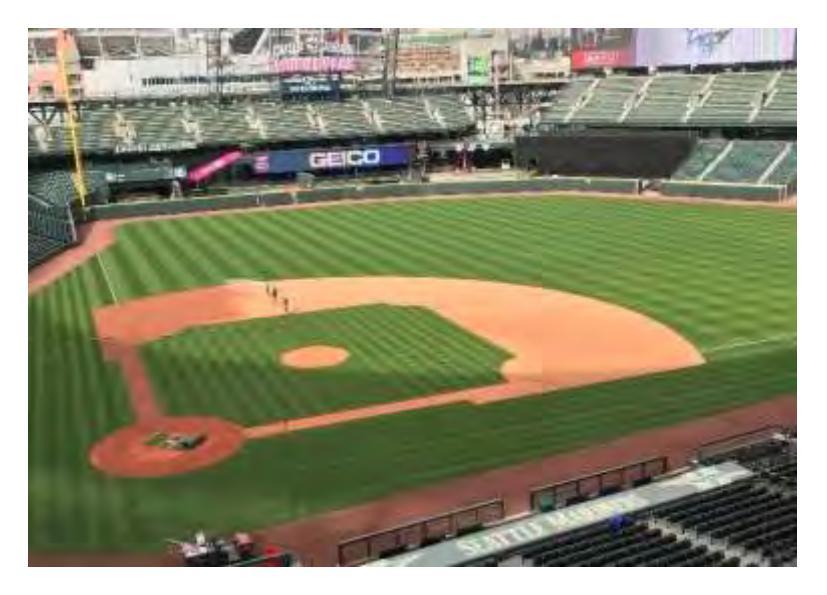
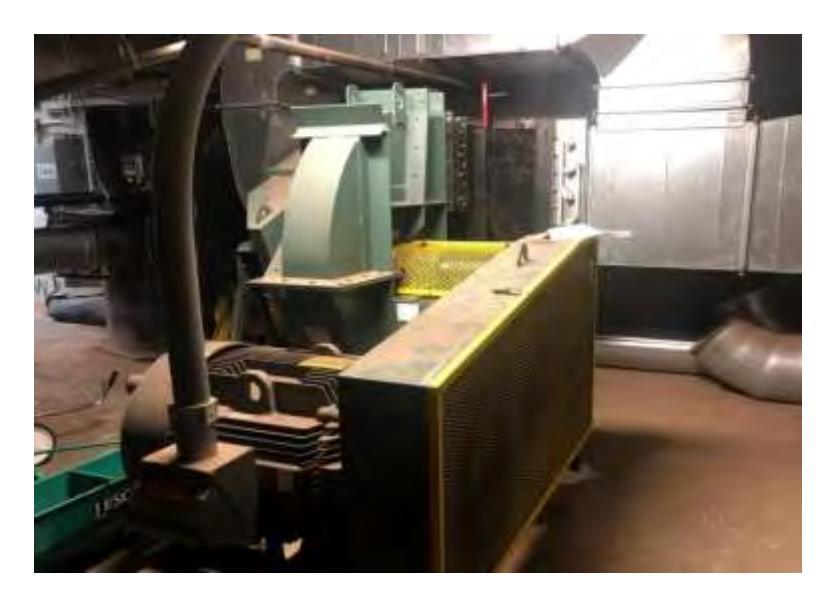
The playing field turfgrass was replaced within the last 3 years and is in good condition, however the field system itself is original construction and nearing the end of useful life and the SubAir system has been decommissioned due to poor operating performance.

Playing field

SubAir equipment for playing field

Replace the entire playing field system, including turfgrass, rootzone, drainage and SubAir, and irrigation be replaced within the first 5 years of the plan.

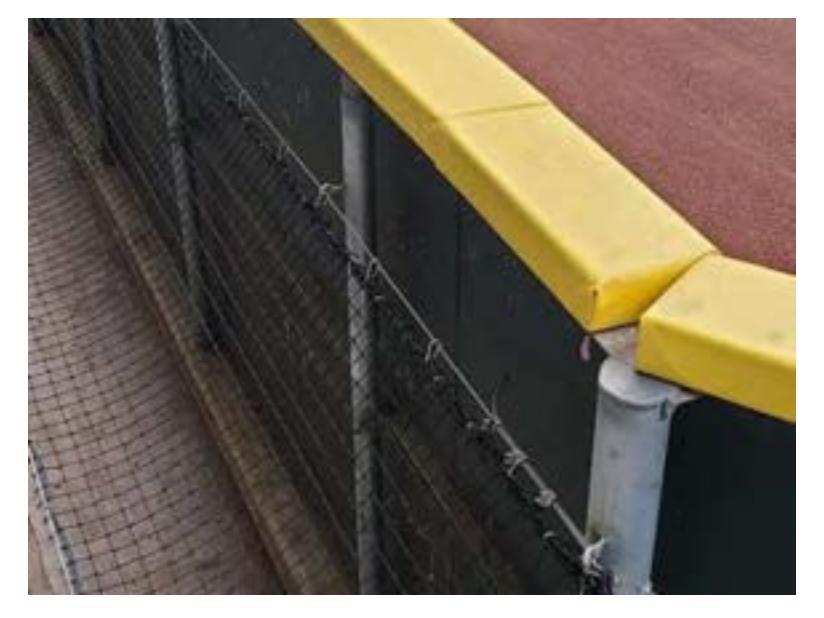
The field wall posts and gates are galvanized steel and appear to be in good condition.

Galvanized steel field wall posts in outfield

Selectively replace components as they fail, but otherwise the system should not need to be replaced within the plan timeframe.

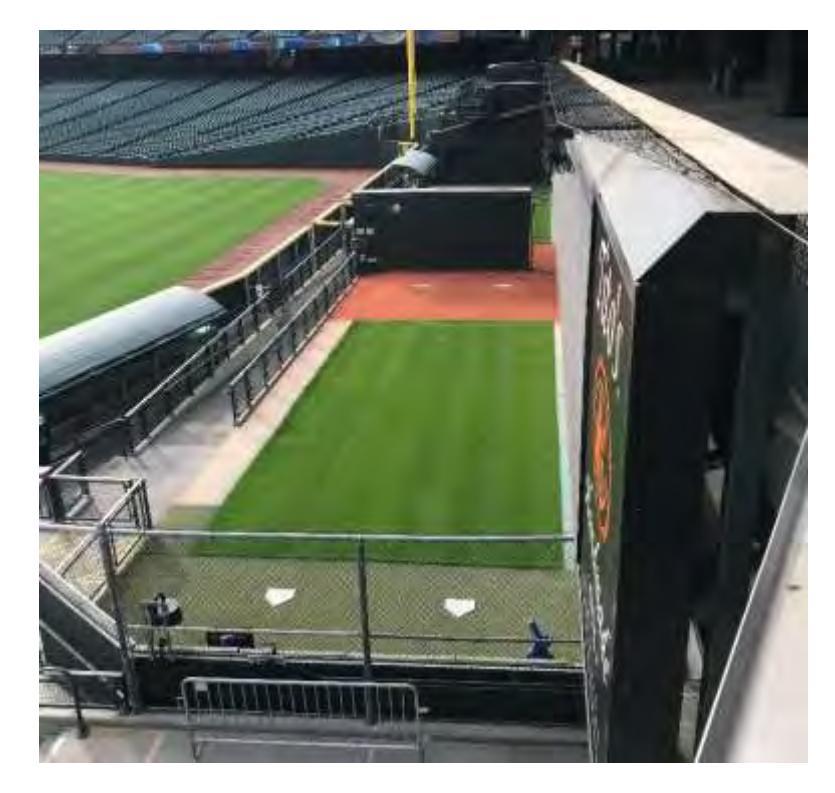
Bullpens in Leftfield

The home and visitor bullpens are in generally good condition.

Replace turf in conjunction with playing field replacement.

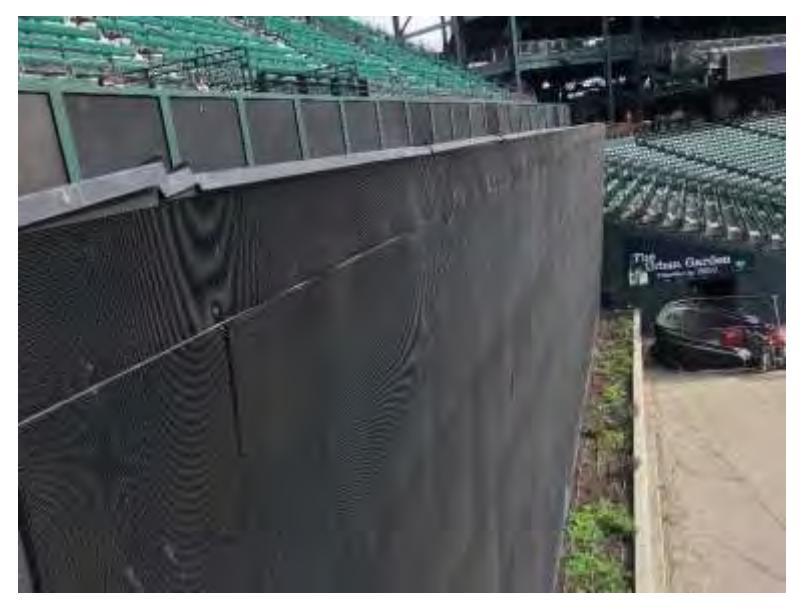
Batters Eye in Centerfield

# **Observation PF-5: Batters Eye**

The batters eye is worn and faded. It's understood that the Mariners are in the process of refinishing the batters eye during this offseason, which should extend the useful life by approximately 5 years.

Reassess the condition of the batters eye in 3-5 years and determine whether it can be refinished again or requires full replacement.

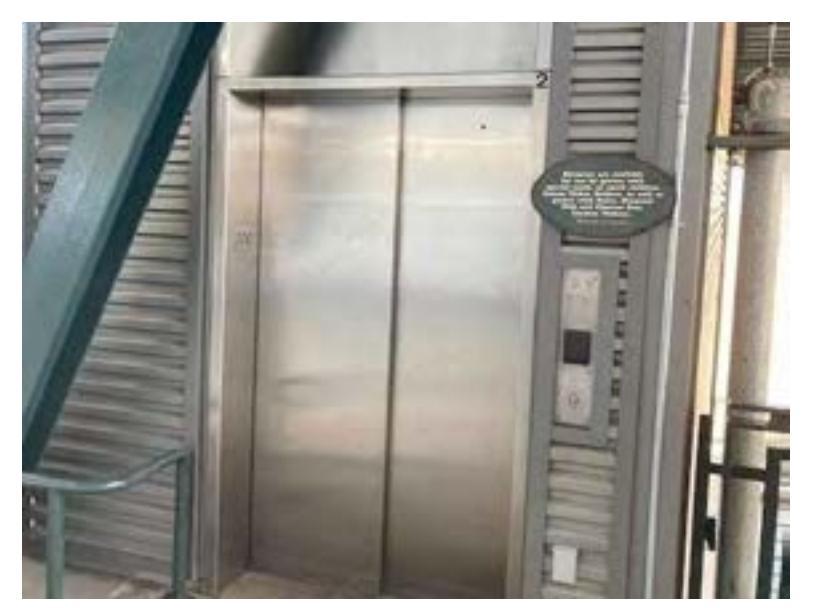
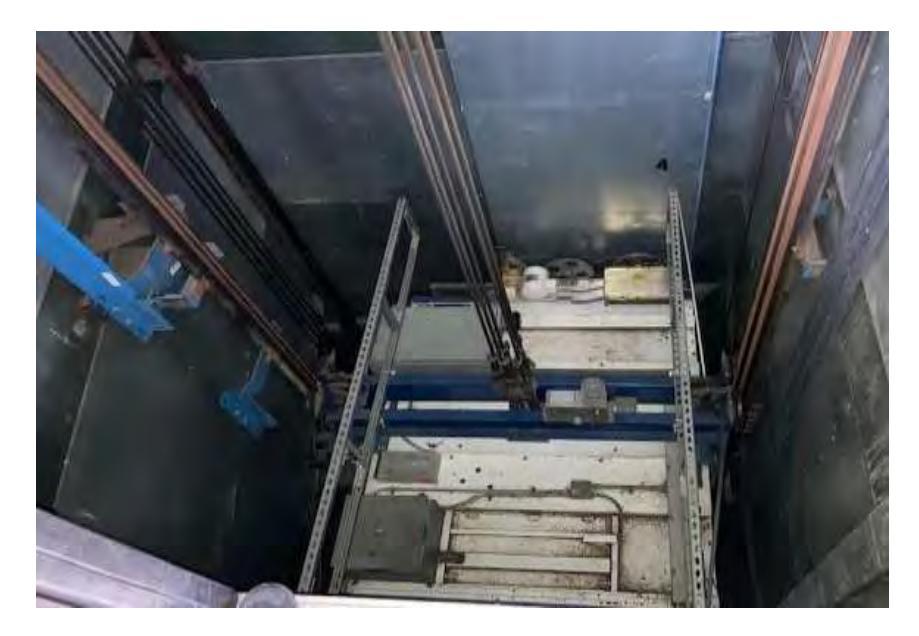
#### **Observation VT-2: Car 2**

Car 2 entrance

Car 2 shaft

Modernize controls, AC VVVF motor and machine refurbishment, fixtures, door operator and door equipment at Car 2. Coordinate with mechanical, electrical, and fire protection.

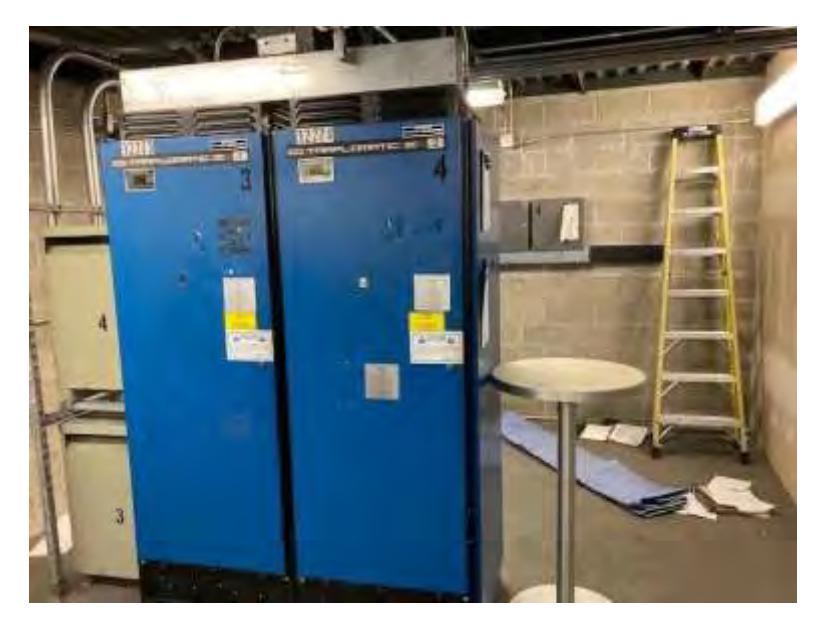
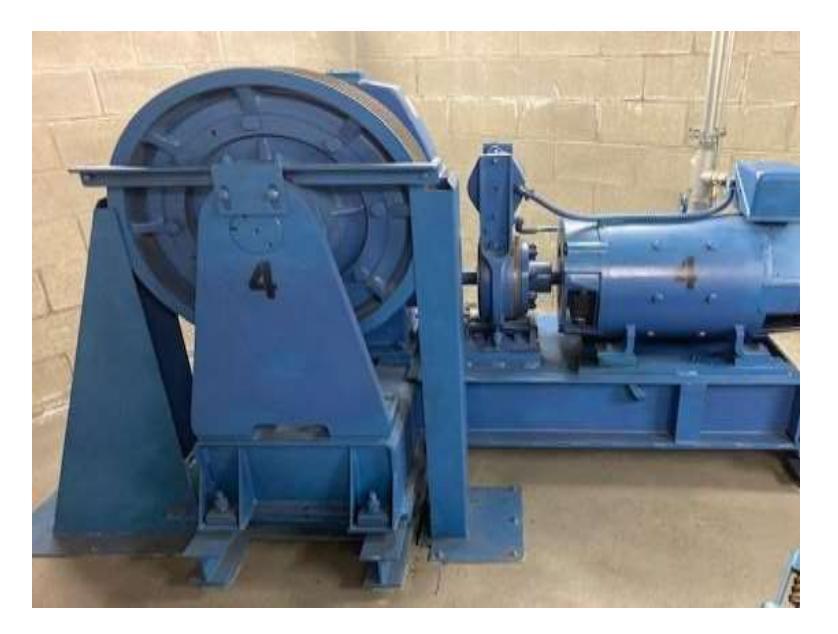
Car 3 and 4 Controllers

Car 4 motor

Modernize controls, AC VVVF motor and machine refurbishment, fixtures, door operator and door equipment at Cars 3 and 4. Coordinate with mechanical, electrical, and fire protection.

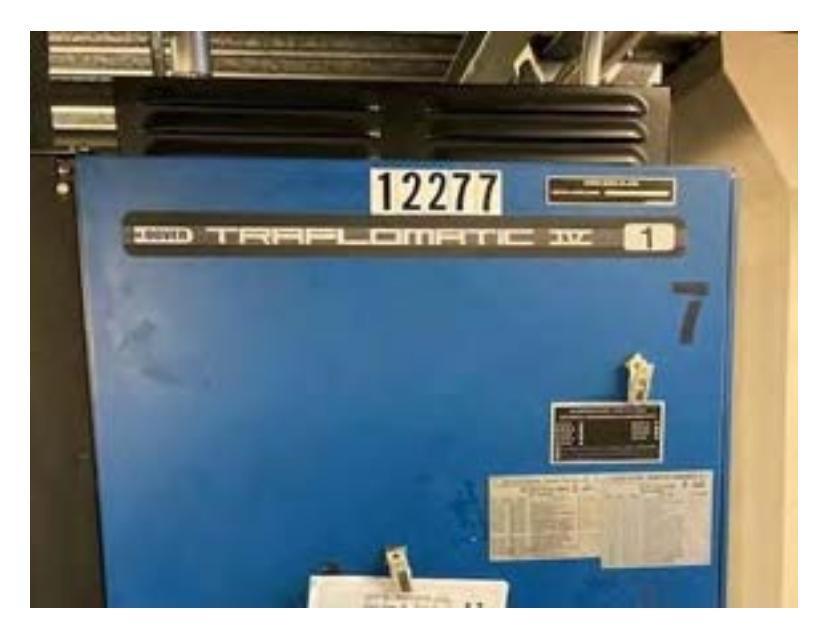
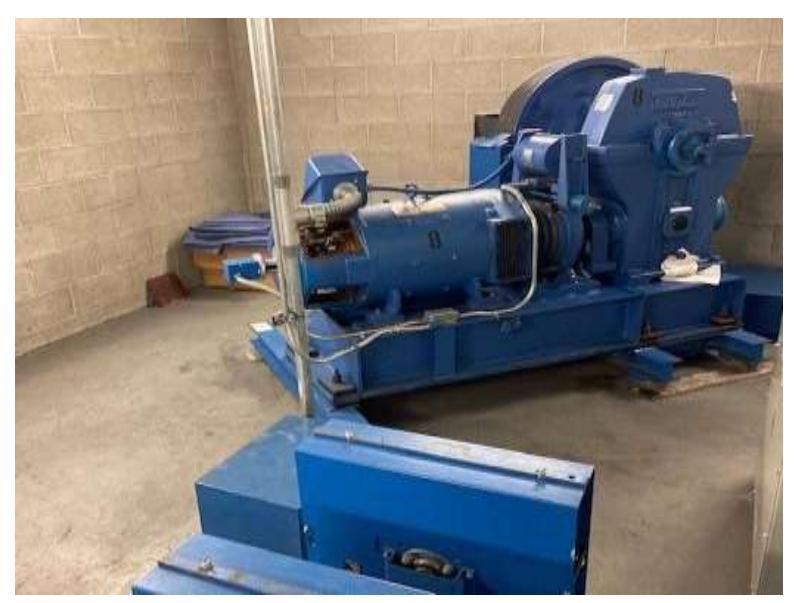
## **Observation VT-5: Cars 7 and 8**

Car 7 controller

Car 8 motor

Modernize controls, AC VVVF motor and machine refurbishment, fixtures, door operator and door equipment at Cars 7 and 8. Coordinate with mechanical, electrical, and fire protection.

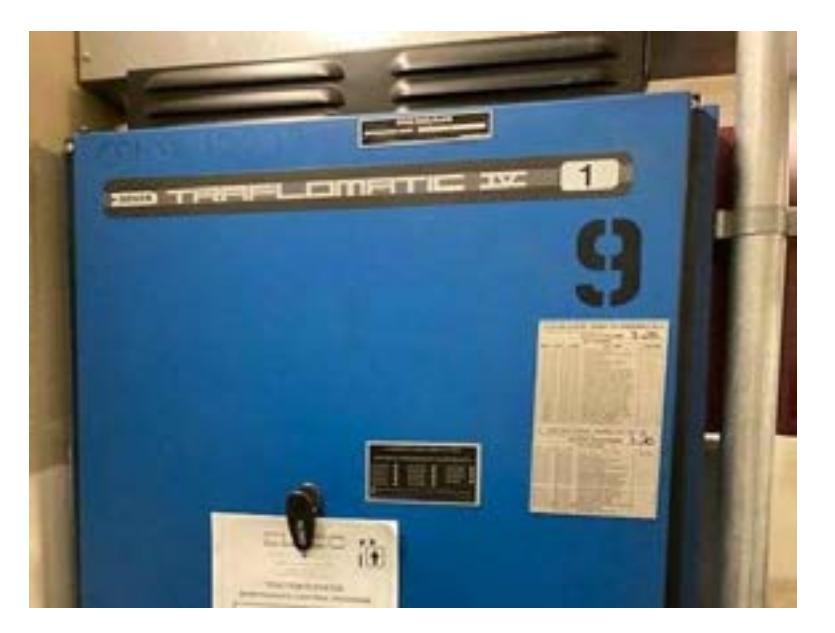
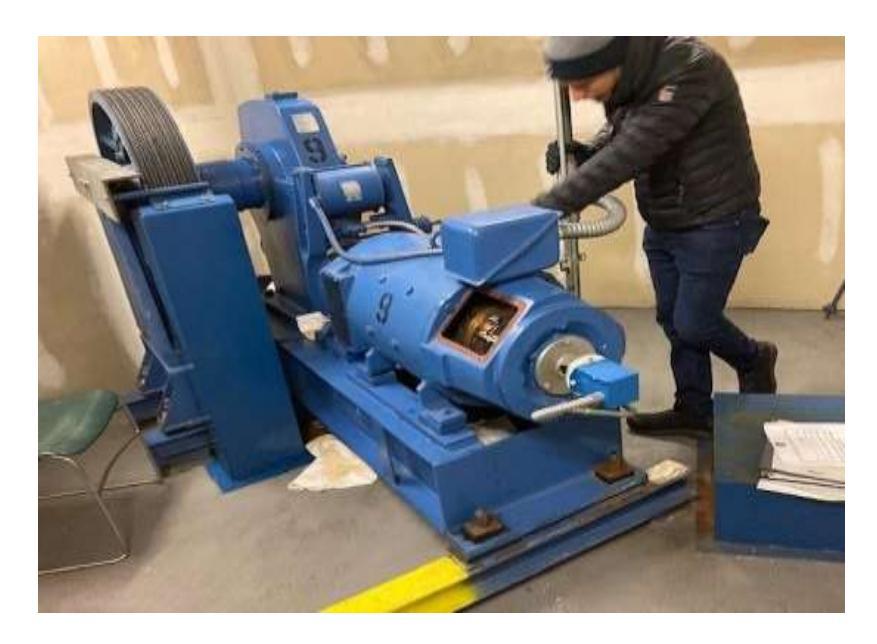
#### **Observation VT-6: Car 9**

Car 9 controller

Car 9 motor

Modernize controls, AC VVVF motor and machine refurbishment, fixtures, door operator and door equipment at Car 9. Coordinate with mechanical, electrical, and fire protection.
