# Seattle Mariners T-Mobile Park Long-Term Capital Needs Assessment REPORT / MAY 2022

# 1.0 - PREFACE

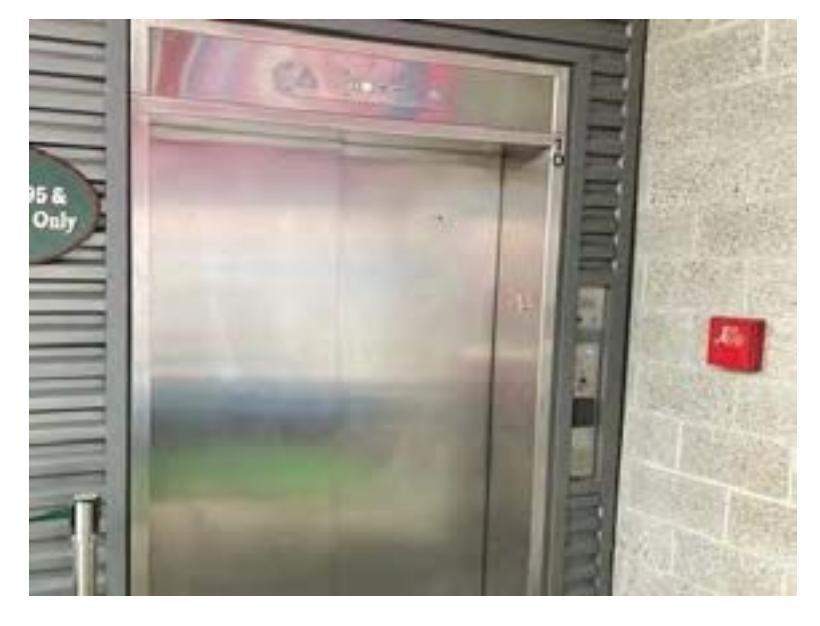
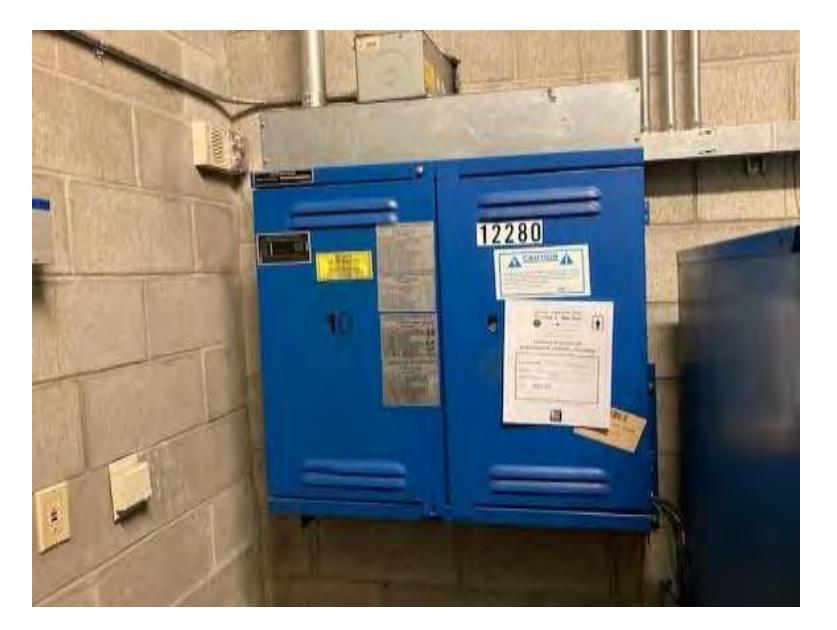
#### **Observation VT-7: Car 10**

Car 10 entrance

Car 10 controller

Modernize controls, AC VVVF motor and machine refurbishment, fixtures, door operator and door equipment at Car 10. Coordinate with mechanical, electrical, and fire protection.

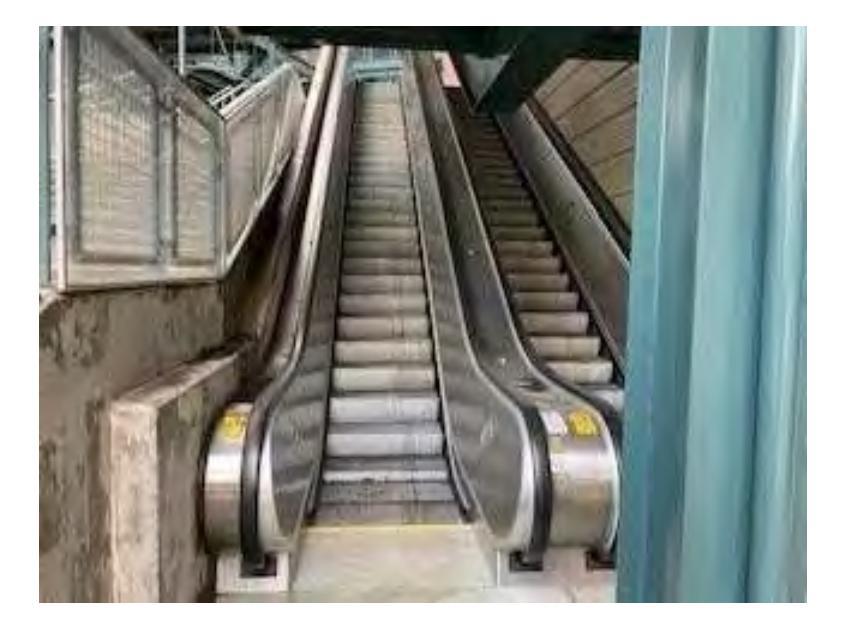
Escalator 12

This unit is nearing the end of useful life and should be considered for replacement.

Replace complete escalator.

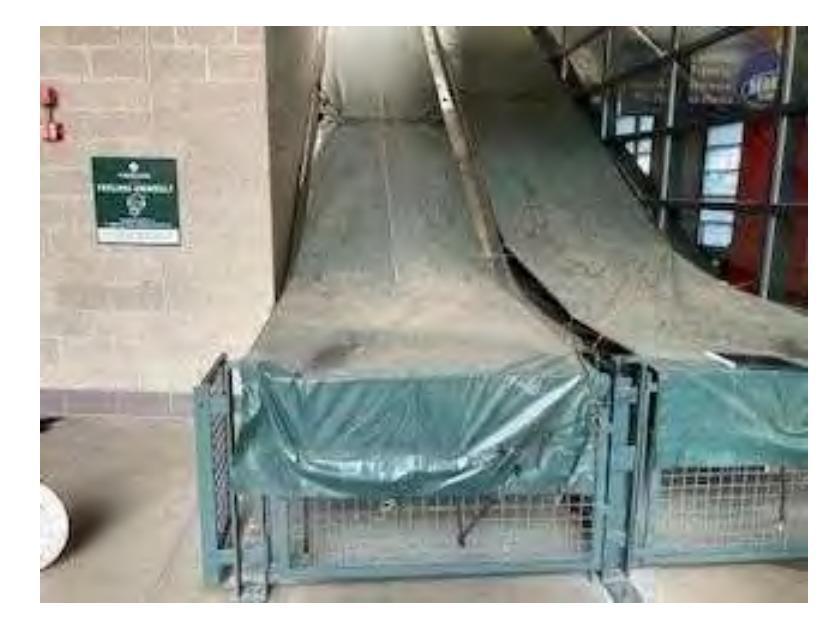
Escalator 13

This unit is nearing the end of useful life and should be considered for replacement.

Replace complete escalator.

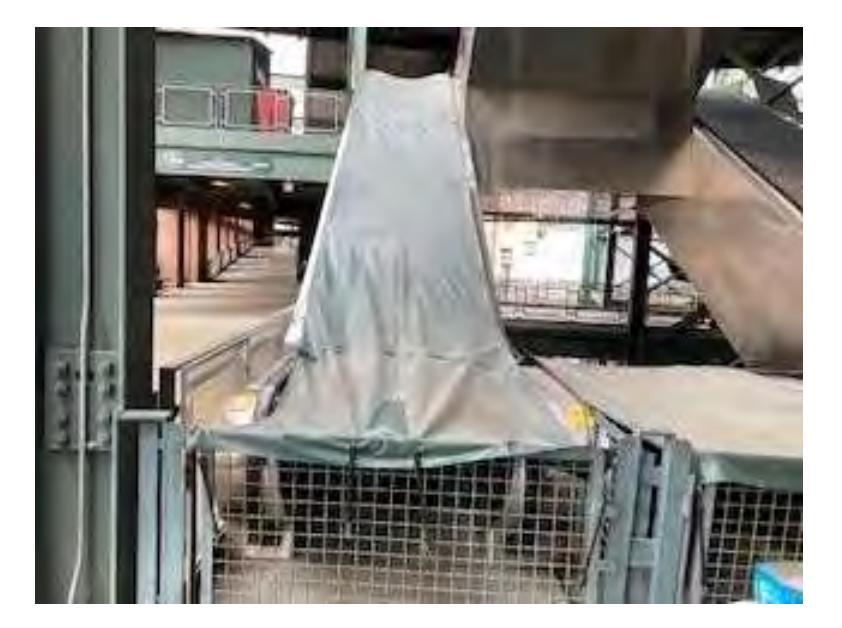
Escalator 15

This unit is nearing the end of useful life and should be considered for replacement.

Replace complete escalator.

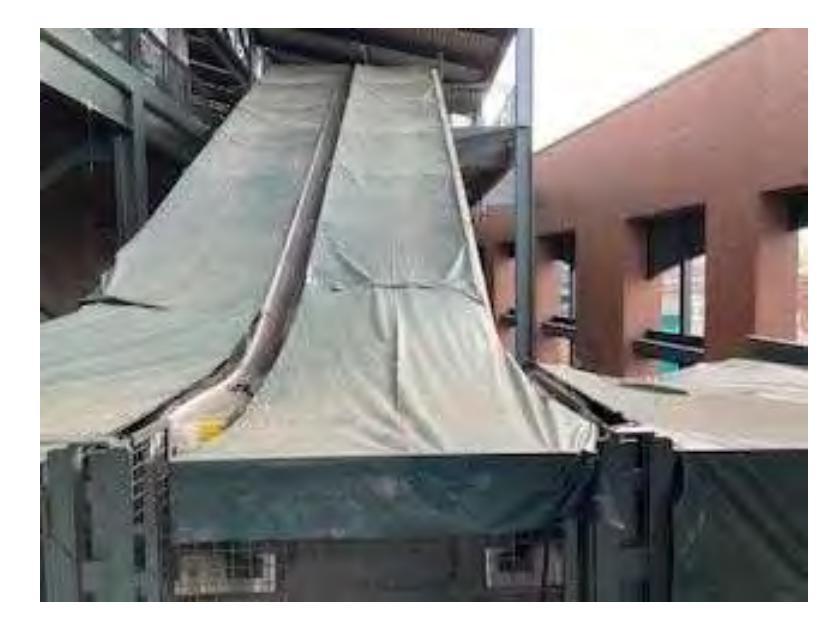
Escalator 17

This unit is nearing the end of useful life and should be considered for replacement.

Replace complete escalator.

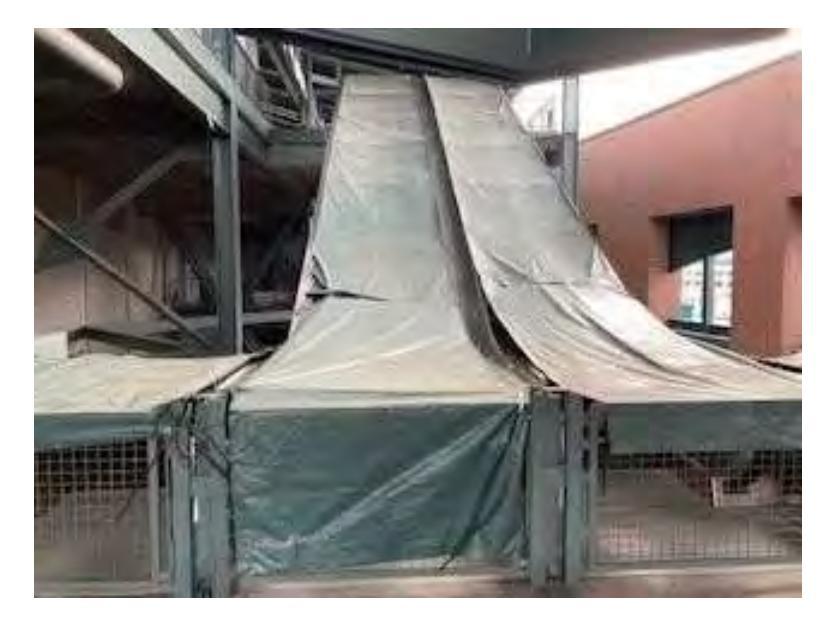
# **Observation VT-15: Escalator 18**

This unit is nearing the end of useful life and should be considered for replacement.

Replace complete escalator.

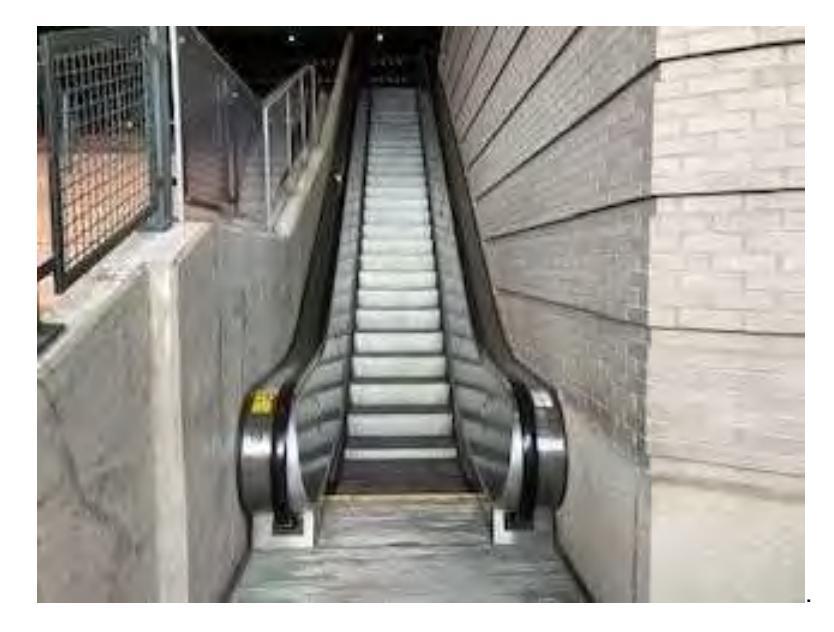
Escalator 19

This unit is nearing the end of useful life and should be considered for replacement.

Replace complete escalator.

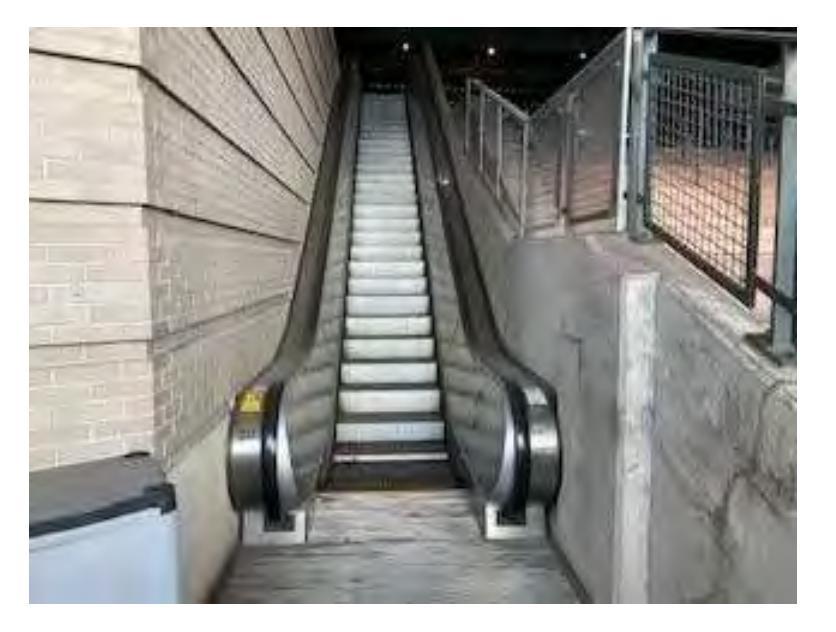
Escalator 20

## **Observation VT-17: Escalator 20**

This unit is nearing the end of useful life and should be considered for replacement.

Replace complete escalator.

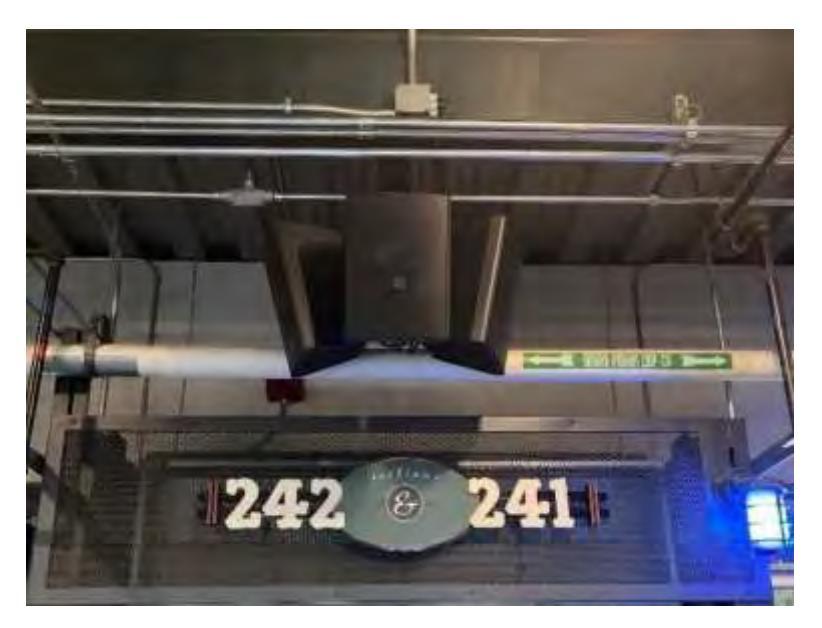
The seating bowl sound system was replaced in 2020; however, certain locations throughout the ballpark were not replaced at that time, including the First Base and Third Base Clubs on 200 Level, Hit Here Café, All-Star Club, and outdoor entrance gate areas. These speakers are original and have reached end of useful life.

Example of speakers at gates and entrances to seating bowl

Replace speakers within the next 3 to 5 years to avoid component failure, either due to weather exposure or parts availability.

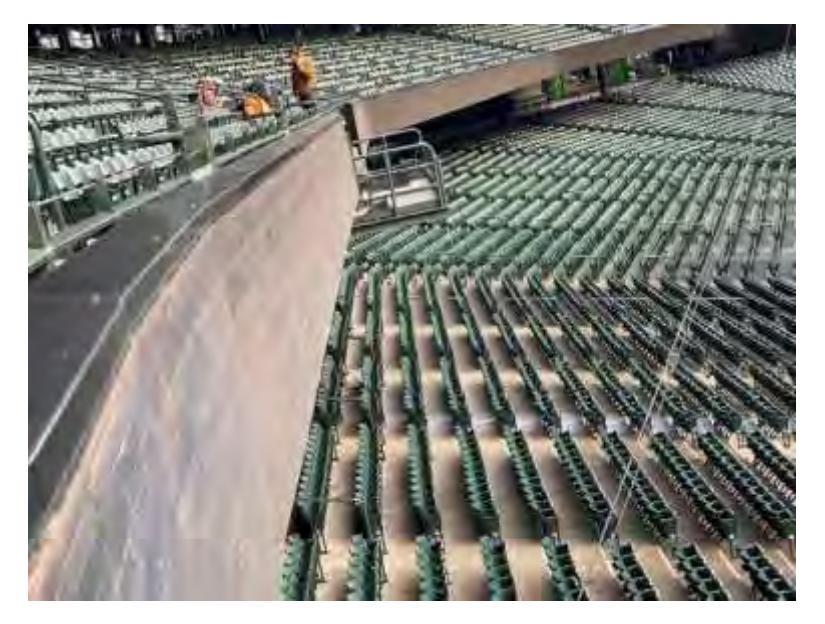
Both the out-of-town and ribbon board LEDs are at the end of their useful service life (installed in 2010 and 2011) and need replacement, either due to parts availability and or weather.

Wear and tear due to weather and other factors on mask for the ribbon boards

Both systems should be replaced in the next 1-2 years to avoid failure in the middle of a game and parts are not available to resolve any issues that arise.

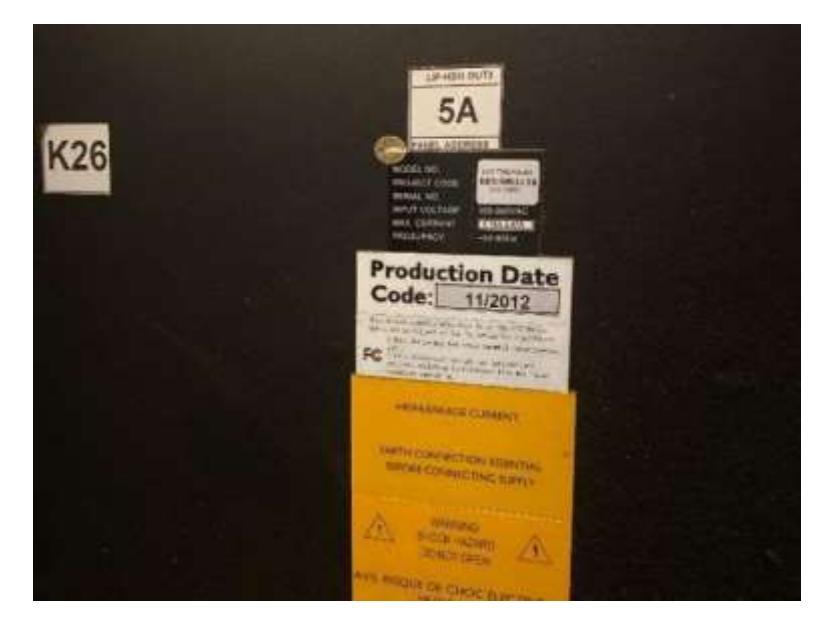
This system appears to be in relatively good condition; however, it is at the end of its recommended service life (installed 2013) and parts are becoming harder to come by, resulting in difficulties with performing maintenance should it arise.

Production date of Mariners Vision LED tiles

LED screen should be replaced in the next 1 to 3 years to avoid failure in the middle of a game since parts are limited (or not available) to resolve any issues that arise.

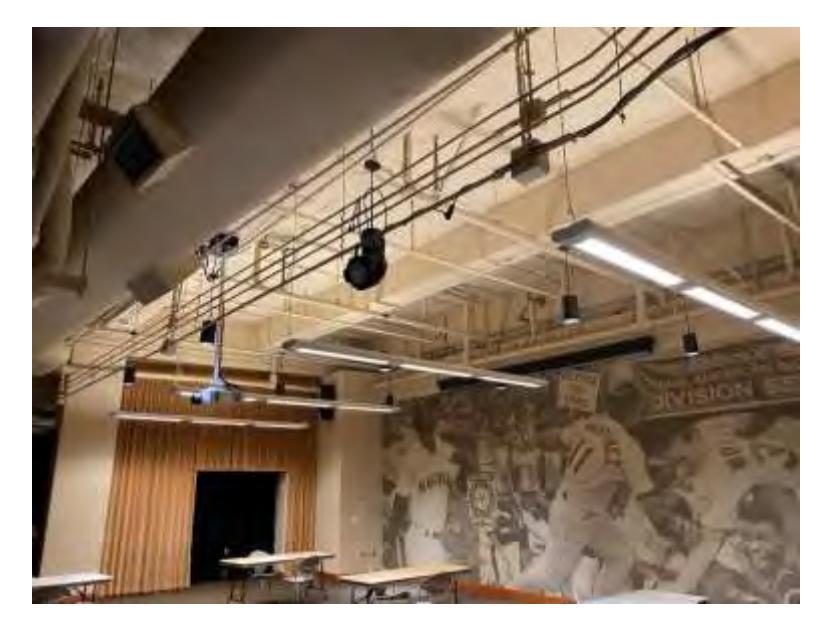
Overview of one of the partitions showing projection, misc. lighting, analog audio connections

A full audio / visual modernization should be considered to better accommodate all the different uses.

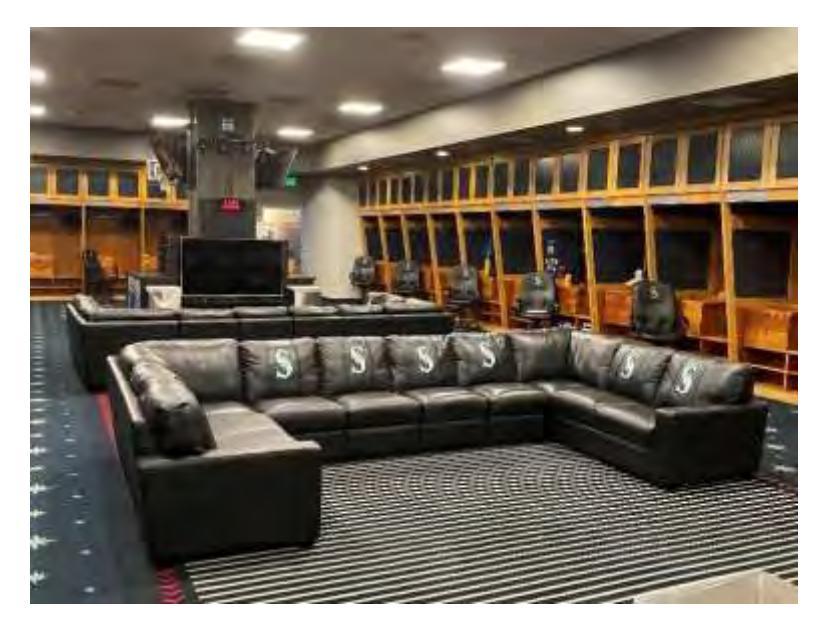
Home team locker room overview

Audio and visual systems are original but in adequate condition.

Home Clubhouse A/V systems should be replaced with current technology, control panels, 4K displays, IPTV, enhanced audio. Perform modernization in tandem with complete clubhouse modernization.

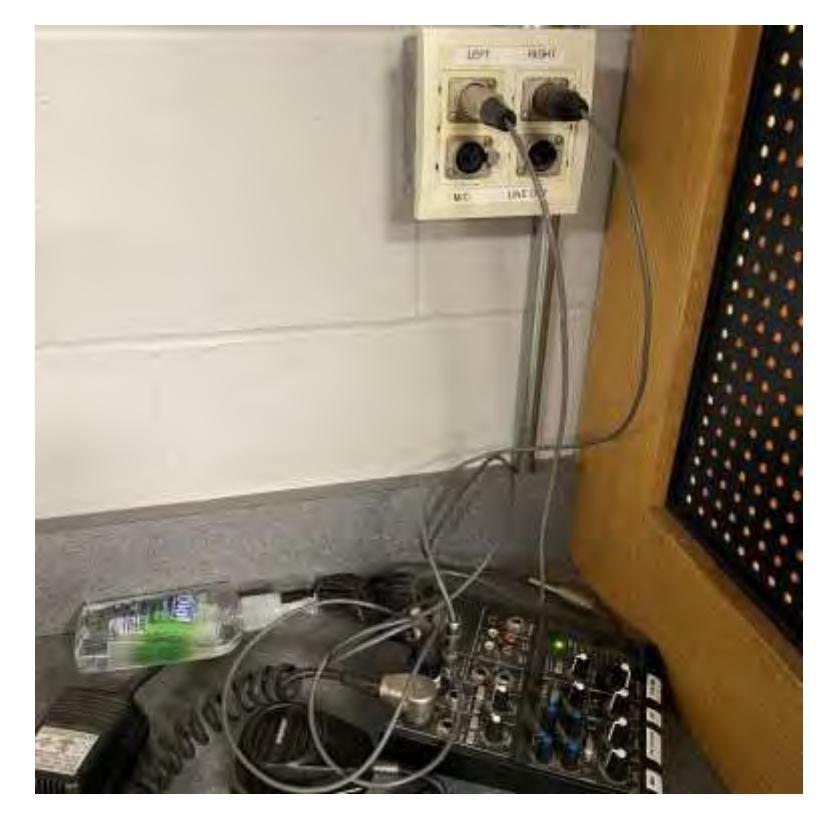
Audio and visual systems are original construction and not current technology but in adequate condition.

Audio connections to speakers in visitors' locker room

Visitor Clubhouse A/V systems should be replaced with current technology, control panels, 4K displays, IPTV, enhanced audio.

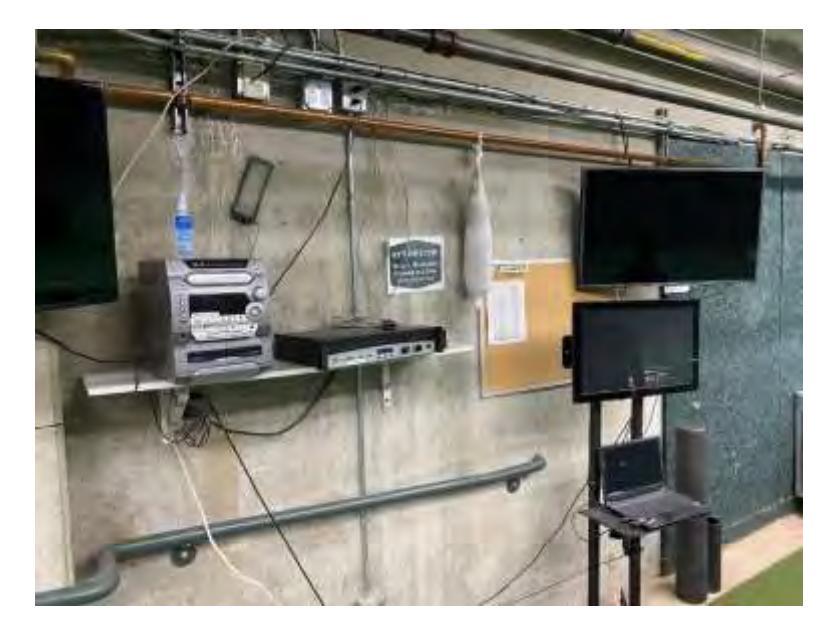
Audio and visual systems are original but in adequate condition.

Audio and visual setup in batting cages

Batting cages A/V systems should be replaced with current technology, control panels, 4K displays, IPTV, enhanced audio.

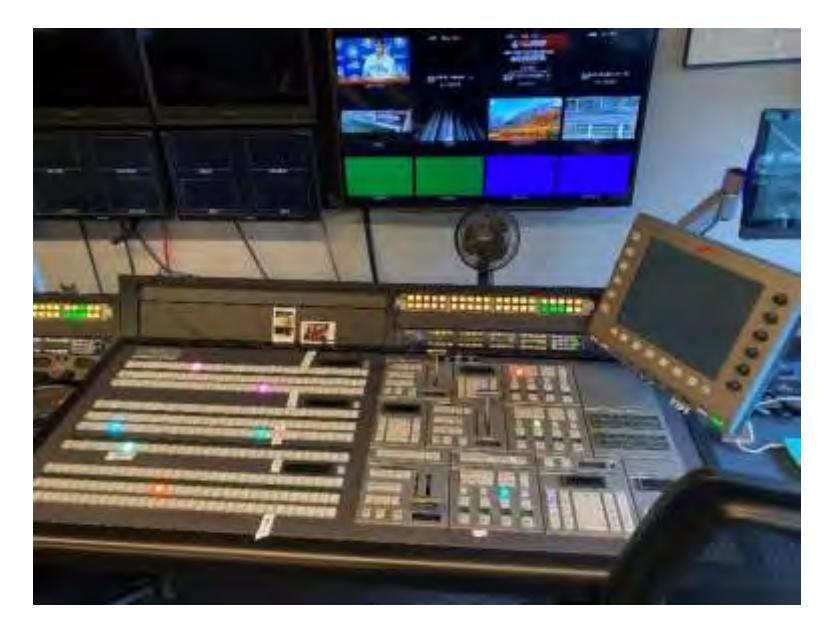
Broadcast video switcher in control room

The broadcast video and audio systems are in marginal to poor condition. Major components of the broadcast video system such as switcher, router, and replay systems were upgraded in 2013 or before. The broadcast audio console was upgraded in 2016. The infrastructure to support the original copper cabling for the broadcast system needs to be evaluated and convert to a fiber-based infrastructure that will allow for future growth and adaptation of technologies that are already in major broadcast facilities. The broadcast video system including the router, switcher, cameras, playback devices, capture devices, graphics machines and LED screen / ribbon boards should be upgraded in the next 1-3 years to 4K to align with the current industry standard.

Replace switcher in the next 1-3 years with a 4K version to support the current technology and have current parts and support.

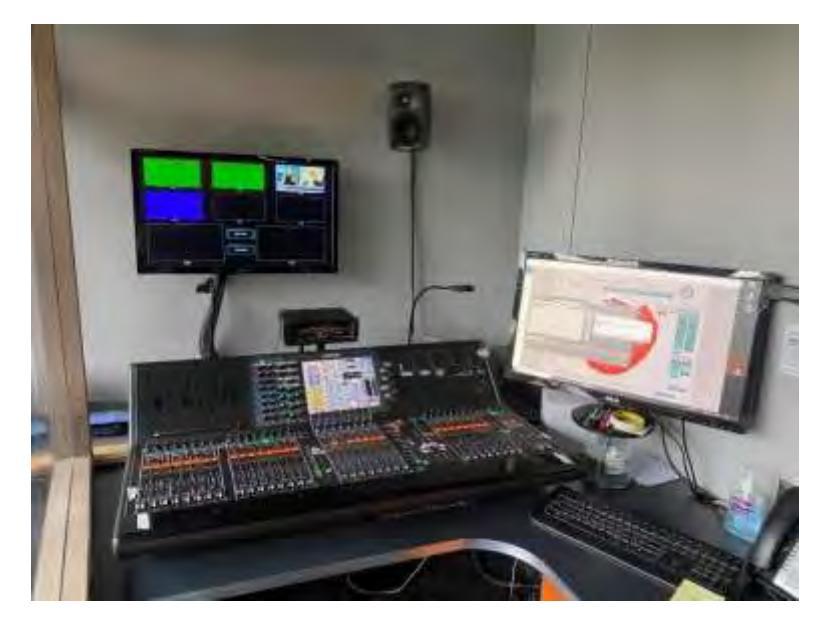
Broadcast Audio Console

The audio console was replaced in 2016 and serves the bowl and concourses.

This console is in adequate condition but should be replaced in the next 3-5 years as parts and support will become hard to find as it's already a 10-year-old product line.

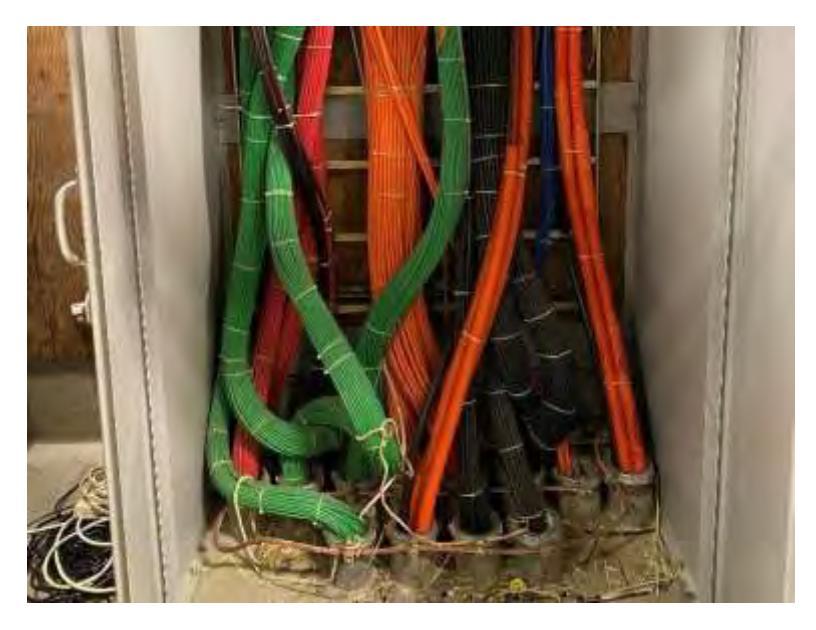
Full risers and pathways

Remove triax from infrastructure and replace with SMPTE to align with current broadcast standards. Remove coax tie lines and replace with SMFO fiber infrastructure that can be utilized for audio, video, or data.

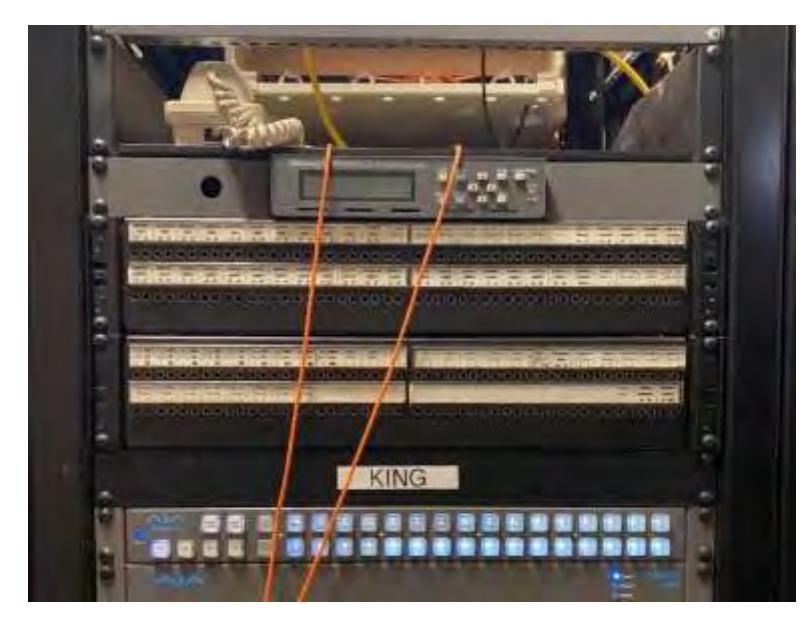
Abandoned / crossed out patch points (cabling associated with these still in rear of rack)

Remove and cleanup all unused end-of-life gear and cabling infrastructure.

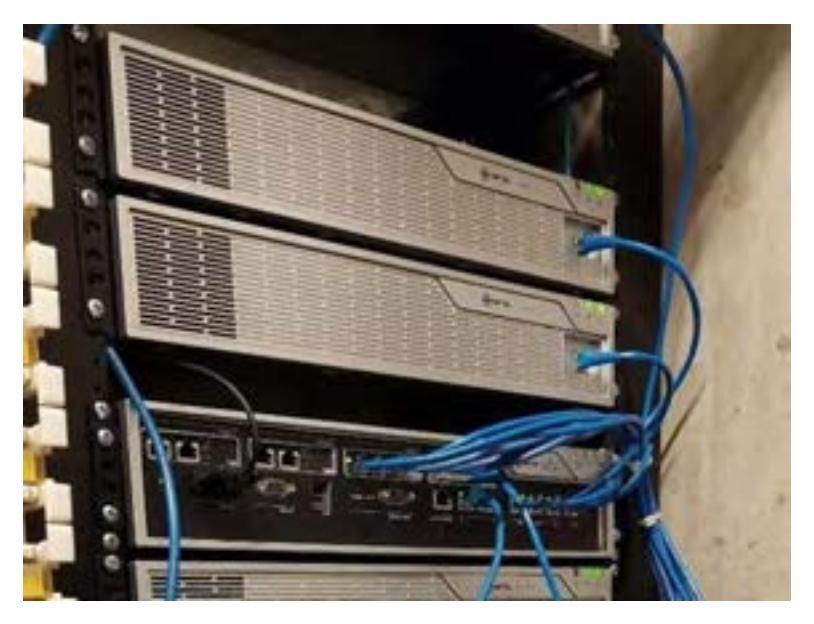
Mitel On-Premises IP-PBX

The telephone system is a Voice over IP (VoIP) from Mitel. The system utilizes an on-premises IP-PBX. The product was a lease-to-own and is between 8-10 years old. Additionally, the phone system utilizes a softphone technology from Ring Central.

Mitel and Ring Central have formed a strategic partnership which may allow for a transition to a cloud-based communications system, if desired to replace the on-premises PBX.

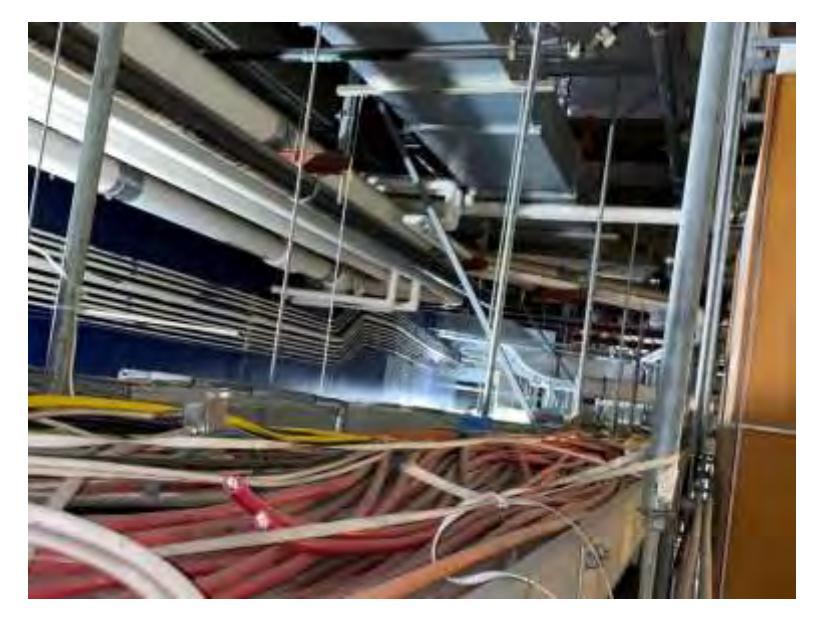
The telecommunications raceway systems are well planned to support cable distribution throughout the park. However, due to initial cable fill and continued additions over the last 20 years the backbone raceways are in adequate to poor condition. The cable infrastructure needs to be culled and older/abandoned cables need to be removed to free up space within the existing cable trays and riser conduits.

Full trays with cut cables remaining

Remove older and abandoned cables from the cable trays.

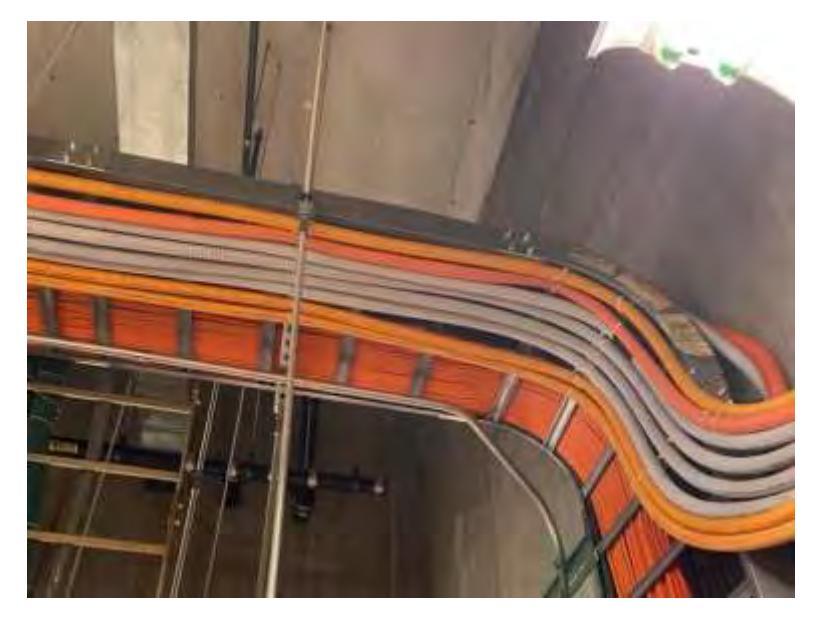
Full trays within Comm Rooms

Remove older and abandoned cables from the cable trays.

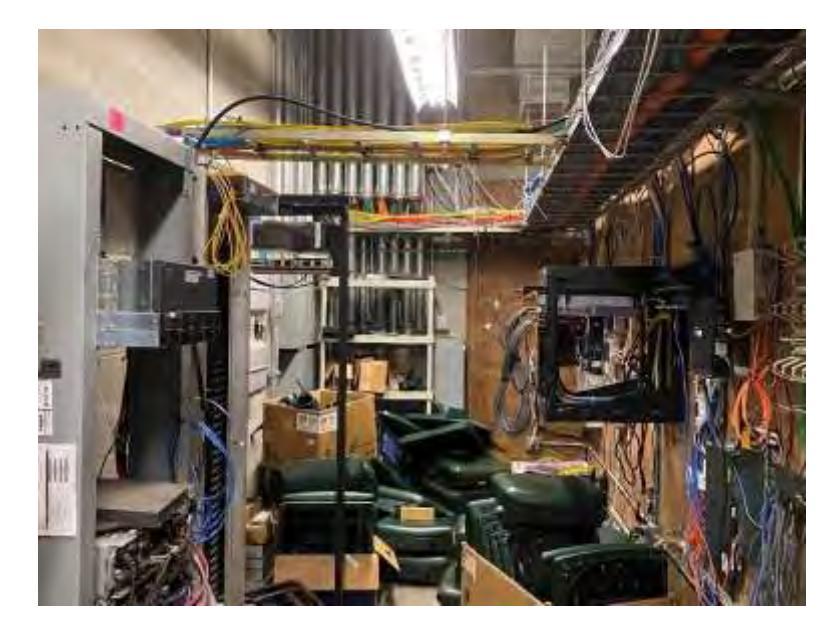
While each of the systems have found space for their systems by utilizing available wall space or floor space, this has caused each system and rack to be a unique installation throughout the venue.

The rooms are also being used for storage of non-IT systems. Use of the IDF rooms for non-IT storage should be viewed as a security concern. General access provides a cyber security concern, and non-IT storage increases the risk for physical damage, cable disconnects, and limits access to the necessary equipment for any maintenance necessary.

Intermediate Distribution Frame (IDF) Rooms with storage of non-IT systems

**Recommendation:** A standard approach should be considered for installation/mounting as part of capital projects for replacing/upgrading backbone fiber optic and horizontal tele/data cabling. Additionally, a cleaning/culling is needed in each of these rooms to remove unused/abandoned equipment. Many systems remain mounted and, in some cases, powered, while not being utilized. To avoid needing to find new space for communications equipment, these rooms need to be maintained.

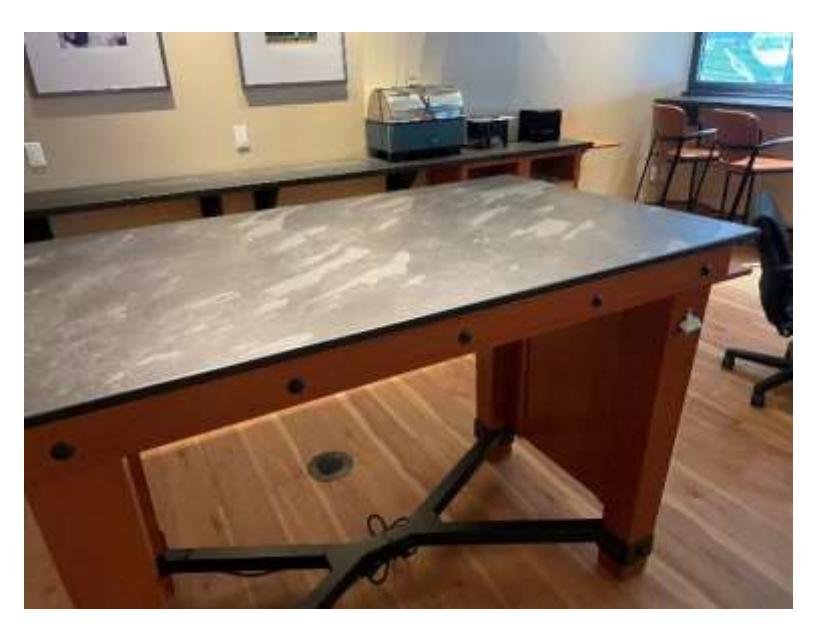
Suite Furniture

The suite level contains over 60 total suites. The suites have a significant number of original furnishings that are dated and contribute to a dated aesthetic feel in the units. Upholstery, wood, and partitions all show sign of degradation. Placards outside the suites are beginning to show signs of wear and tear and are missing letters in some instances. The suite level corridor is well maintained and received investment in 2018 in the form of new carpet and paint.

Program a modernization of suites and corridors to provide an experience similar to other Applicable Standard Ballparks. This planned investment should be made in the first three years of the plan.

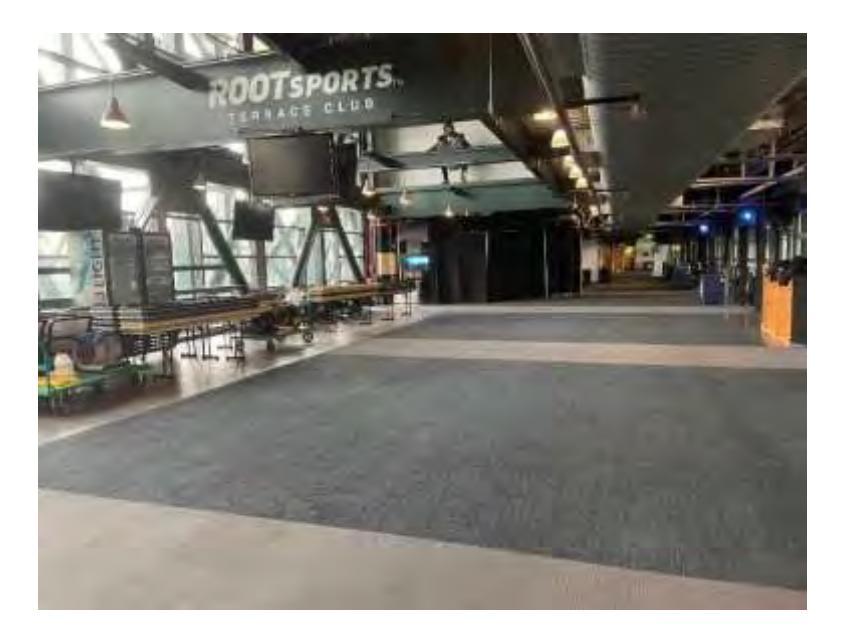
ROOT SPORTS Terrace Club
## FACILITY ASSESSMENT

With potential introduction of a new club in the existing writing press area, the ROOT Sports Terrace Club will become the third-tier club in the ballpark after the Diamond Club and new press club. The club area itself appears to be generally in good repair.

Program a modernization of the club space approximately five years into the plan. Replace with like basic FF&E commensurate with its positioning in relation to other club spaces throughout T-Mobile park.

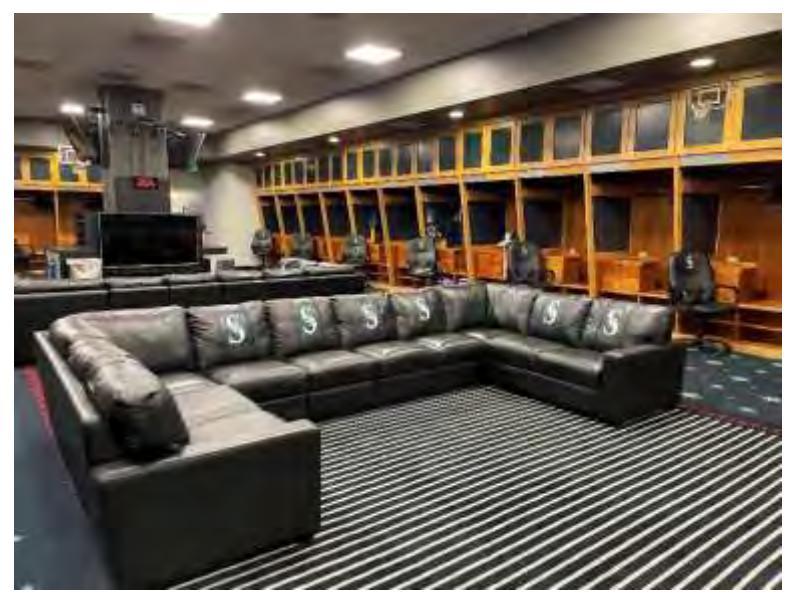
Home Clubhouse

The home clubhouse is generally in good condition but is starting to show signs of age – particularly with regard to player locker millwork and technology aspects. Furniture in the clubhouse is generally consistent with what is provided in peer ballparks, though dining areas furniture is noticeably basic and in need of improvement to provide improved player comfort. The player lockers lack technology amenities that are frequently integrated into similar space in contemporary MLB ballparks.

Program a modernization of FF&E in conjunction with an overhaul of the home clubhouse. Program the home clubhouse overhaul within 3 to 5 years.

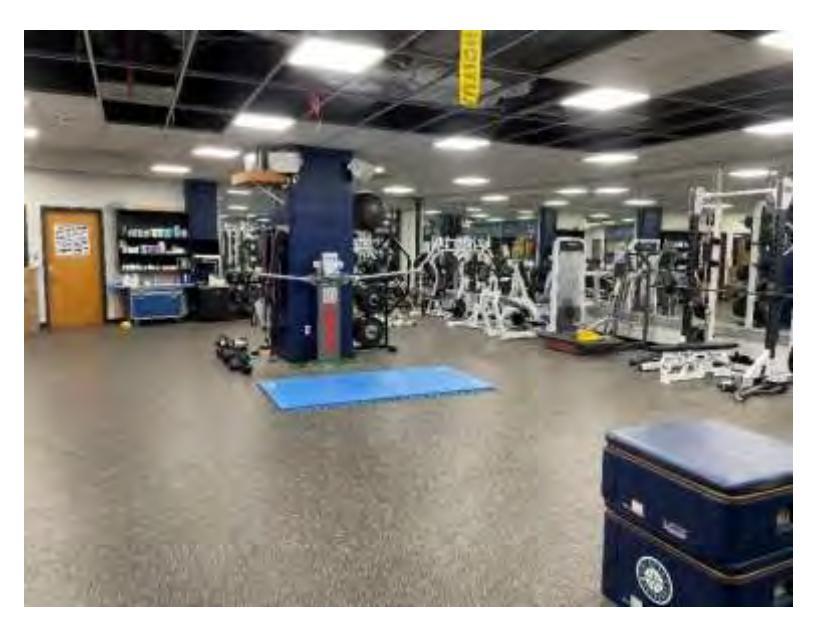
Home Clubhouse Weight and Fitness Space

Program a modernization of the training space in conjunction with an overhaul of the home clubhouse. Plan for overhaul of team spaces within 3 to 5 years.

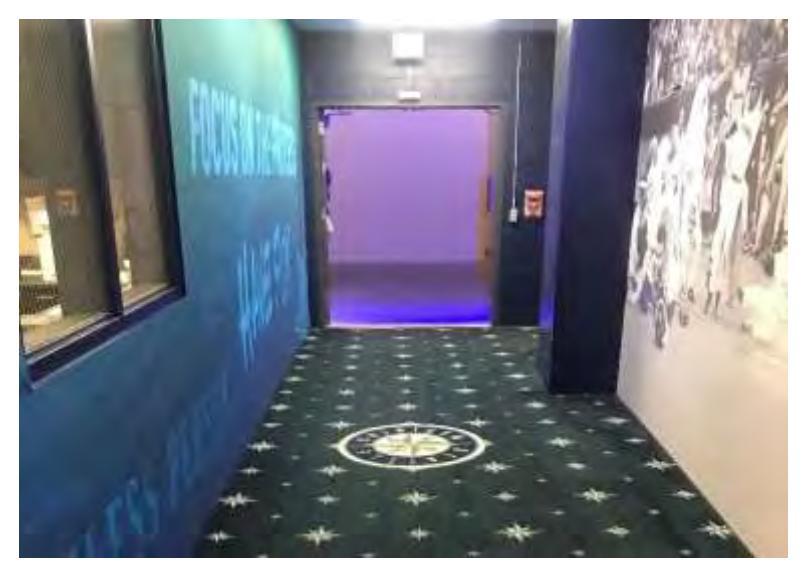
The Home Clubhouse is currently undergoing a minor refresh with some painting and updated graphics. Overall, it's in adequate condition, but needs a modernization. The finishes and surfaces are worn, and the lighting is a variety of different fixtures that don't provide quality illuminance.

Entrance to Home Clubhouse

Replace finishes at Home Clubhouse, including training area. Coordinate renovation with MEP systems and FF&E.

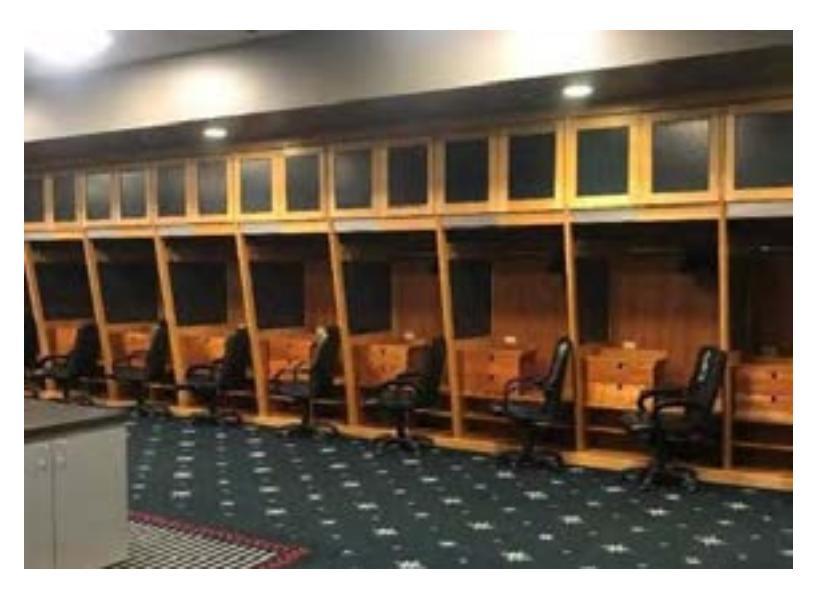
Player lockers

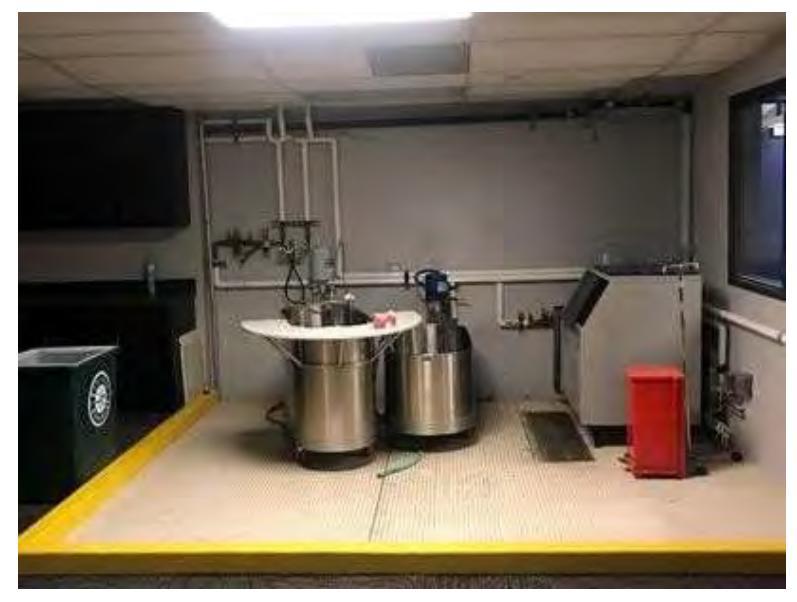
Visitor locker room

The Visitor Clubhouse is in adequate condition but needs a modernization to be in alignment with other MLB clubhouses. The finishes and surfaces are worn, and the lighting is a variety of different fixtures that don't provide quality illuminance.

Replace finishes at Visitor Clubhouse, including training area within first eight years of the plan. Coordinate renovation with MEP systems and FF&E.

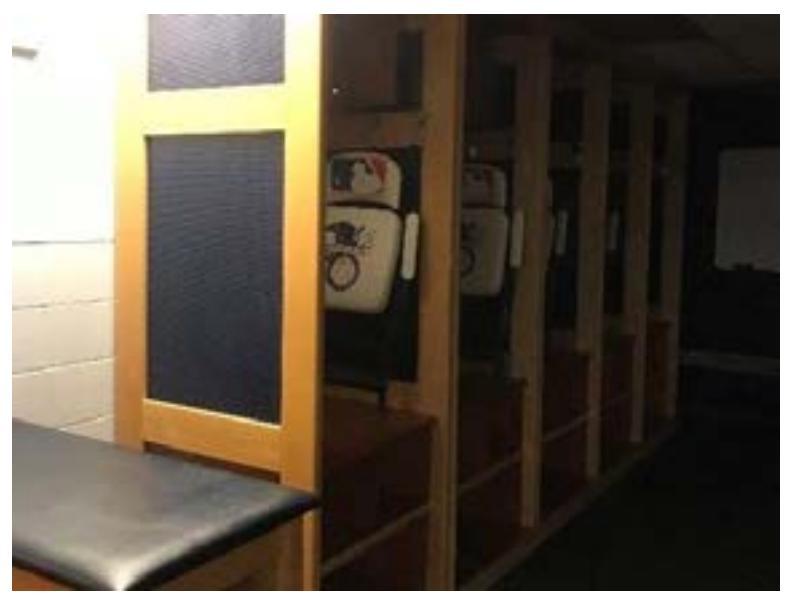
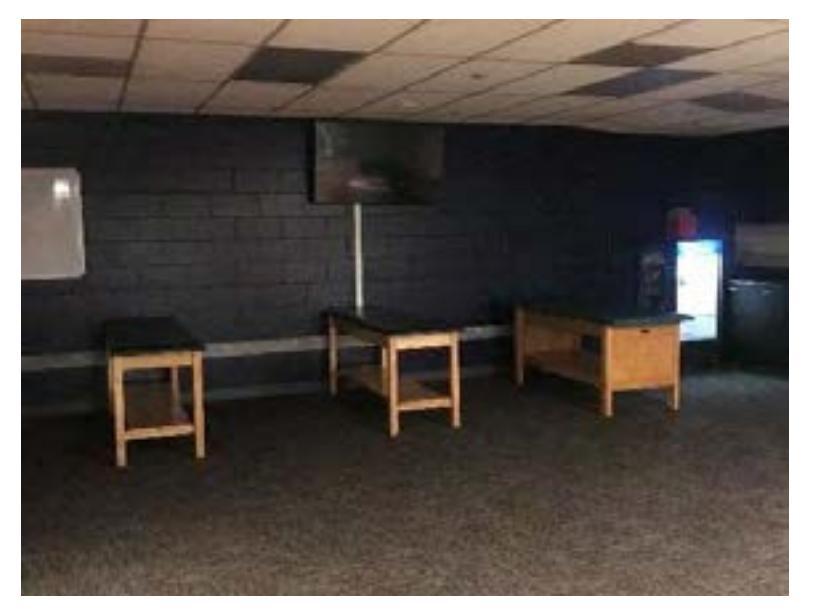
Visitor locker room

Visitor training area

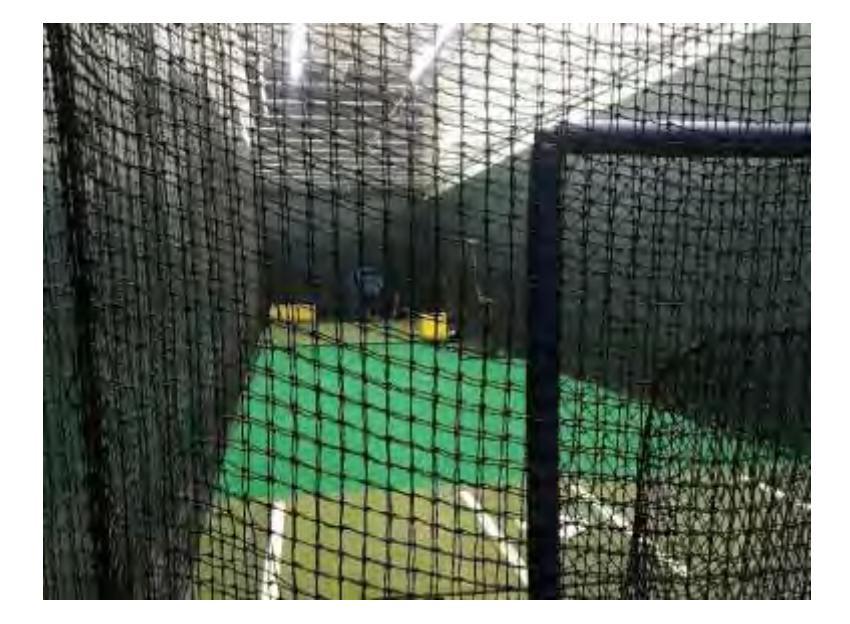
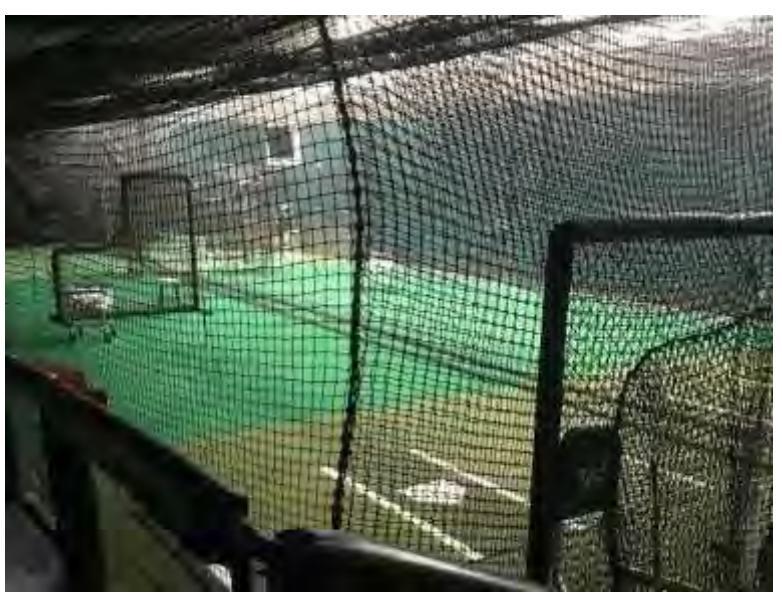
The Batting & Pitching Tunnels are in adequate condition, but areas of carpeting are mismatched and worn and appear to have water damage. Netting needs repair in certain locations and the lighting could be improved.

Replace finishes and netting at the Batting & Pitching Tunnels within the first five years of the plan. Coordinate with lighting, technology, and FF&E.

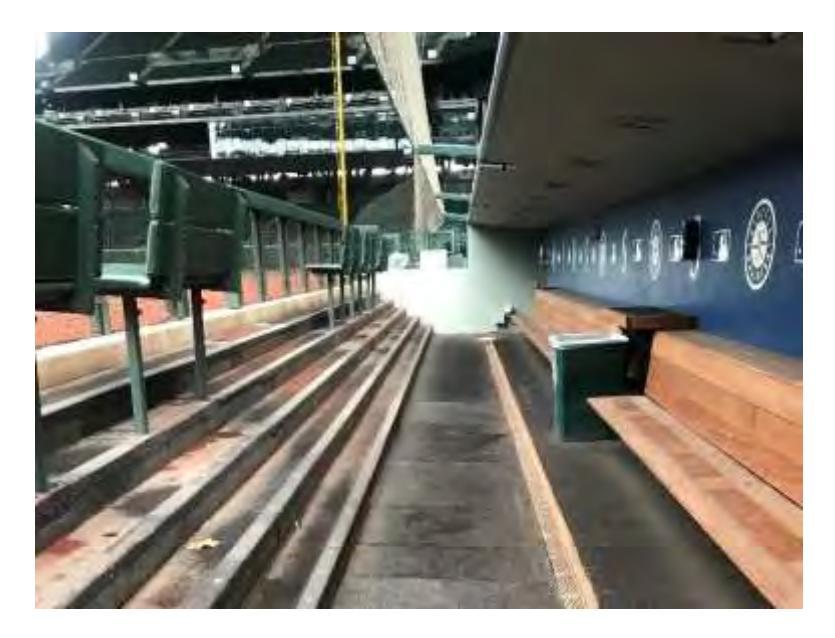
The home and visitor dugouts are in generally good condition, but certain components like the flooring and seating take abuse and require regular replacement. The Mariners were in the process of replacing flooring in both dugouts in advance of the 2022 season.

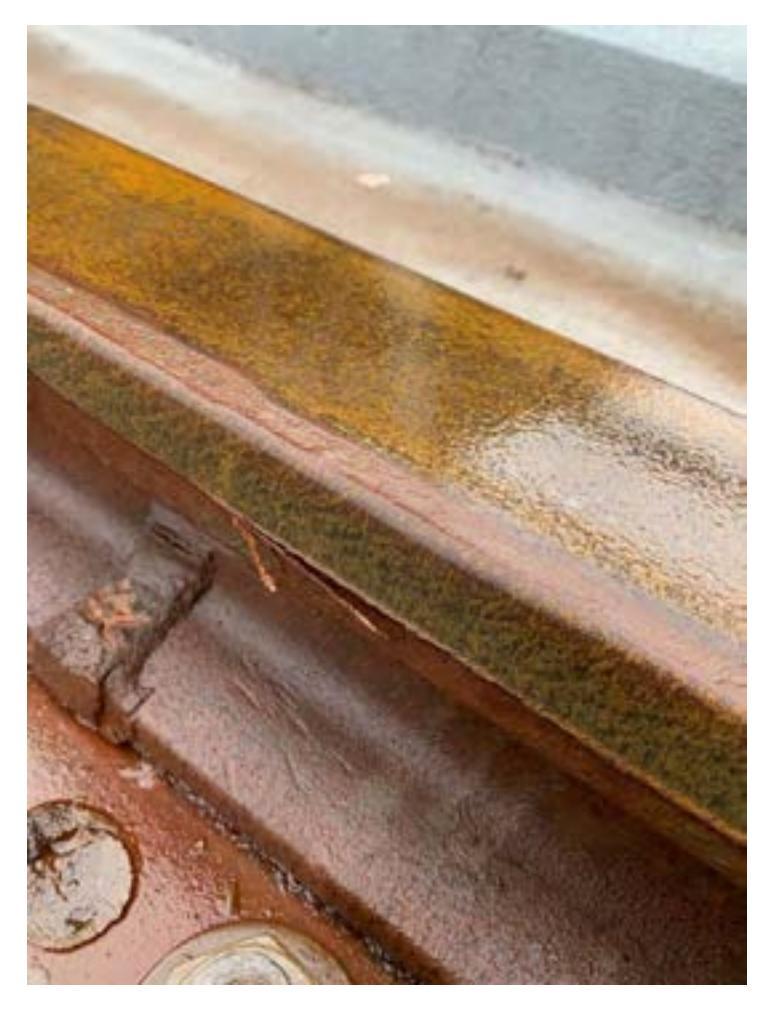
Photo M-2: Thermite welds found to be in good condition.
