# Seattle Mariners T-Mobile Park Long-Term Capital Needs Assessment REPORT / MAY 2022

# 1.0 - PREFACE

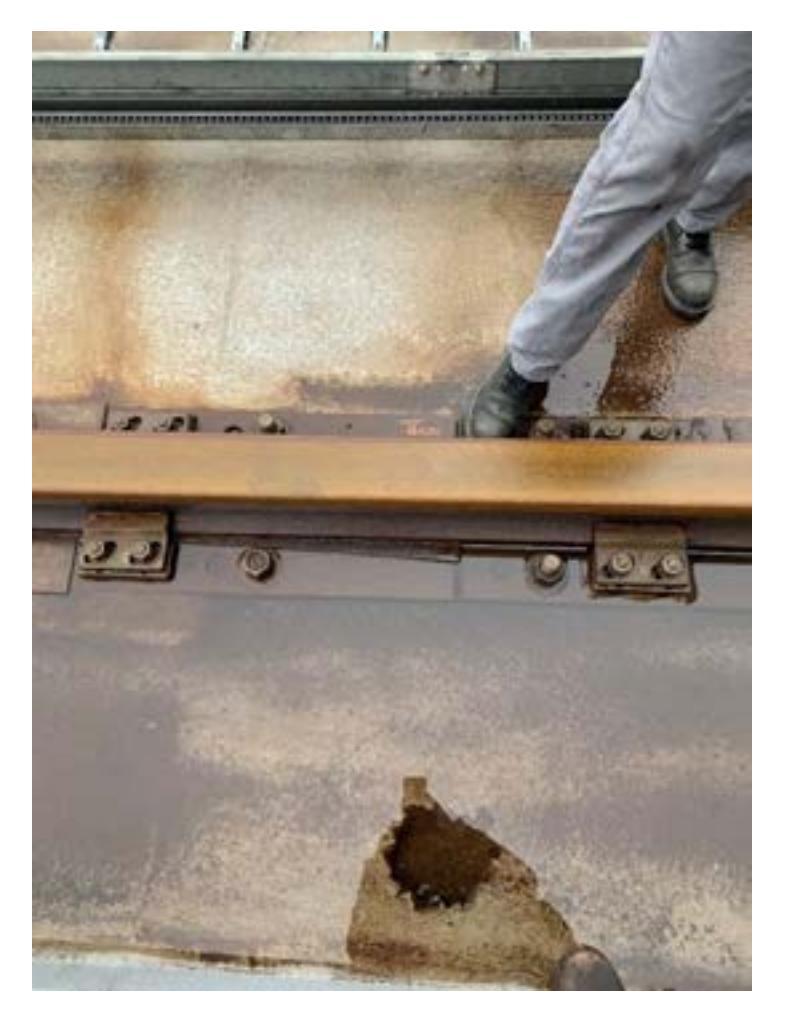
Photo M-4: Rail support shim plates shifted transversely.

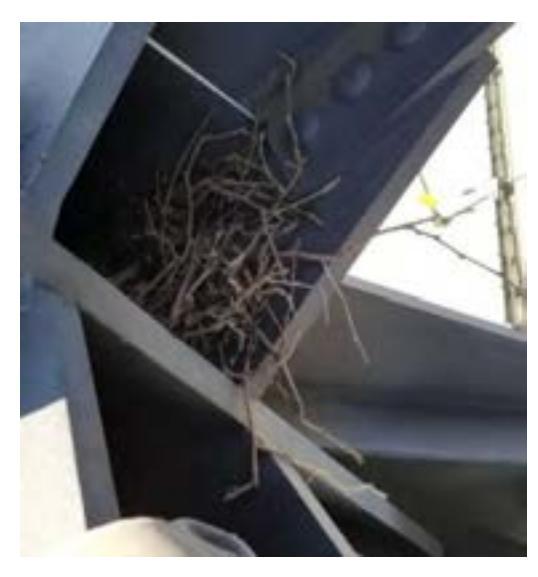
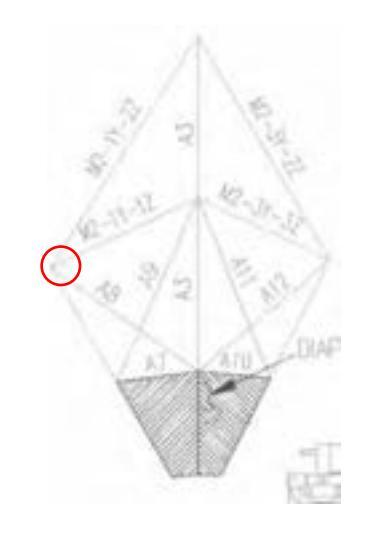
#### PANEL 2 COLUMN 1 ELEVATION

Photo #2	Guano	Buckling	✓ Other
Description:	Chalking	Paint Failure	
Nests	Crack	Corrosion	
Recommendations:	Bent	Warping	
Remove nest.	✓ Minor	Moderate	Significant
## **Panel 2 South Towers**

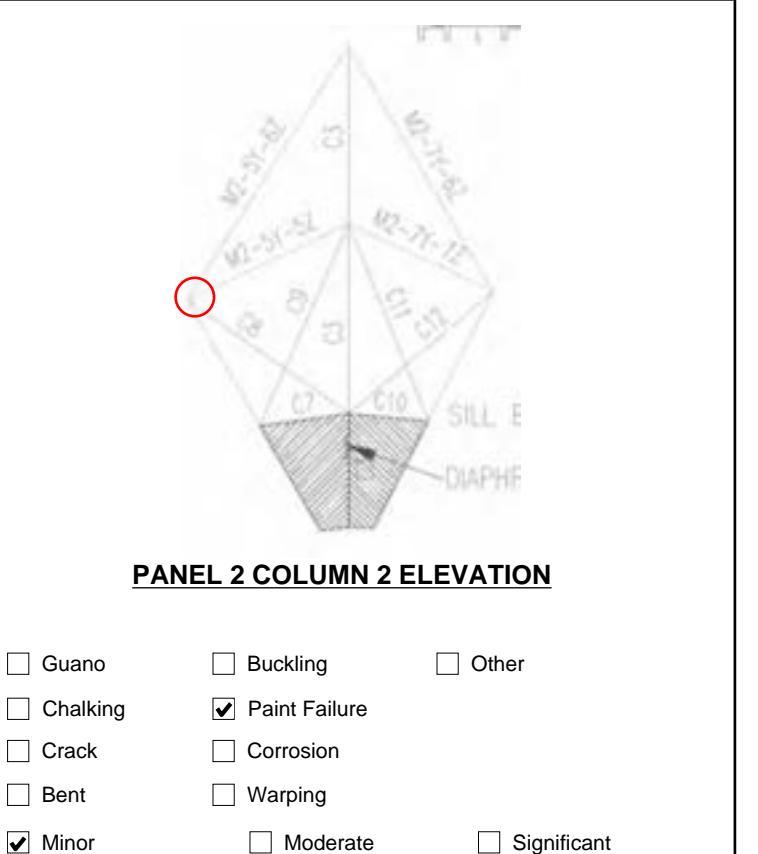
Photo #4 Description:

Topcoat failure.

Recommendations: Refer to paint repair recommendations.

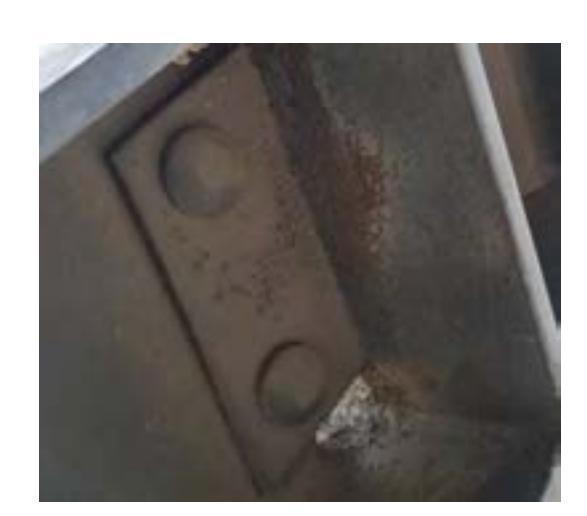
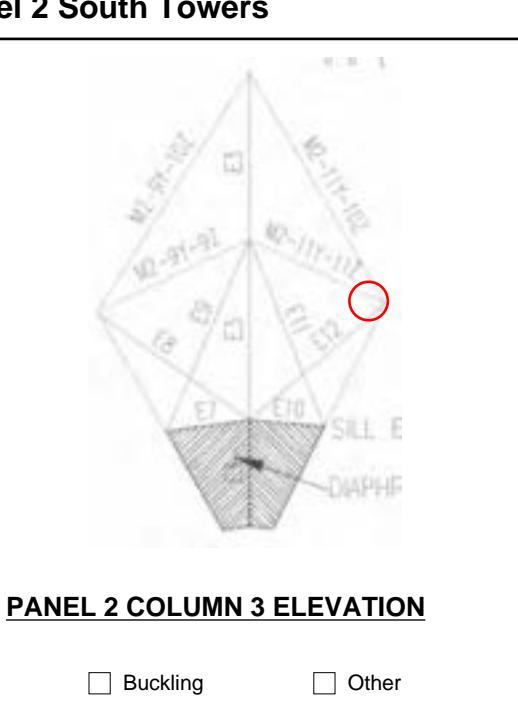
## Photo #3

Description: Chalking of top coat paint with pinhole corrosion.

Recommendations: Refer to paint repair recommendations

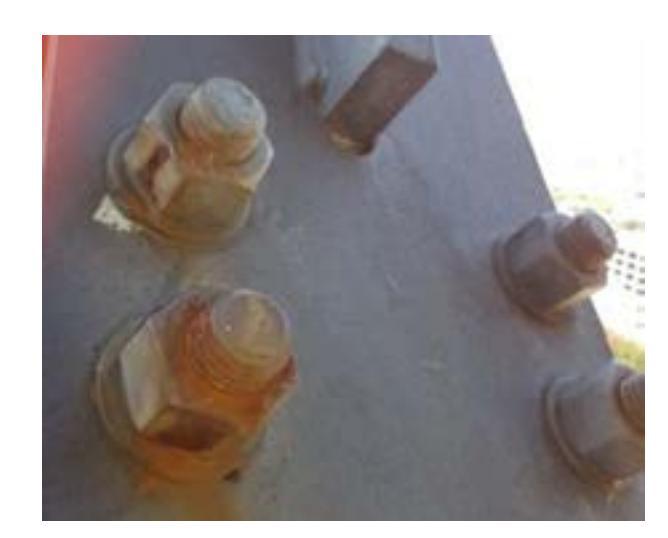
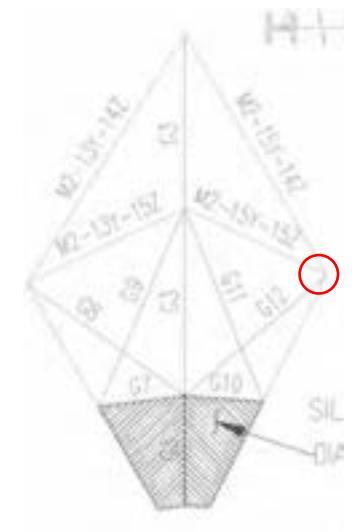
### PANEL 2 COLUMN 4 ELEVATION

Photo #4			
	Guano	Buckling	Other
Description: Chalking of top coat paint with minor surface	Chalking	✓ Paint Failure	
corrosion.	Crack		
Recommendations:	Bent	U Warping	
Refer to paint repair recommendations.	✓ Minor	Moderate	Significant

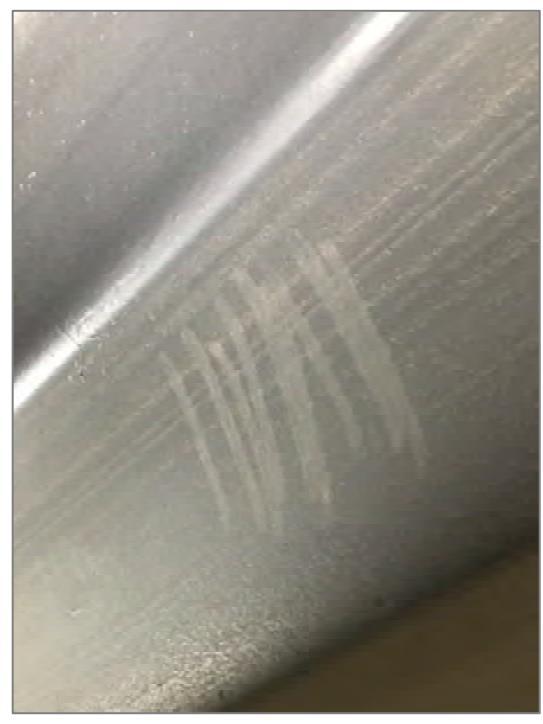
Figure 2: Dislodged chalking on surface of painted steel.

Most prevalent is chalking, a whitish deposit observed generally on the bottom surface of the steel member (ground-facing). There is an observable, powdery layer on top of the paint film that easily dislodges by wiping with a finger or cloth. This chalking can be relatively uniform,

splotchy, or have the appearance of brush strokes. Chalking can occur as a result of the disintegration of the paint binder, due to UV exposure and high humidity conditions. It can also signal the formation zinc hydroxide, the chemical formed when the zinc-rich primer is exposed to moisture and oxygen in the environment.

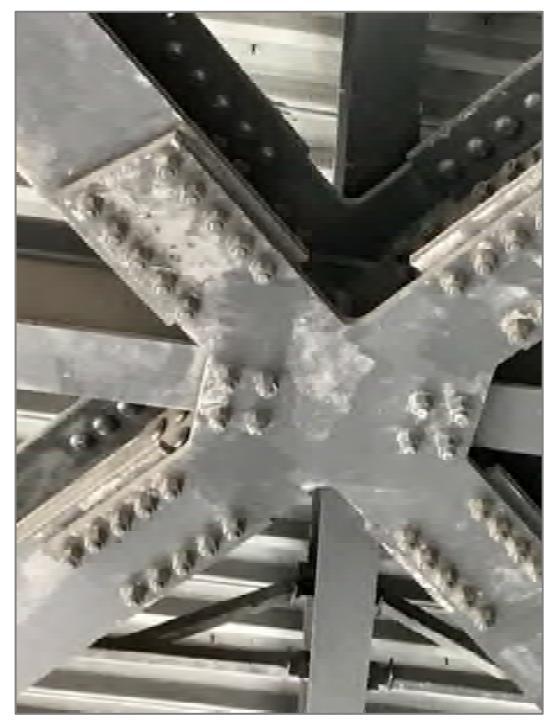
Figure 3: Chalking with splotchy appearance at a connection plate.

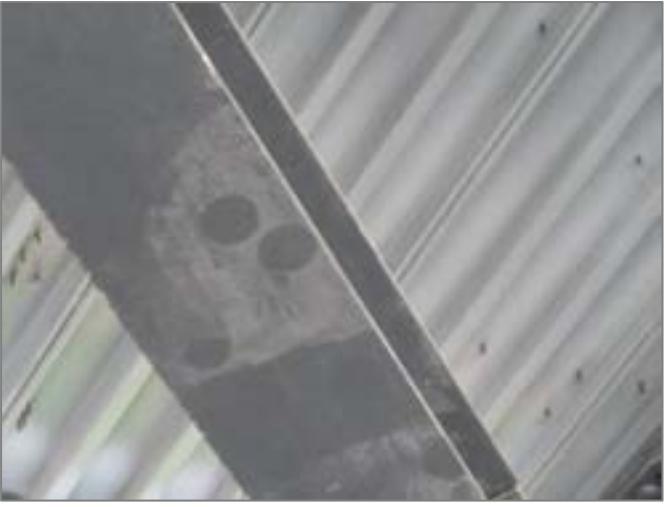
Figure 4: Chalking surface with distinct circular pattern that appears to be an artifact of the shop painting.

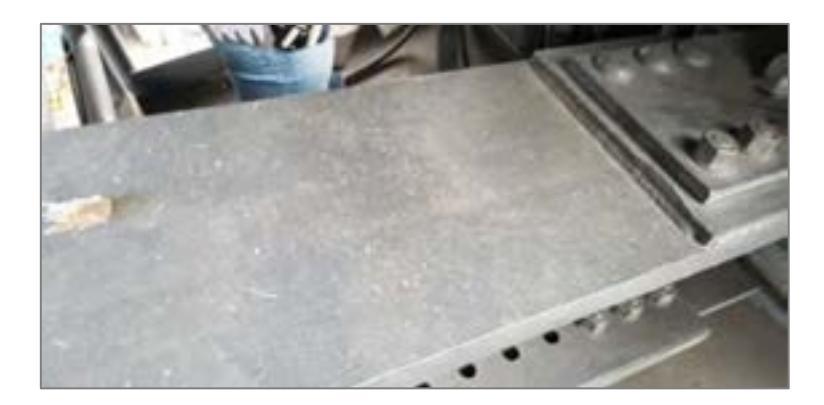
Abrasion damage is located in areas where the structural members are in the path of access for maintenance workers and staff. This occurs in very limited areas.

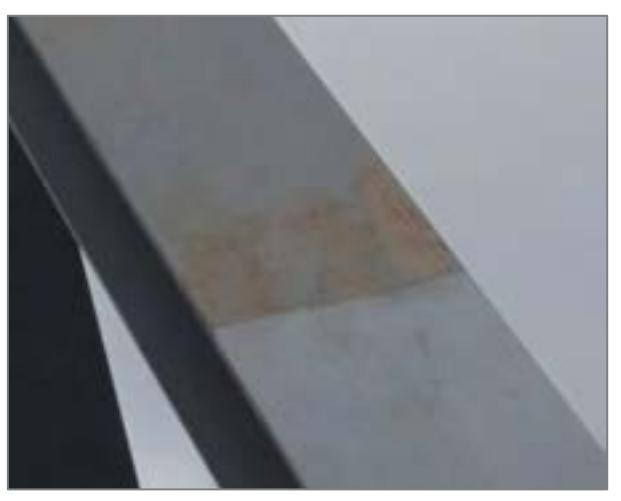
Surface rust is a bleed-through or blush of light corrosion through the coating. It is characterized by corrosion of the steel that discolors the surface of the coating. In Figures 5 and 6 below, the touched-up portion of the structural steel is evident below the surface corrosion visible in the older coating. The beginning of bleed-through corrosion can be seen at the touched-up area (lighter shade).

Figure 5: Close up of bleed-through corrosion beginning at the repainted steel.

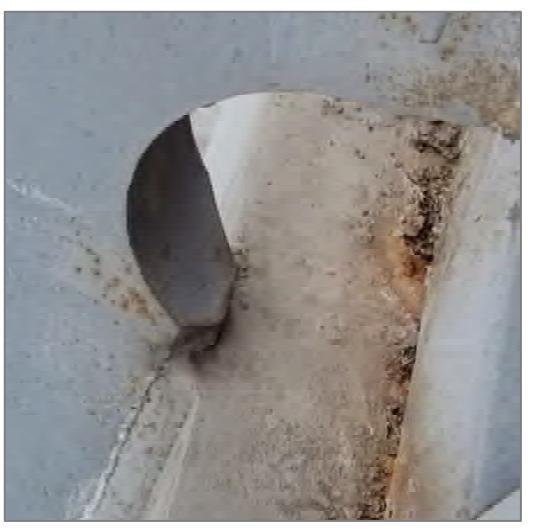
Pitting is characterized as small, localized areas of corrosion attack. This type of corrosion was observed primarily at joints and connections, most notably those where mill scale and weld spatter had not been cleaned from the surface of the steel.

Figure 6: Pitting in the coating caused by breakthrough corrosion.

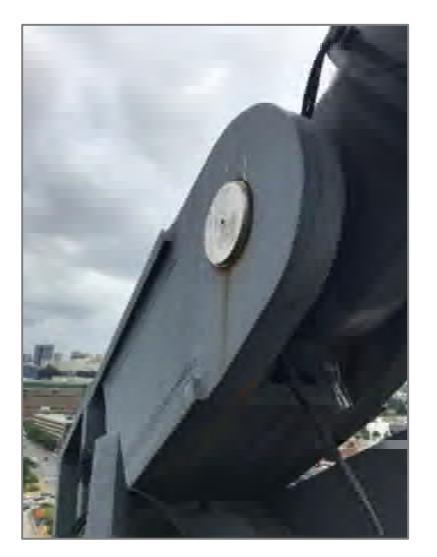
Crevice corrosion occurs between faying surfaces.

Figure 7: Corrosion between connection pin and steel support.

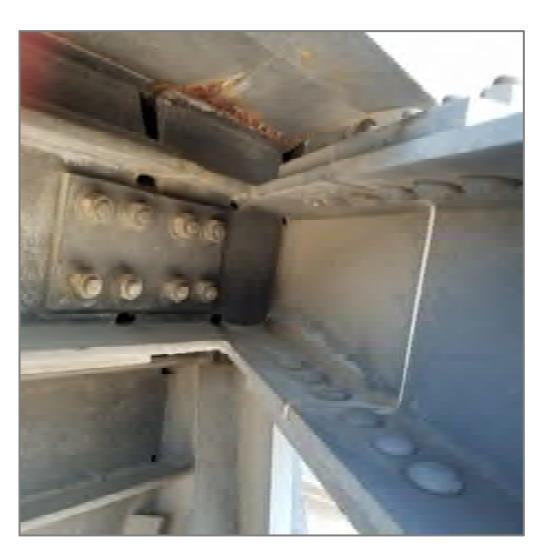
Figure 8: Corrosion between plates.

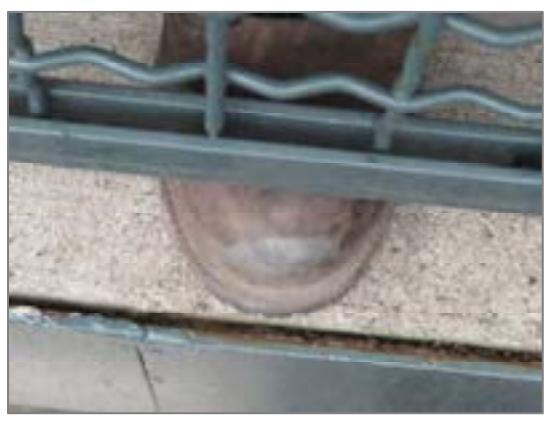
Pack rust is a localized expansive corrosion that occurs in a confined space.

Figure 9: Pack rust between steel edging and concrete walking surface at an elevated walkway.

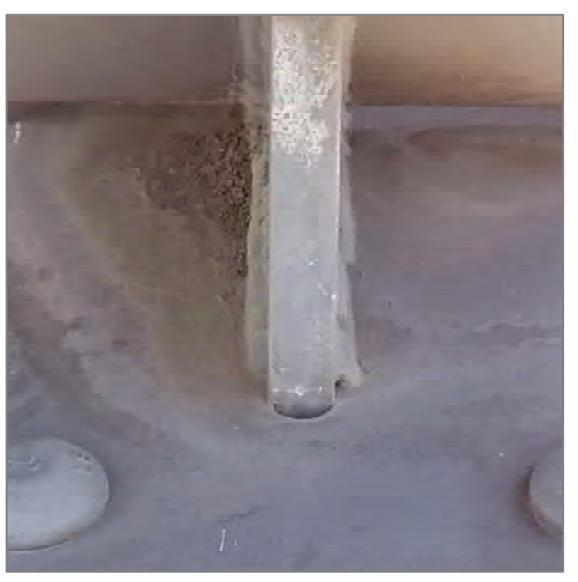
One example of an area where water and environmental debris has collected. The whitish rings indicate pooled water had collected at this location.

Figure 10: Evidence of pooled water at a connection.

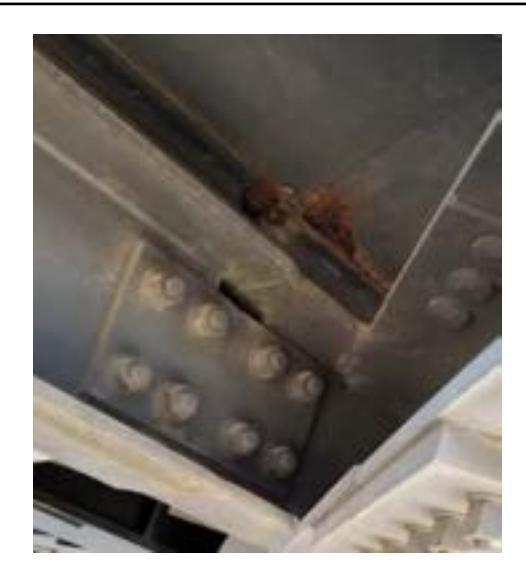
## PANEL 2 COLUMN 1 ELEVATION

Chalking of top coat paint with minor corrosion.

Recommendations: Refer to paint repair recommendations.

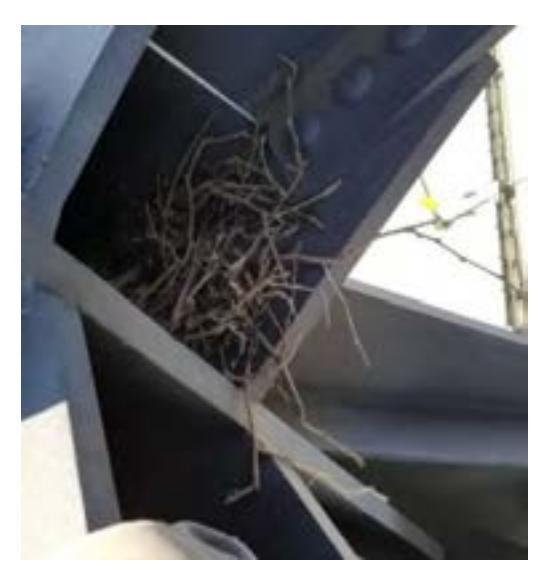
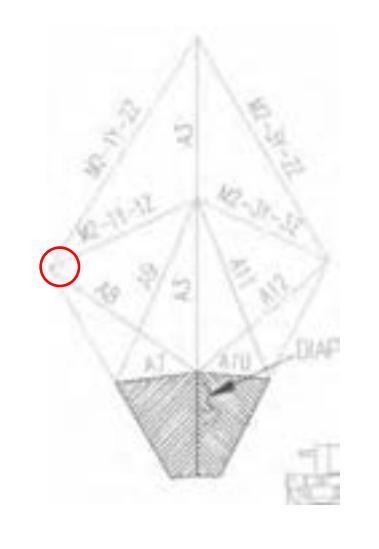
## PANEL 2 COLUMN 1 ELEVATION

Photo #2	Guano	Buckling	✓ Other
Description:	Chalking	Paint Failure	
Nests	Crack		
Recommendations:	Bent	Warping	
Remove nest.	✓ Minor	Moderate	Significant

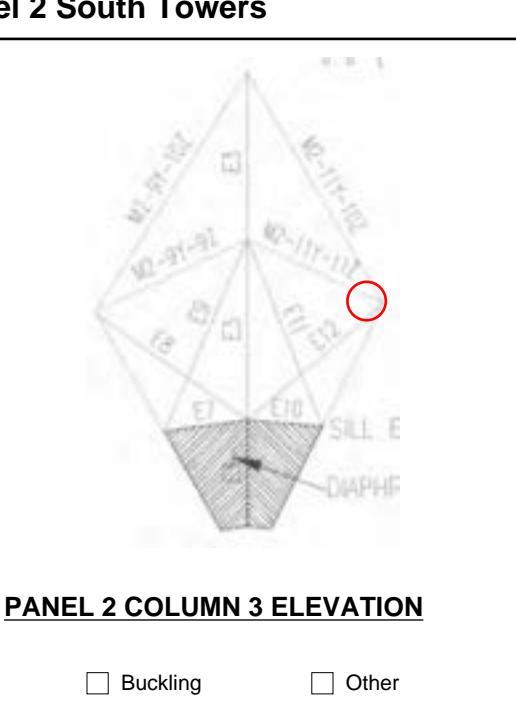
Description: Chalking of top coat paint with pinhole corrosion.

**Recommendations:** Refer to paint repair recommendations.
